HONG KONG MERCHANT SHIPPING INFORMATION NOTE

Fatal Accident during the Recovery of a Lifeboat

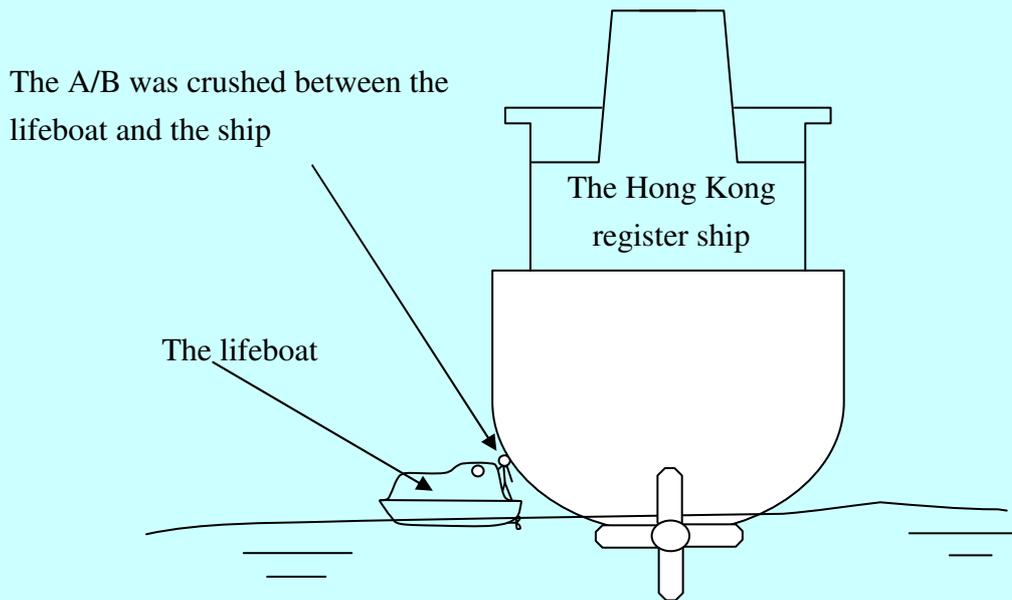
1. On 18 July 2005, an accident occurred on a Hong Kong registered ship during the recovery of a lifeboat in a drill. While the crewmembers were connecting the floating blocks onto the hooks of the lifeboat, the lifeboat was drifted under the influence of water current and wind into the curvature area of the aft side shell of the ship. A crew standing in the area was crushed between the canopy of the lifeboat and the side shell. He fell into the water and died in the incident. (See fig. 1)

2. The investigation revealed that there were blind sectors inside the lifeboat for the helmsman to view the outside environment. He was not able to maintain a proper lookout during the recovering process. Neither the top hatch of the canopy was used, nor a designated crew was assigned to keep a proper lookout while the helmsman was manoeuvring the lifeboat. As a result he was not able to assess properly the surrounding situations and react promptly to deal with the emergency.

Fig. 1: The scene of the accident

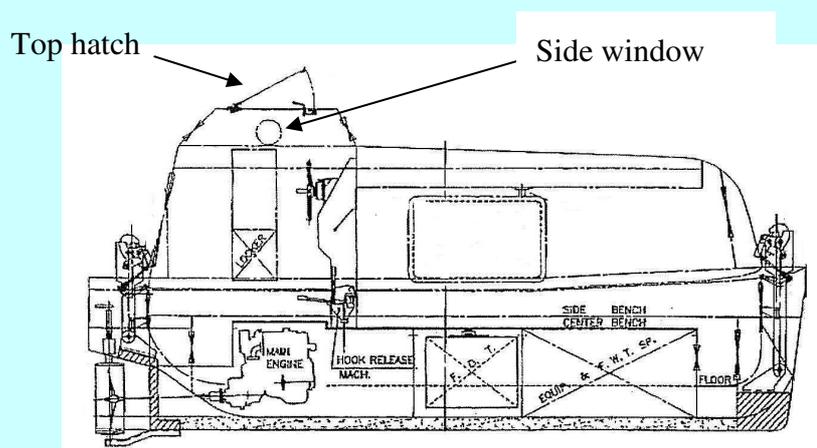
3. The windows of the enclosed type lifeboats are generally small in size and could not provide an unobstructed view to the helmsman (see fig. 2). To ensure a proper lookout, the helmsman could open the top hatch of the lifeboat to obtain a clear view outside the lifeboat. Alternatively, a crew can be assigned to maintain a lookout for any irregularity.

Fig. 2: Drawing of the lifeboat showing the arrangement of the side window and top hatch
