HONG KONG MERCHANT SHIPPING INFORMATION NOTE

Collapse of Gantry Crane Trolley

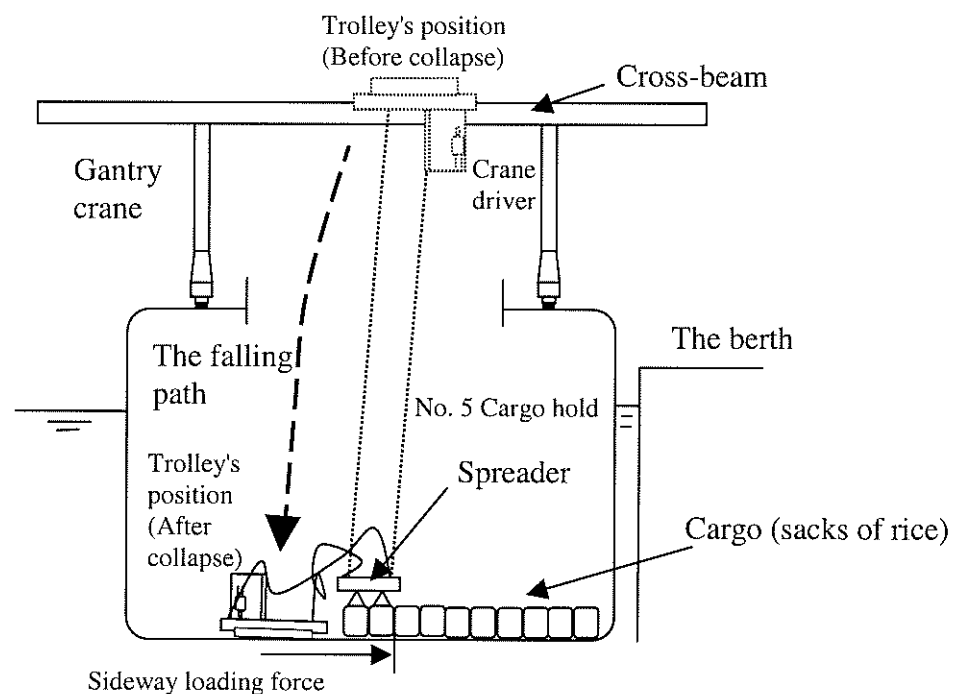
1. On 20 October 2004, the Hong Kong registered ship berthed at a dock of Brazos Harbour, Freeport, U.S.A. for loading. A cargo of rice in sacks was loaded into the No. 5 cargo hold using the ship's gantry crane. A crane driver was inside the driver cab of the gantry crane trolley to operate the crane for loading of cargo while the other two stevedores were working inside the cargo hold.
2. While sacks of rice were being loaded into the cargo hold, the supporting frames of the gantry crane trolley suddenly detached from the cross-beam of the gantry crane. The trolley and the crane driver fell down into the bottom of the No. 5 cargo hold (see figure 1). The accident caused the death of the crane driver and injury to the two stevedores.
3. The accident was probably caused by the failure of the mounting bolts at the supporting frames of the gantry crane trolley.

Figure 1 : The scene of the incident

4.
 - a) The gantry crane, including the trolley assembly should be inspected periodically by a competent person to ensure free of defects;
 - b) For critical components such as bolts subjected to repeated, fluctuating or alternating stresses, they should be examined regularly and maintained in top condition. Only genuine parts should be used for replacement if necessary;
 - c) Any trolley which might fall off from its mounting should be fitted with an anti-tipping device of sufficient strength to hold the trolley in position in case of critical part fails; and
 - d) Applying sideloading force (see figure 1) on the cargo by the crane trolley is a malpractice which could cause uneven loading on the support frames and their mounting bolts. Crane operator should not operate the gantry crane in a manner that exerts sideloading force.
