MARINE DEPARTMENT NOTICE NO. 107 OF 2002

Notice to Owners, Operators and Persons-in-charge of Locally Licensed Lighters - Safety in Anchor Handling

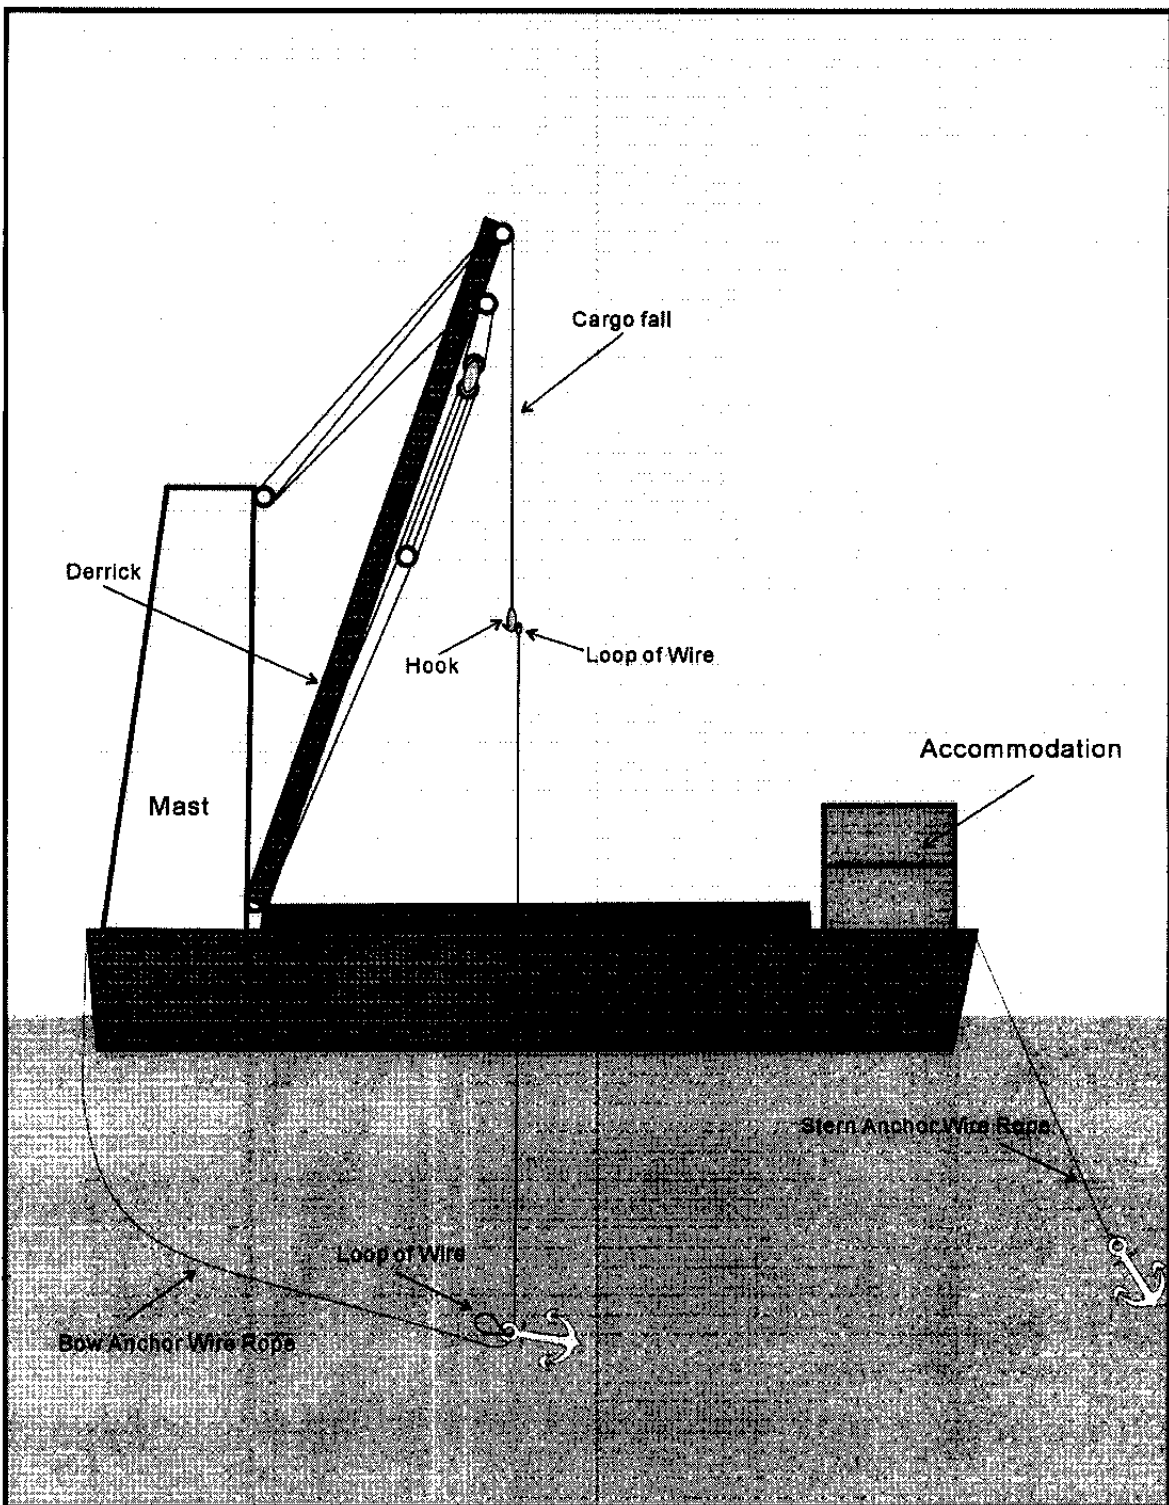
Appendix

A fatal accident happened on 13 December 2001 in that a worker on a locally licensed dumb steel lighter was hit by a wire sling whilst transferring the lighter's anchor from its secured position on port main deck back to its original position at the bow. During the operation the anchor was first hoisted up from the main deck and then lowered into the sea by means of the lighter's derrick together with a wire sling with looped ends. The wire sling was first led through the ring of the anchor stock and then both looped ends were attached to the derrick hook. When the anchor was lowered and resting on the seabed, one end of the wire sling was detached from the derrick hook and the other end was being hoisted up in order to pull it out from the anchor stock. However the looped end of the wire sling in the water was jammed in the anchor stock ring. The subsequent clearing of the jam due to the weight of the anchor and possible movement of the lighter caused the wire to bounce in an uncontrolled manner and jump out of the derrick hook. The bouncing wire hit the worker who was standing nearby serving as a signaller in the operation, causing him to fall overboard. Although the worker was rescued almost immediately, he later died in the hospital. A [diagram](#) showing the operation is attached in the appendix.

2. The danger of uncontrolled movement of steel wire due to sudden release of tension is well known and has in the past caused casualties to personnel working on board ships. The method employed by the workers in shifting the anchor in this incident is therefore considered not a safe practice, as there is no guarantee that the wire sling would not jam. Furthermore, since the anchor was submerged in the water, it was not possible for the workers to tell what was happening with the anchor and to take appropriate actions.

The loop of wire and the bow/stern anchors in water

3. Owners, operators and Persons-in charge of local licensed lighters are requested to take note of the above-mentioned accident and the lesson derived therefrom, and to consider employing safer practices as appropriate in shifting of anchors or other heavy weights in order to avoid any uncontrolled movement of wire slings.
