## **Whilst engaging in wakeboarding, the local pleasure vessel Wakeaholic collided with a local mechanized sampan on 28 July 2002**

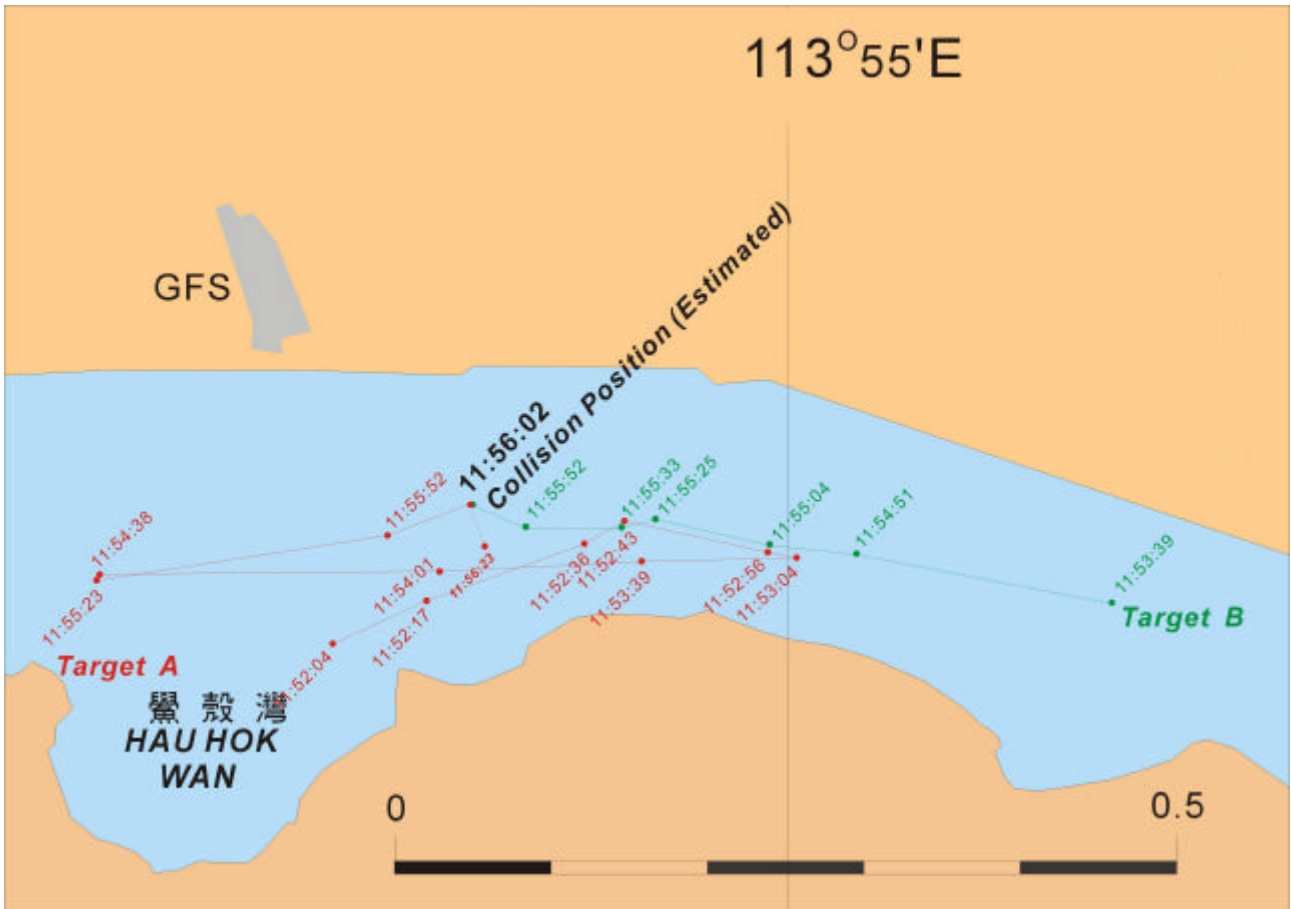
1. At about 1156 on 28 July 2002, the local pleasure vessel Wakeaholic, whilst engaging in wakeboarding, collided with the locally licensed mechanized sampan in the approximate position 22° 17.64' N 113° 54.79' E, north of Lantau Island near the Hong Kong international Airport (Fig. 1).
2. Wakeaholic sustained minor scratches and damages to her hull whilst the sampan sustained considerable damages to her hull on the port side and the casing of the outboard engine (Fig.2 and 3). Two persons on board the Sampan were killed and other two suffered severe injuries.
3. The sampan was overloaded by 10 persons on board.

Fig. 1 The Collision Tracks of the local pleasure vessel Wakeaholic and the locally licensed mechanized sampan.

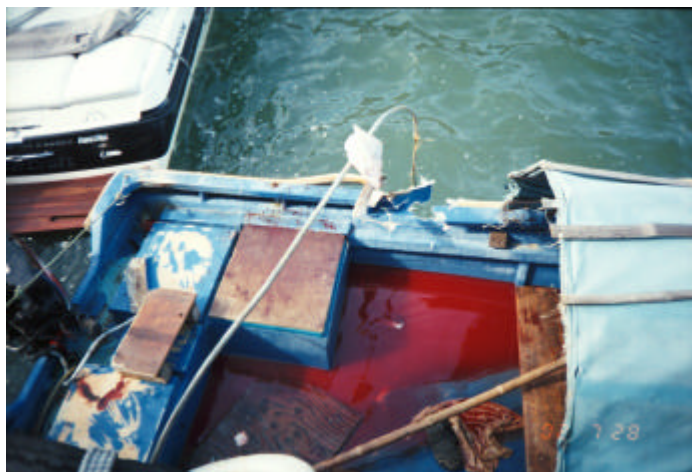
Fig. 2 Damages to the hull on the port side

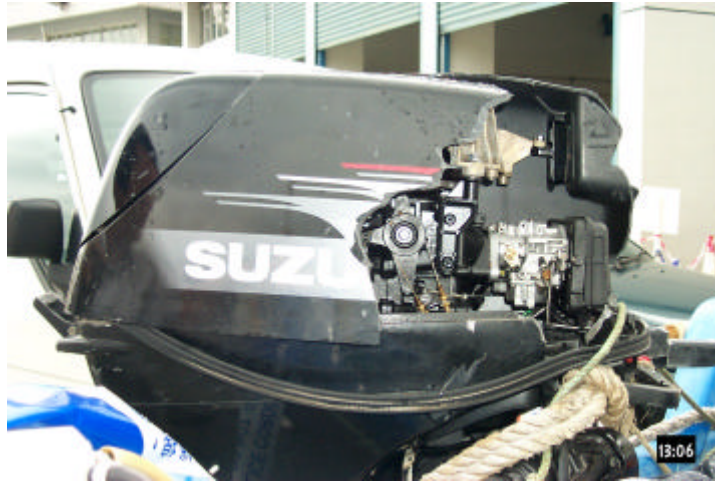
Fig. 3 Damages to the casing of the outboard engine
