Fatality of two persons inside enclosed space

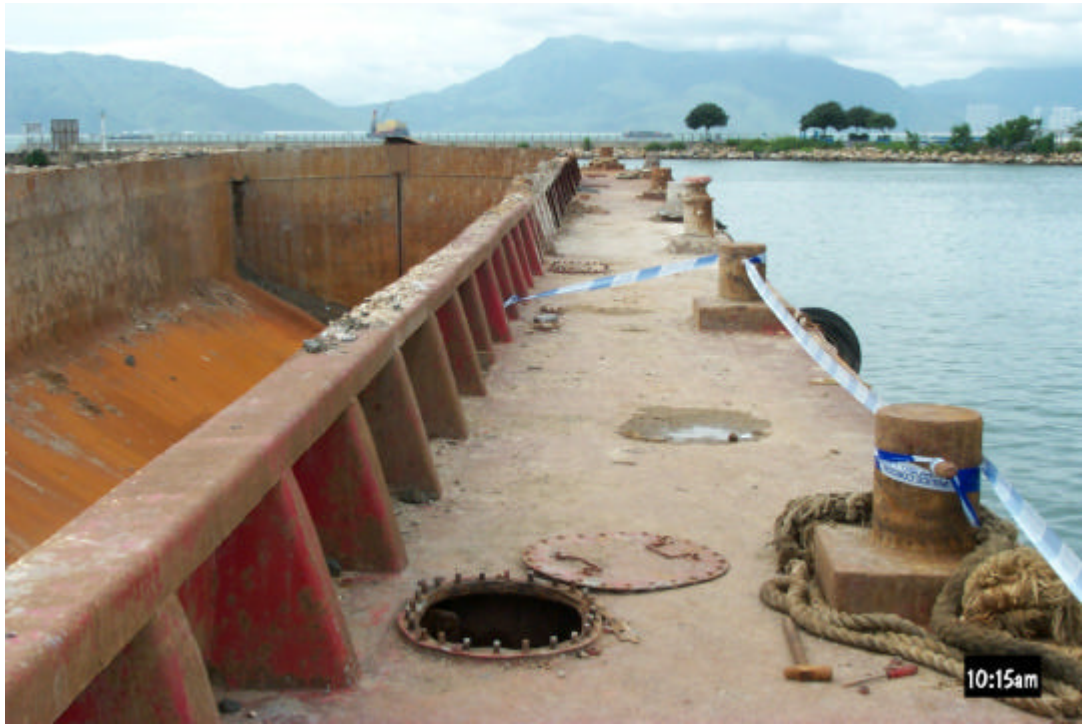
1. On 6 August 2002 at around 1230 hours, two persons were reported to have collapsed inside No. 4 starboard buoyancy chamber of the split hopper barge “Ho Hon 6 (浩航 6)” which was moored inside Tuen Mun typhoon shelter (Fig. 1). Various government launches rushed to the scene for assistance after the emergency call on “999”. The two persons were later rescued by the Fire Services team and were sent to the hospital for emergency treatment. Both persons were certified dead upon arrival at Tuen Mun hospital.

Fig. 1 Location of manhole at No. 4 starboard buoyancy chamber

1. The deceased did not follow the procedures as laid down in the code of safe working practice, in particular, without applying prior ventilation and testing of the inside atmosphere, or using protective equipment such as breathing apparatus in maintaining their survival inside the chamber. Workers should be reminded of the danger of entering into an enclosed space that was not adequately ventilated.

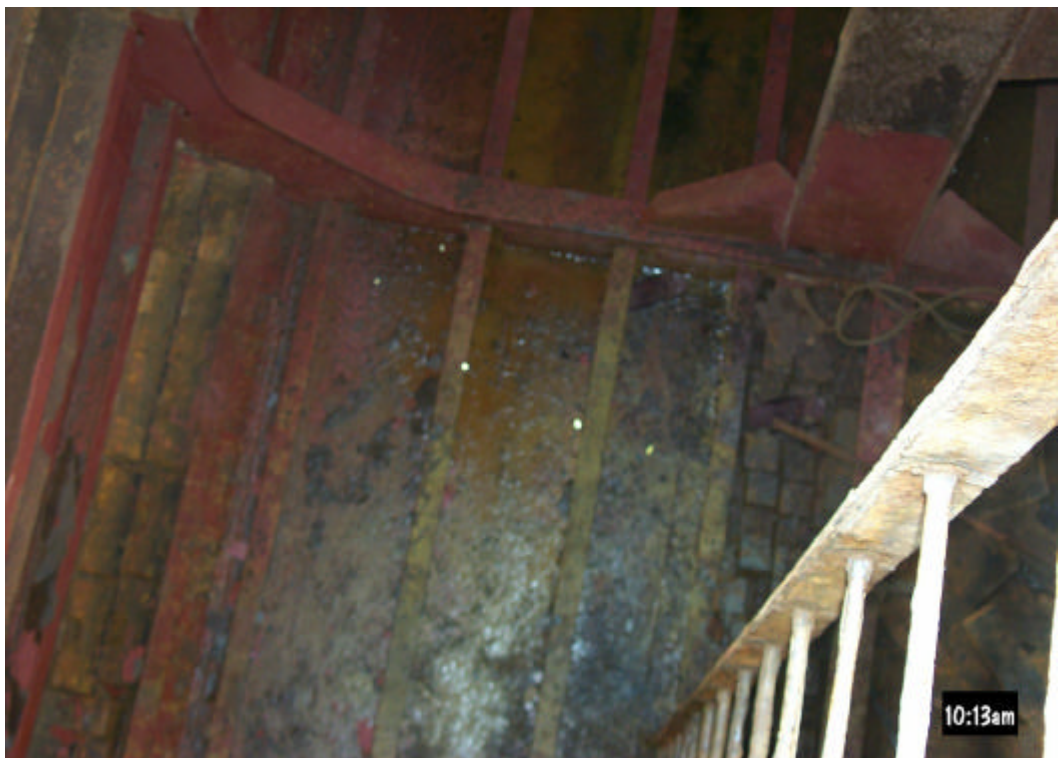
1. There is no reasonable explanation as to why the two deceased entered the buoyancy chamber. The buoyancy chambers are used solely to provide buoyancy to the split hopper barge and under normal circumstances there is nothing inside that needs to attend to (Fig. 2).
2. In this accident the cause of death of the two deceased was identified to be suffocation due to depletion of oxygen. As the buoyancy chambers of the barge had been closed for a considerable periods, the oxygen content of the atmosphere inside had been consumed by oxidation in the process of rusting and corrosion of steel structures over a period of time and was unable in sustaining human survival.

Fig. 2 Internal structure of No. 4 starboard buoyancy chamber
