**Sudden Landing of the Hong Kong- registered Passenger Jetfoil “URZELA”
Occurred off the Macau Channel at about 1920 hours on 23 October 2002**

1. The Incident

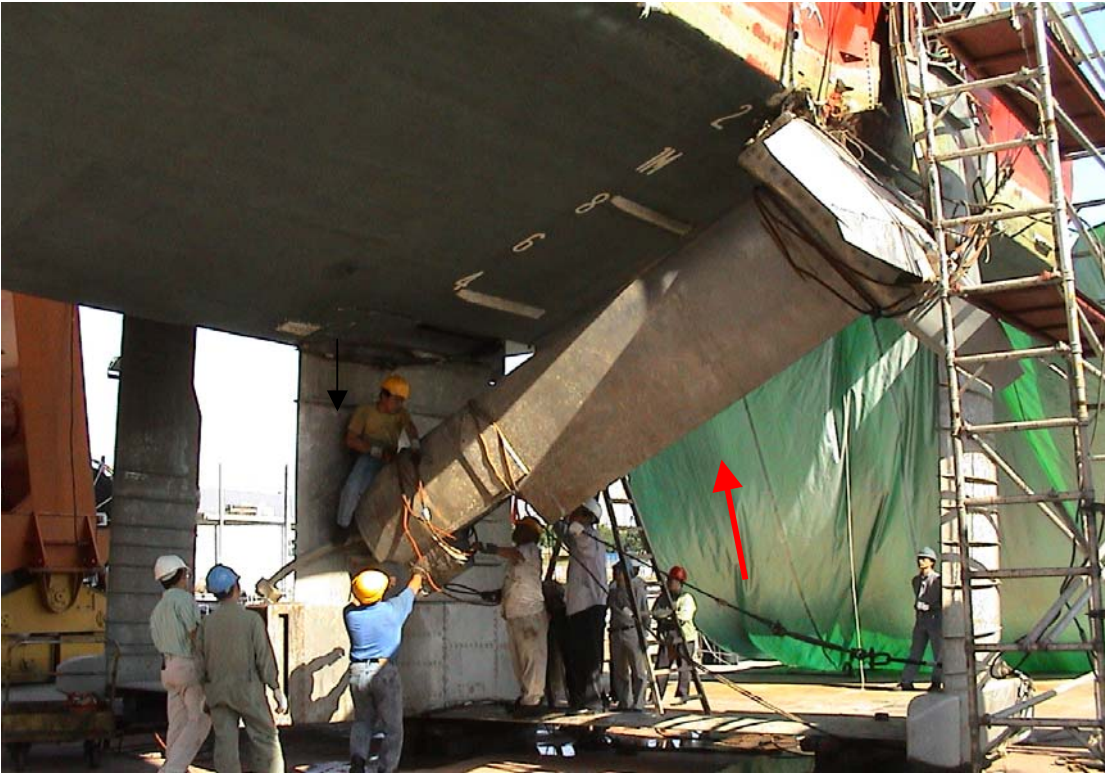
1.1 At about 1920 on 23 October 2002 the Hong Kong registered high speed passenger craft Urzela, whilst plying on foilborne mode from Hong Kong to Macau, was suddenly brought down on hull in the approximate position $22^{\circ} 10.84'N$, $113^{\circ} 37.94'E$ which was about 2 miles away from the entrance of the Access Channel to Outer Harbour of Macau. At the time of the accident, the weather conditions were cloudy, with north-northeasterly wind at a speed of about 37.4 km per hour and the visibility was good. The king post in the forward strut of the Urzela was later found parted and the strut was stuck between the aft struts and the vessel's hull (see Fig. 1). The vessel also sustained considerable damages to its port hull. About 29 passengers and 7 crewmembers were injured. No oil pollution was reported.

Fig. 1: Forward strut stuck between the aft struts

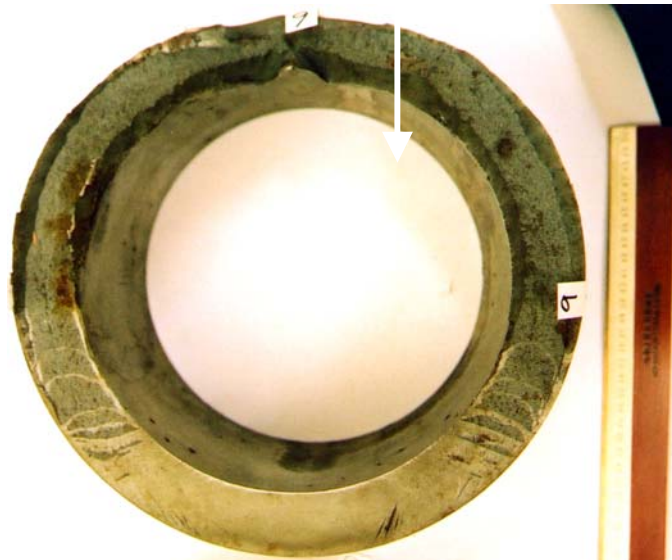
2.1 The investigation has established that the cause of failure of the king post was due to metal fatigue (see Fig. 2). The factors identified as attributable to the premature fatigue failure of the king post are:

Fig. 2 : Fractured surface of the upper portion of the king post

- (a) Specific procedures and criteria for conducting non-destructive tests on the critical areas of the king posts, such as the stepped section for the bearing sleeve, on all jetfoils within Shun Tak - China Travel Ship Management Ltd's (ST-CTS) fleet under the supervision of Marine Department should be established to ensure the tests could effectively identify the potential defects in the king posts.

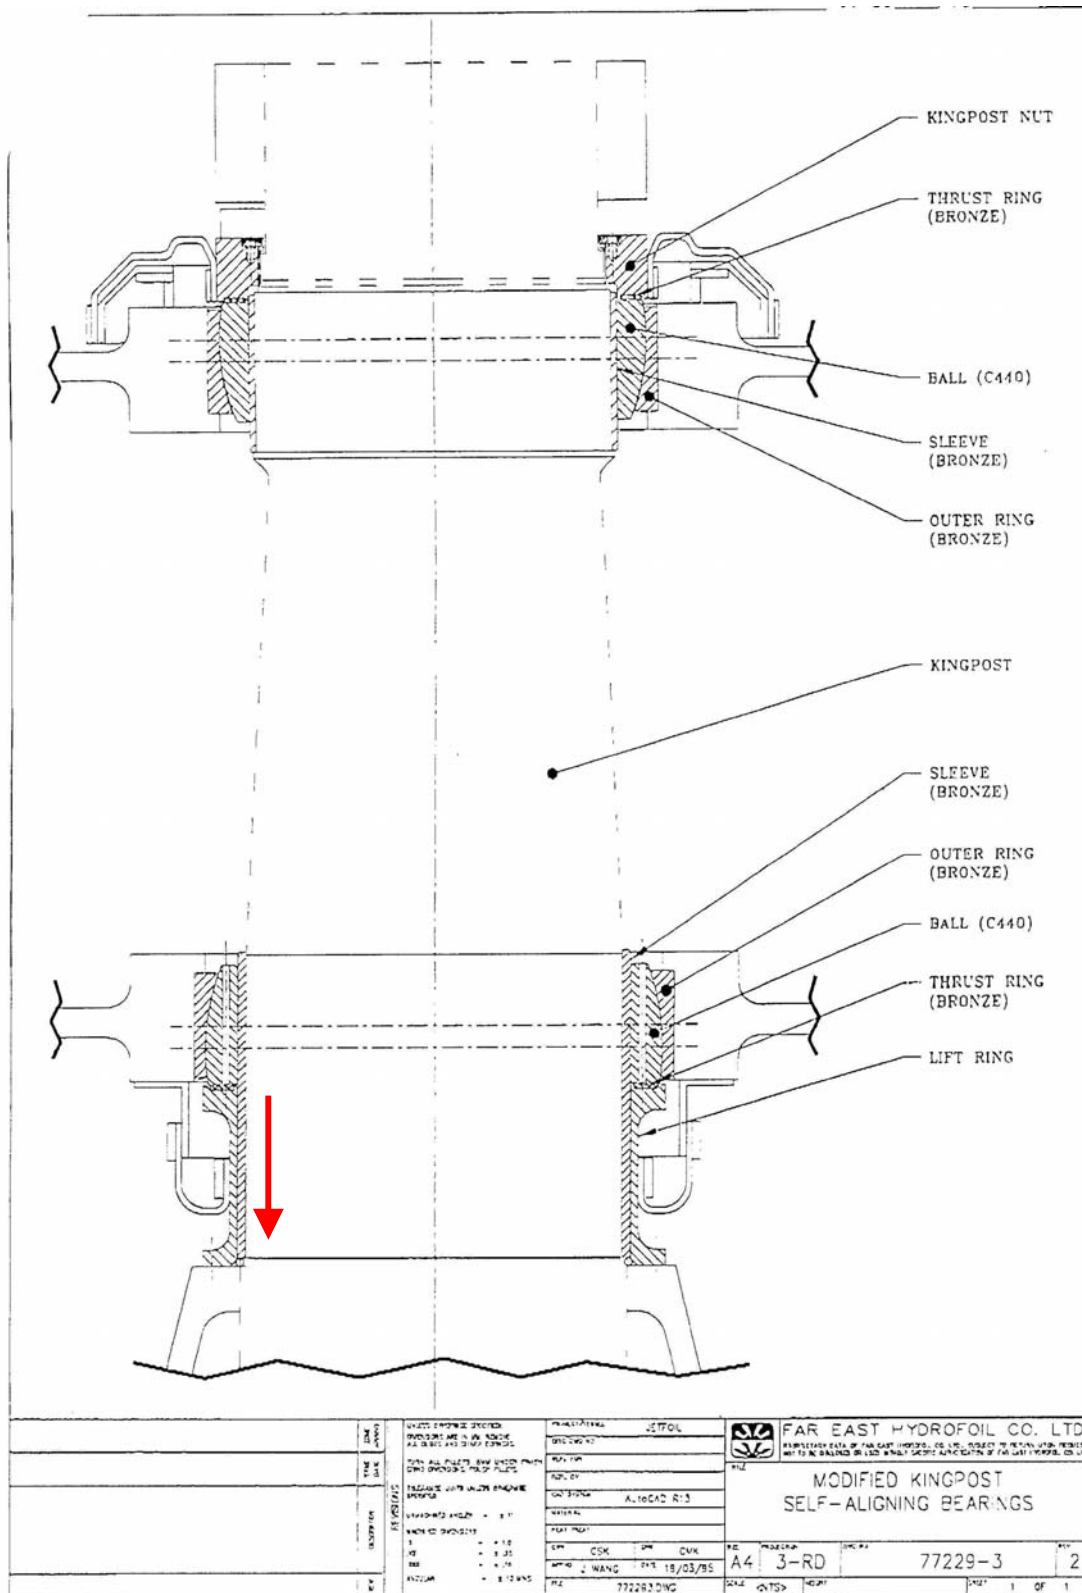
- (a) In modifying the king post of Urzela to suit the installation of the bearing sleeves, a stepped section for the lower bearing sleeve had been introduced which was made at right angle with negligible shoulder fillet. The abrupt change of section (see Fig. 3) had induced stress concentration effect and served to reduce the fatigue life of the king post. At the time of the failure the operational hours of the king post is estimated to be about 42,000 hours, and about 6,000 hours after the modification.

- (b) The location of the change of section in close proximity to the king post's insert to the strut, as well as the shrink fitted bronze sleeve on the stepped section might have to some extent augmented the stress condition of the king post, making it susceptible to premature failure.

Fig. 3: Stepped section near the lower bearing surface of king post (Block-I jetfoils)

- (d) ST-CTS should conduct/commission study or research on the reliability and/or serviceable life of the king posts on jetfoils. This may include reviewing the dimensions and geometry of the king posts to minimize discontinuities and avoid stress concentration effect augmented by continuous condition monitoring, and/or establishing a threshold at which a king post is considered to have reached the end of its serviceable life and requires replacement.
