## **Man slipped during mooring whilst standing on top of a fender and his leg was caught between the fender and the seawall**

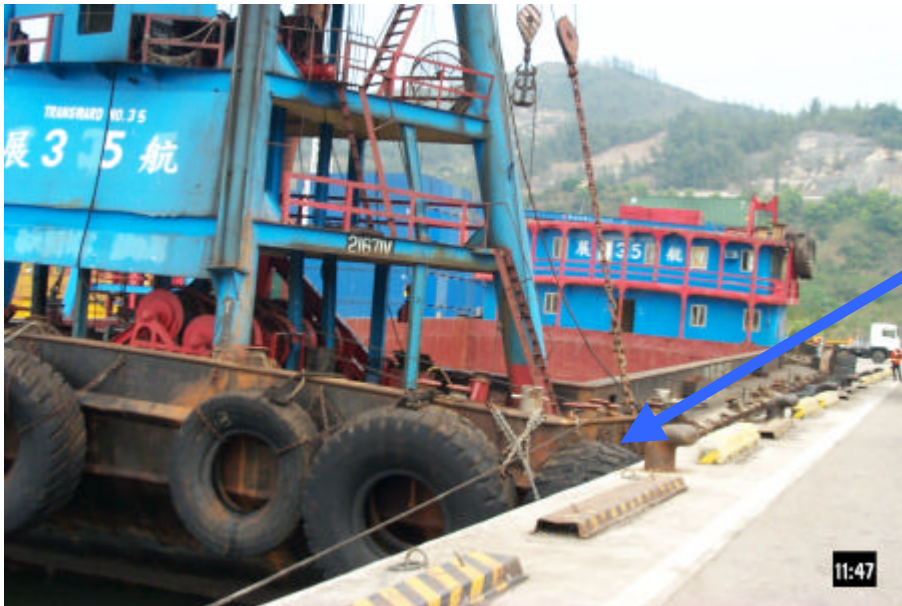
1. At about 2050 hours on 30 January 2003, one of the crewmembers of the dumb steel lighter “Wah Fai 8” (華輝 8), slipped during mooring operation while he was standing on top of a large rubber tyre fender (Fig. 1). At that instant the lighter was pushed by a tug to moor at berth 37 of the River Trade Terminal (RTT) in Tuen Mun. At time of accident the fender was almost in contact with the seawall. The deceased slipped himself while holding the mooring wire. As he slipped he clung onto the quayside with his right leg hanging between the fender and the seawall. The lighter continued to close in and the fender crushed his right leg against the seawall and resulted in serious injury. He was sent to Tuen Mun hospital for emergency treatment and was certified dead at 2350 hours at the hospital.

Fig. 1 A similar Lighter at moor in River Trade Terminal  
(Note the location of forward fender and the bollard)

2. Although fixed landing ladders are provided for the crew to access ashore for mooring, it is not always used because more shifting works may be required. However, it would be much safer if a crewmember could land ashore first before receiving the mooring line from other crewmembers.

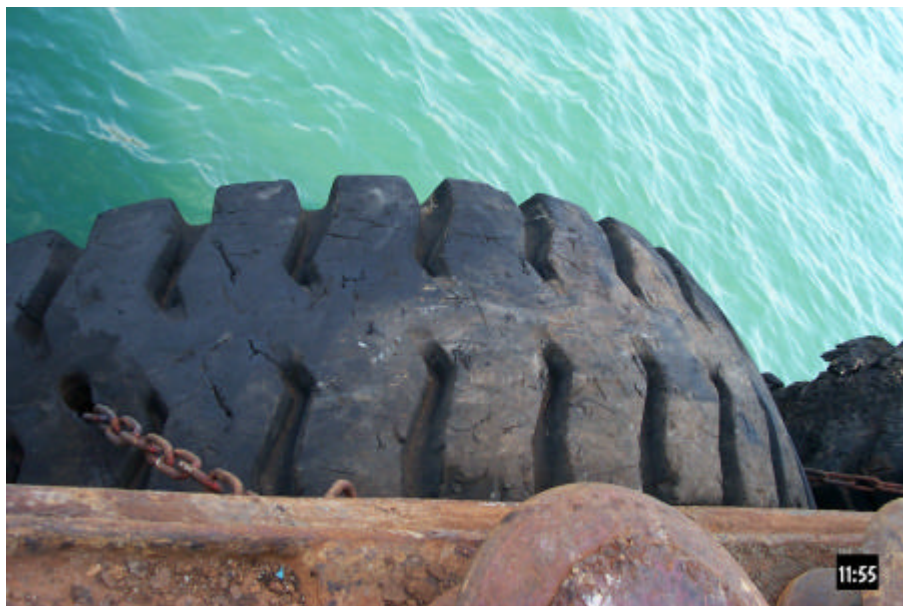
1. The footwear worn by the deceased did not belong to any type of anti-slip shoes that aim to prevent people from slipping when working on smooth and wet surface. Also the rubber tyre fender chained to the side of the Lighter did not provide a stable, flat surface for people to stand on it (Fig. 2).
2. The weight of the mooring wire imposed difficulty for the deceased to maintain his balance. Furthermore, when both of his hands were engaged in holding the wire, he could no longer use them to maintain balance in case of any sudden movement. The lighter could be subjected to unexpected jerk and bumping movements when it was being pushed by a tug. These sudden movements might cause the crew to lose foothold temporarily if he is not holding on to some fixtures.

1. The dangerous mooring practice employed in this incident is considered to have contributed to the accident. The deceased was standing on a non-stable, curved surface on top of the rubber tyre fender which was susceptible to movements during the mooring operation while holding the mooring wire in both hands. Also the shoes worn by the deceased did not offer much protection against

slipping on wet surfaces.

Fig. 2 The topside surface of the fender where the deceased stood
