Inadvertent Release of a Lifeboat from “OGRADY” after Collision with Loss of Two Lives

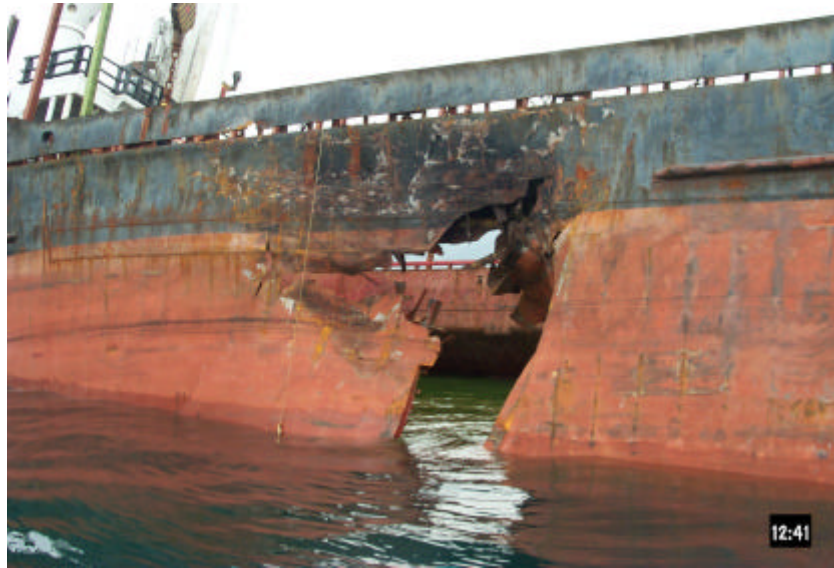
1. At about 2040 hours on 21 February 2003, a Hong Kong registered ship “Ogrady” collided with a Cambodian registered ship “Lora” in the Inland Sea of Japan. “Ogrady” sustained severe damage at the port side shell plating (fig. 1) while “Lora” crushed its stem. “Ogrady” developed a starboard list as a result of water ingress to its cargo hold. The master of “Ogrady” ordered to standby the ship’s lifeboats for emergency use. During the lowering of the port side lifeboat, the forward and aft lifting hooks suddenly released from its secured position and the lifeboat dropped 15 metres into the sea. Two crewmembers were later found dead inside the lifeboat (fig. 2).

1. “Ogrady” was navigating in the opposite traffic lane at Bisan Seto traffic separation zone before collision as a result of incorrectly plotting of ship’s positions. The master was not aware that the vessel was in the wrong lane and hence did not take action to bring the ship back to the correct lane. “Ogrady” also failed to take early action to avoid collision with “Lora”. On the other hand “Lora” was required to keep out of the way of “Ogrady” in a close quarter situation inside the Traffic Separation Scheme failed to take proper action.

Fig. 1 Collision damage of “Ogrady”

1. The Master should have used the passage plan in preparing the voyage. Monitoring of ship’s position should not solely rely on the radar fixed positions. Fixes shall be taken at frequent intervals and

shall be carried out by more than one method whenever circumstances allow.

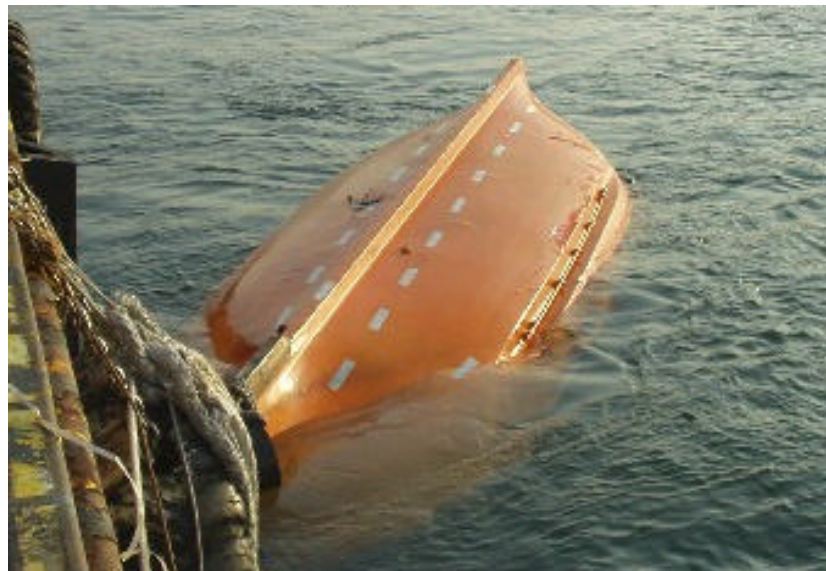
2. The primary cause of this lifeboat incident is believed to be the inadvertent release of the on load release mechanism by person inside the lifeboat. A general lack of appreciation and understanding of the lifeboat launching equipment by the crew and inadequate safety familiarization training were apparent. Other contributing factors are the lack of clear operating instruction and conspicuous warning notice for the lifeboat on-load release mechanism which could enable the crew on board to understand the effect of the operating procedures and their associated danger.

Fig. 2 The capsized lifeboat

2. Adequate familiarization training and detailed operating procedures for the lifeboat on load release mechanism should be provided to the crew. The adequacy of the securing arrangement for the on load release lever should be reviewed and improved as necessary.
