**Fatal Accident on board
the Bahamas registered Ro-Ro-Car/Truck Carrier Platinum Ray
at the Modern Terminals Limited Berth No. 1
1 April 2003**

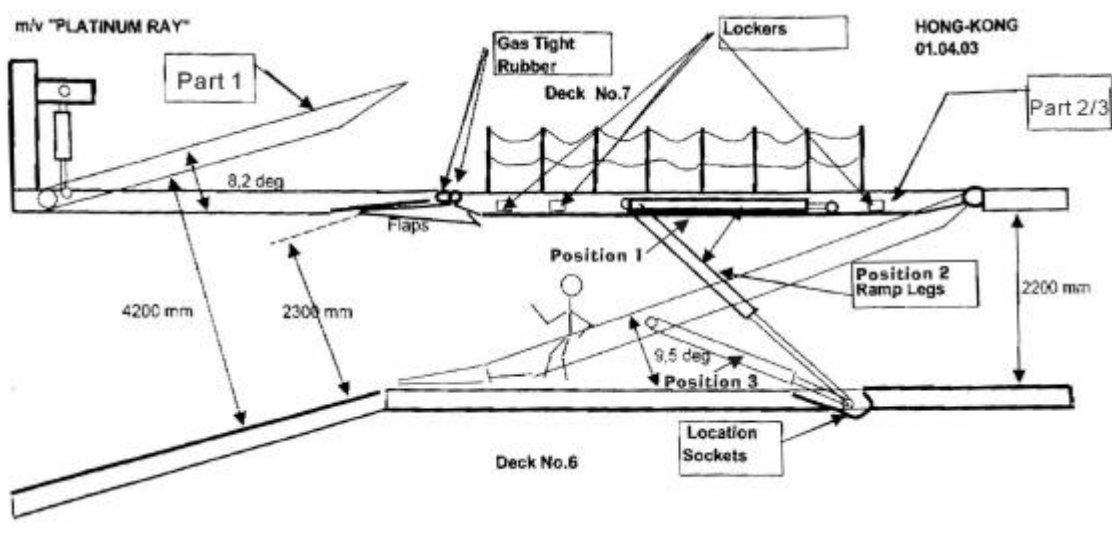
Fig. 1 The elevation view of the ramp and ramp legs

1. The Chief Officer is responsible for the operation of all ramps to allow the systematic unloading of vehicles on board Platinum Ray. The deceased was assigned to assist him.
2. The Chief Officer was the operator at the console. During the lowering operation of the starboard side ramp, the ramp was momentary jammed in position. The jamming of the ramp might be due to slight deformation of the ramp itself after a period of loading and unloading operations. Despite the jamming obstruction, the ramp legs supporting the ramp continued to retract. As a result the ramp was unsupported. When the ramp was free from the hindrance, it fell all the way down and crushed the Deck Cadet who was standing underneath it (Fig. 1).
3. The Chief Officer did not ensure that the deceased had stood clear of the ramp before lowering it.

1. The person operating the ramp should ensure all other persons to stand clear of the ramp before lowering it.
