Whilst navigating in the Western Fairway, the Hong Kong registered chemical carrier Larasati collided with the Chinese registered container ship Bai An 6 on 5 May 2003

A. The Incident

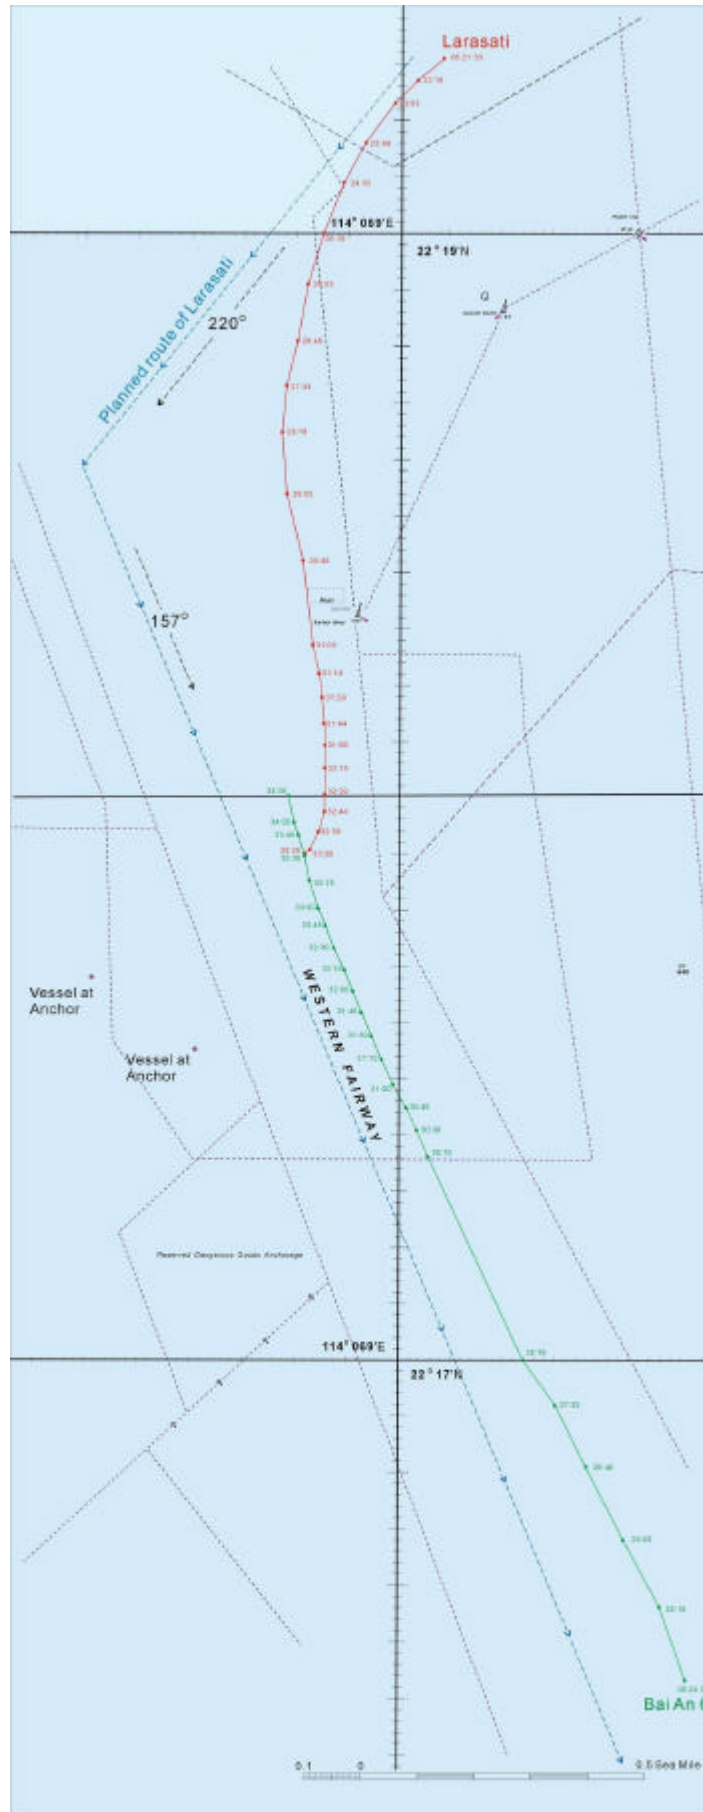
1. At about 0833 on 5 May 2003, the Hong Kong registered chemical carrier Larasati collided with the China registered container ship Bai An 6 in the Western Fairway at the approximate position 22° 17.90 ' N 114° 05.82 ' E. Both ships were under pilotage. Larasati was an outbound vessel departing from CRC terminal while Bai An 6 was a transiting ship proceeding via Hong Kong to Shekou, China (Fig 1).
2. At the time of the accident, the weather conditions were rainy with thunderstorm in the vicinity. The wind was southwesterly at force 5 and the visibility was about 3 miles, occasionally deteriorating to about 0.35 mile due to localized rainsqualls.
3. Larasati sustained considerable damage to the side shell plates and deck structures on the port side while Bai An 6 sustained minor damage to the bulbous bow and the stem. There was no oil pollution reported in the incident.

1. The investigation has revealed that the probable causes for the collision were the master and pilot of Larasati had failed to keep the ship as near to the outer limit of the fairway which lies on the starboard side as was safe and practicable as required by Rule 9(a) of COLREGs. They had also failed to proceed at a safe speed in accordance with Rule 6 of COLREGs, and use proper sound signals in accordance with Rule 35(a) of COLREGs in time of restricted visibility. Upon detecting Bai An 6 on the radar and receiving warning from VTC, no avoiding actions were initiated by Larasati in ample time to avoid close-quarters situation and subsequent collision as required by Rule 19 of COLREGs.

2. On the other hand, the master and pilot of Bai An 6 failed to proceed at a safe speed required by Rule 6 of COLREGs so that the ship could be stopped within a distance appropriate to the prevailing circumstances and conditions. They also failed to sound signals required by Rule 34(d) of COLREGs when Larasati was seen manoeuvring on the wrong side of the fairway, and use proper sound signals in accordance with Rule 35(a) of COLREGs in time of restricted visibility. Furthermore, they failed to comply Rule 7(a) of COLREGs in determining that risk of collision did not exist.

Fig. 1 The collision tracks of Larasati and Bai An 6

1. The masters and officers of the watch navigating in the waters of Hong Kong have to pay particular attention in restricted visibility, and to strictly follow the requirements of COLREGs as appropriate to the prevailing circumstances. They should also ensure proper communication with pilots for safe navigation.
2. Pilots have to pay particular attention when piloting vessels in restricted visibility, and strictly follow the requirements of COLREGs as appropriate to the prevailing circumstances.
