## **Man hit by mooring wire**

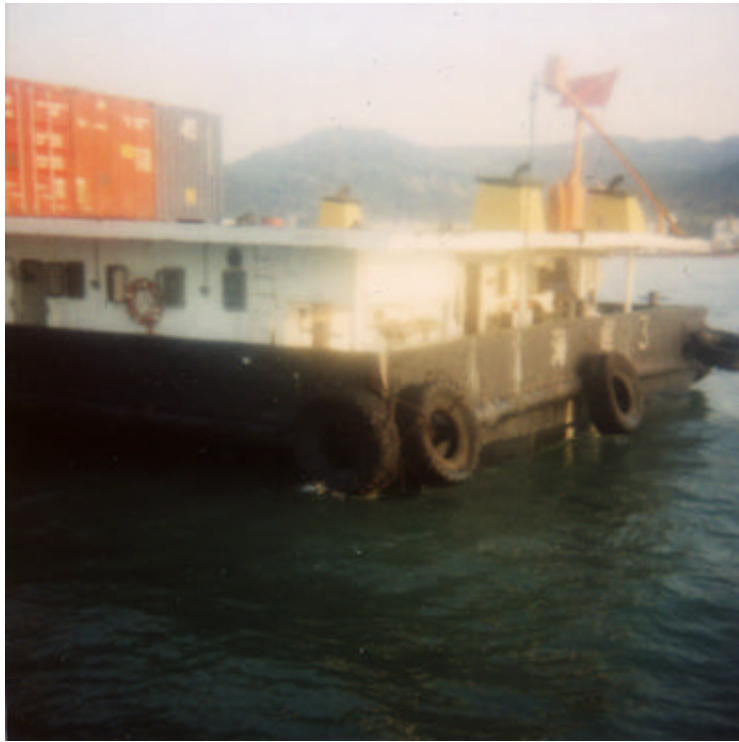
1. The watch sailor of the barge aft had no equipment to communicate with the PIC who was controlling the mooring wire. Should the PIC be notified of the approach of the coaster he could have slackened the mooring wire, the accident might have been avoided. On leaving the berth there was insufficient sea room at the aft of the coaster. As it moved astern it contacted with the mooring wire and the sand barge.
2. The deceased was not engaged on duty. While strolling aft he was not aware of the dangerous situation and unknowingly walked into the straightening path of the mooring wire.

Fig. 1 Stern of PRC Coaster “海暉 3”

1. Masters should observe good seamanship practice in maneuvering of vessel to ensure sufficient sea room before leaving berth. Other crewmembers not involved in related duty in hazardous working station should stay away from such places as far as possible. Crew engaged in the mooring operation should maintain proper communication between the winch operator and the lookout person if the view of the winch operator is obstructed.

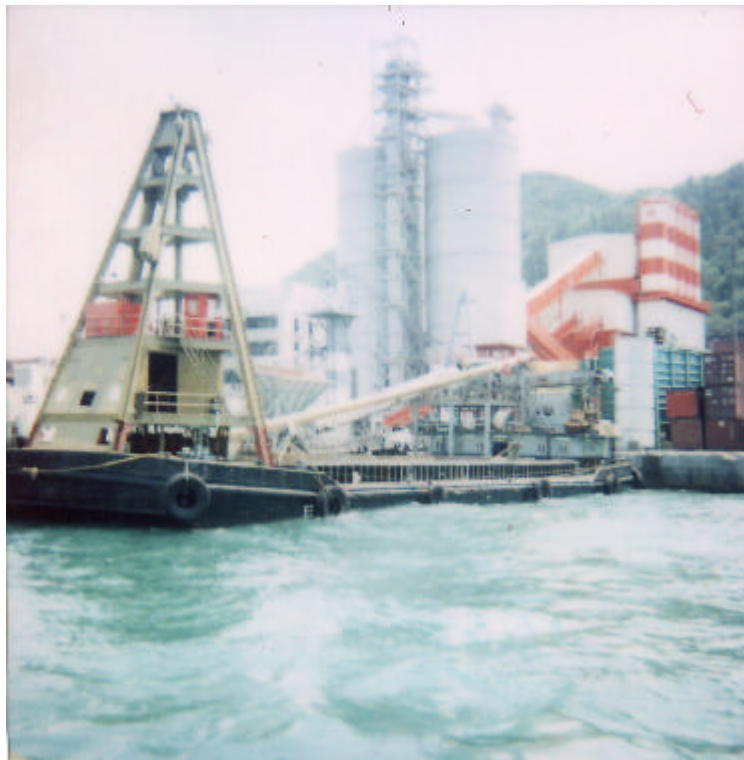
Fig. 2 Sand Barge “永迅” secured to the cement pier
