Collision between Passenger Ferry “First Ferry VI”(新輝陸) and Mainland Sand Carrier “圍機 292 ”

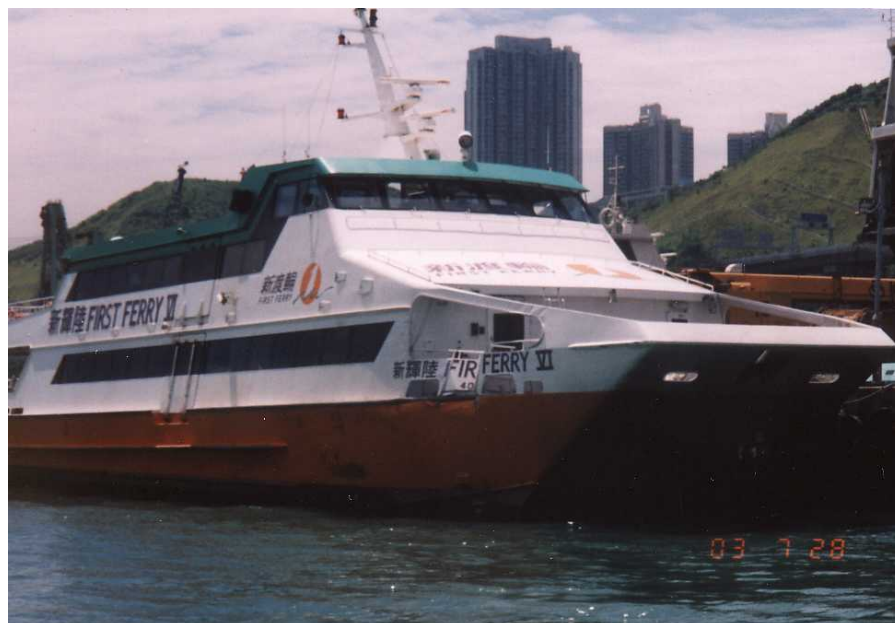
1. At about 2224 on 26 July 2003, a fast passenger ferry “First Ferry VI” (新輝 6) with 310 passengers on board collided with a mainland sand barge “圍機 292” while overtaking in the traffic lane south east of Hei Ling Chau. “First Ferry VI” sustained minor structural damage at the starboard bow. “圍機 292” sustained minor paint scraping at the port side.
2. “First Ferry VI” did not stop after the collision and the accident was not reported immediately to the Marine Department. “First Ferry VI” continued to proceed to its destination in Cheung Chau at normal cruising speed of 22 knots and disembarked the passengers after arrival. It was later found that 22 passengers had suffered from minor injuries in this accident.

Fig. 2 : Photograph of First Ferry VI after collision
