**Fire on board and the subsequent sinking of the PRC wooden cargo vessel
“Yue Hui Zhou Huo 3861” in the waters near Fat Tong Mun on 13 November 2003**

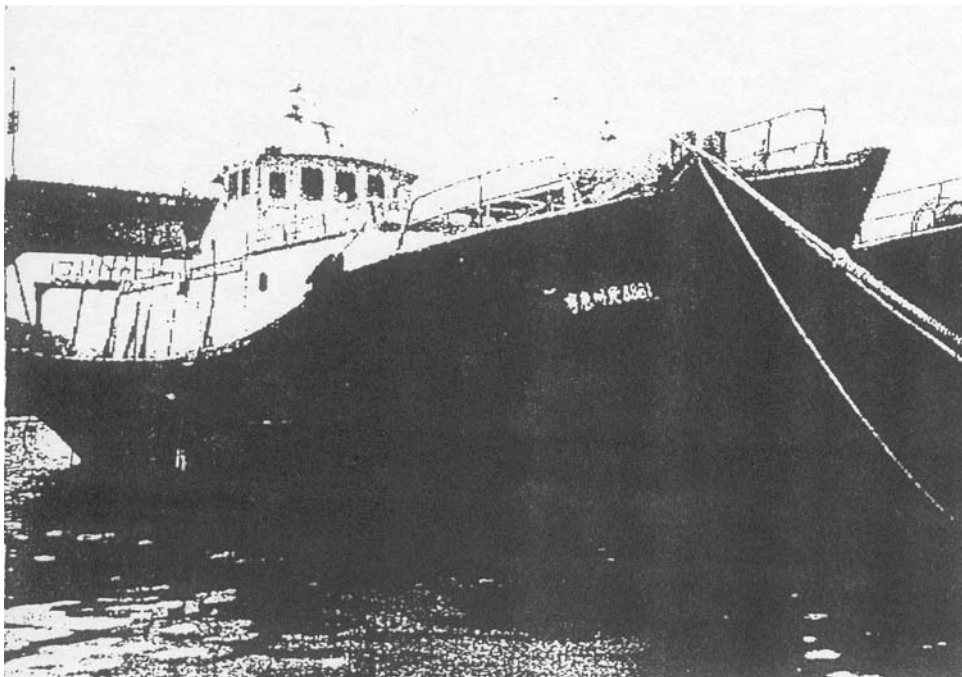
Figure 1

- 1.1 At about 1900 hours on 13 November 2003, a fire broke out in the engine room of the vessel “Yue Hui Zhou Huo 3861” (粵惠州貨3861) (Figure 1) while it was on passage in the waters near Fat Tong Mun. The fire spread rapidly and went out of control. All 5 crewmembers on board abandoned the Vessel and escaped into the sea without any life-saving appliances. The Master, the Engineer and one sailor were able to swim to Steep Island nearby and later rescued by helicopter while two other crewmembers were reported missing. The Vessel was destroyed by the fire and later sank. On 18.11.2003 and 25.11.2003, Marine Police found the dead bodies of the two missing crewmembers.
