While berthing alongside the pier at Mui Wo, the passenger ferry Xin Xing (新興) rammed the seawall adjacent to the pier

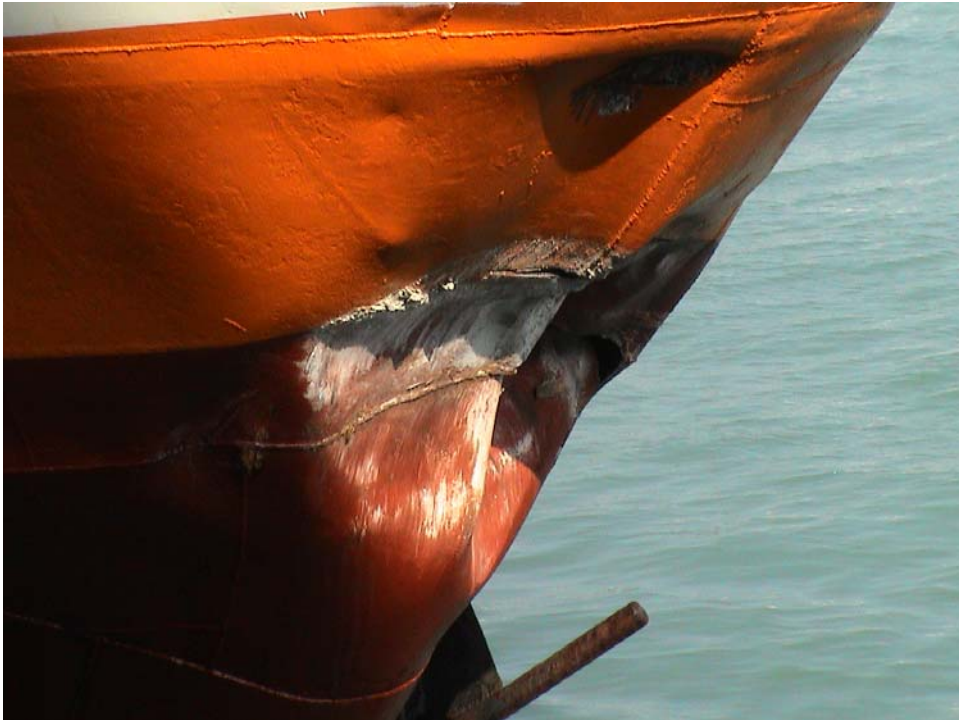
1. The investigation identifies the most probable cause of Xin Xing ramming the seawall was that while approaching to the pier under strong wind condition, the master had given a kick ahead on the engine in order to gain headway for counteracting the wind force setting the vessel towards the pier. Due to the close proximity to the pier, once the vessel had gained headway there was insufficient time for the astern engine to be effective to halt the vessel's forward movement. As a result, the vessel was unable to stop in time and it rammed the seawall in front.
2. Some passengers had stood up and were waiting to get off when the ferry collided with the seawall. The sudden ramming impact had caused some of them losing their balance and falling down on the deck, thus sustaining minor injuries.

Figure 1 Damage sustained to the stem of Xin Xing (新興)

1. The masters of all conventional ferries should exercise utmost caution when berthing their vessels during adverse weather conditions
2. The masters should also make special verbal announcement emphasizing the need for passengers to remain seated instead of using routine taped announcement under such situations.

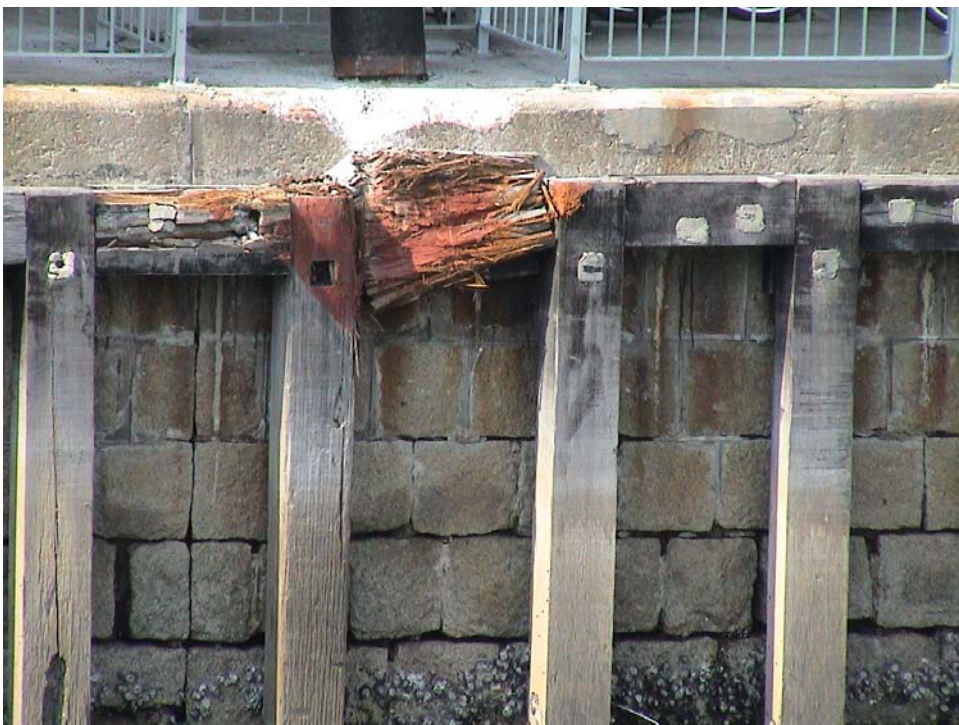
1. At about 0923 on 27 November 2003, the locally licensed passenger ferry Xin Xing (新興), while berthing alongside the pier at Mui Wo, rammed the seawall adjacent to the pier.
2. At the time of the incident, the weather conditions were fine with northerly wind at force 5 occasionally gusting to a maximum wind speed of 54 km per hour.
3. The contact resulted in minor damage to the ferry's stem. The concrete structure of the seawall was also smashed. 9 passengers suffered minor injuries as a result of the contact.

Figure 2 Damage sustained to the seawall
