**Engine Room Fire on board the Hong Kong - registered Passenger Jetfoil “FUNCHAL”
Occurred off Western District Public Cargo Working Area at about 0240 hours
on 1st December 2003**

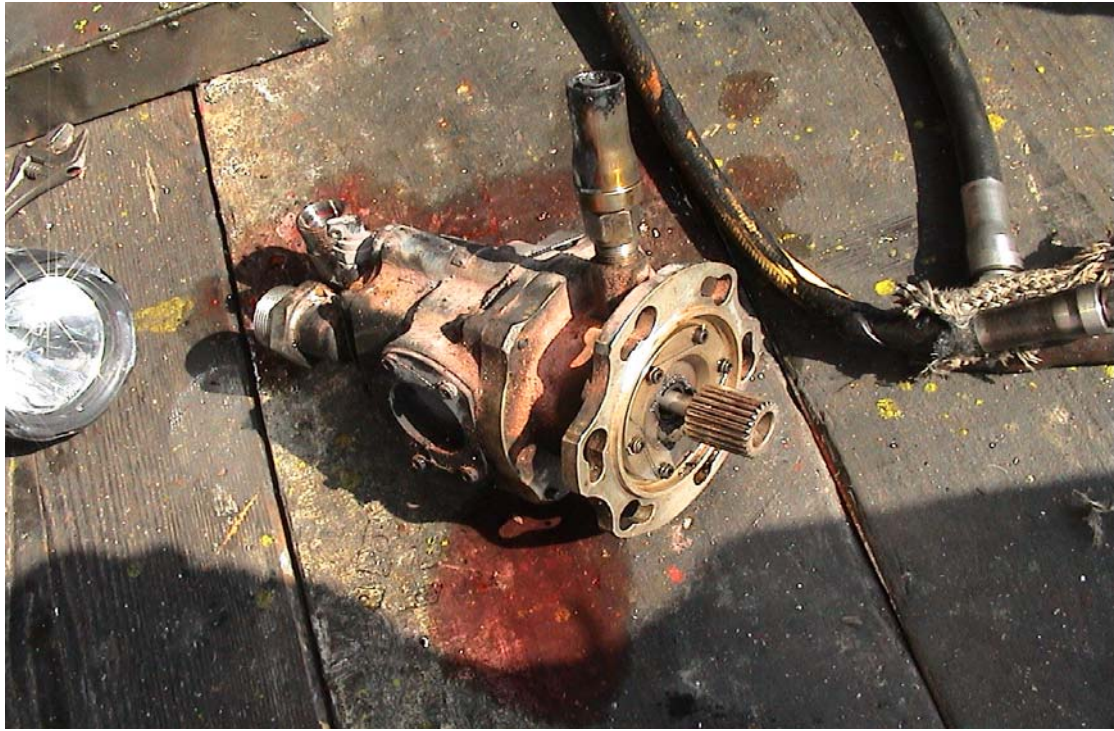
2.1 The investigation has identified that the most probable cause of the fire on Funchal was attributed to the malfunctioning of the overrunning clutch inside the port N1 turbine engine starter (see fig. 1). Such malfunction might have been caused by the jamming of the tilting pads between the outer and inner races of the clutch. Upon losing of the overrunning function, the starter was continuously driven at an excessive speed by the turbine engine even after the hydraulic circuit was deactivated. The intense heat and excessive starter casing pressure thus generated caused the failure of the hydraulic hose of the reservoir return line, releasing the hydraulic oil and setting off the fire.

2.2 Attributable to the defective engine starter was that there was no specific maintenance or inspection method for the delicate parts of the overrunning clutch assembly.

Fig. 1 : Engine starter with the seized splined drive coupling

- (i) To avoid reoccurrence of unexpected fouling of the hydraulic engine starter, the ship company is recommended to consult the manufacturer of the engine starter in order to establish appropriate inspection criteria and maintenance requirement on the overrunning clutch, and to incorporate them in the maintenance programme of their jetfoil vessels.
