26 Containers fell overboard from a locally licensed dumb steel lighter

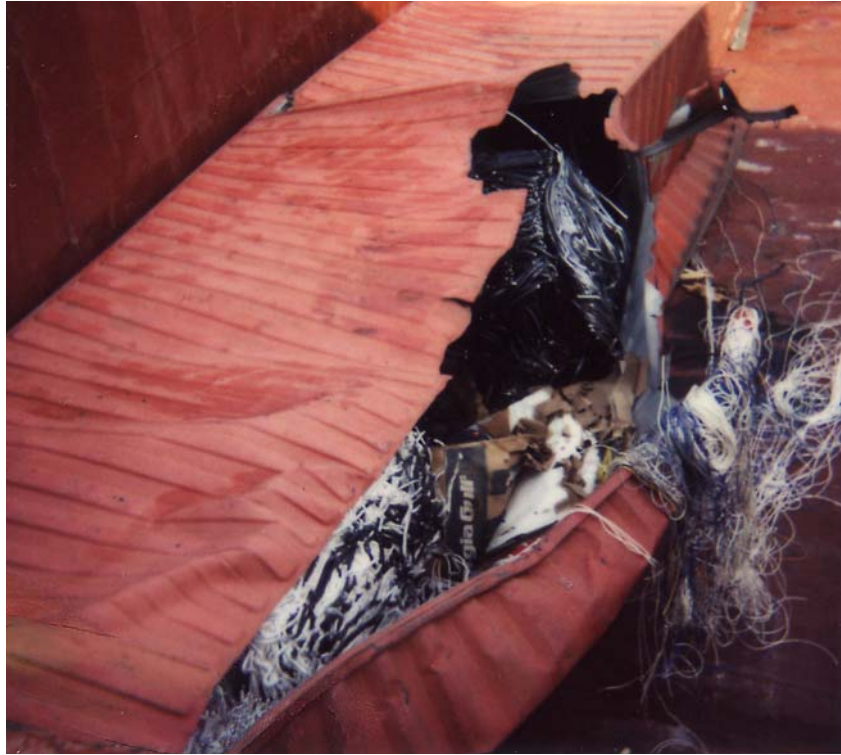
1. The dumb steel lighter was reported to have developed a slight list to port before the accident.
2. The containers loaded onboard the dumb steel lighter were kept in position by means of stacking cones. The use of stacking cones alone would not be able to prevent containers from slipping out or toppling if the dumb steel lighter is subject to excessive heeling or rolling.
3. The damages sustained to the containers remaining on board revealed that the containers had been subject to localized stress. The cargo stowed inside the containers might have been shifted and generated a momentum which might cause shifting of the containers.

Figure 1 Condition of a damaged container

1. Loading of dumb steel lighter should be evenly distributed to ensure the vessel is upright.
2. Containers should be adequately secured using appropriate securing gears, such as bridge fitting and twistlocks etc., before the departure of vessels.
