Fatal Accident of a crew after fallen overboard from the Indian registered motor tanker “Havildar Abdul Hamid PVC” in Hong Kong on 23 April 2004

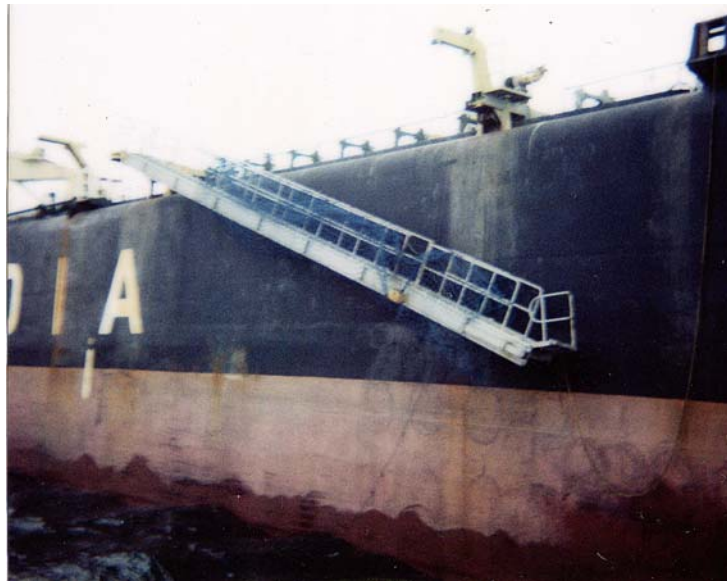
2.1 After finishing weighing the anchor for the ship’s departure, the anchor team went to the port gangway to check the cause of the vibration noise which was heard during lowering of the gangway in earlier hour. To reach the gangway from the side, one had to climb over the 1.5 m high railing and stepped across the sheer strake of the ship (edge of the shipside). However, the sheer strake was a curved shell plating and did not provide proper foothold for personnel to stand on. Also the steel wires for operation of the sliding frames were running just above deck level along the row of steel frame seatings. Personnel getting across through the seatings to the gangway might easily tripped over the steel wires.

The gangway under operation at the port side of the vessel

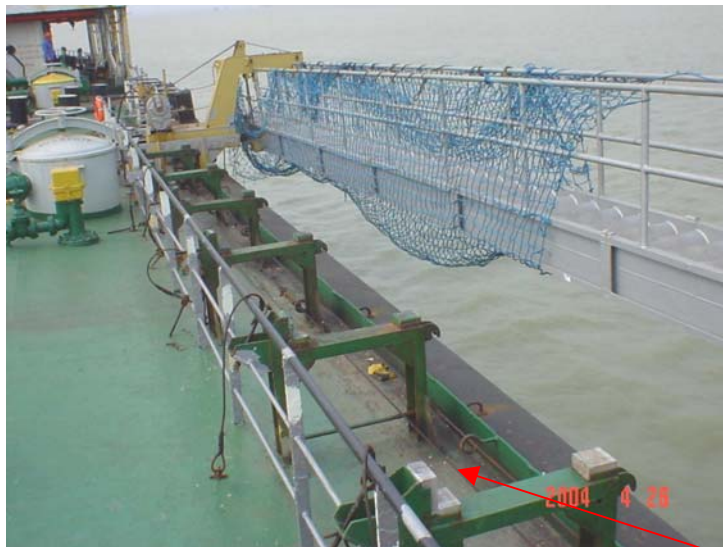
2.2 At the rear end of the gangway a safety net was loosely laid around the gangway. However the net did not straddle across the shipside and the gangway and therefore could not offer protection to personnel from falling through the gap between the gangway and the shipside.

2.3 It is believed that the deceased had climbed over the handrail trying to reach out to the gangway from the side in order to investigate the abnormal noise. While crossing over he might have slipped or tripped by the steel wire and fell through the gap between the gangway and the shipside into the water below.

Position of the gangway when the accident occurred

Steel wire

- 3.1 The investigation establishes that the lack of awareness of the deceased to the man-over-board hazards associated with the inspection on the gangway under the prevailing circumstances without taking the necessary precautionary measures, had contributed to the occurrence of the accident.
- 3.2 The Master is recommended to enhance crew training on board to improve their safety awareness while at work in a potentially hazardous environment.
