## **Fire aboard the Locally Licensed Motor Launch “SEA SMOOTH” at HKJC Kau Sai Chau Golf Club Sai Kung Pier, Sai Kung at about 1440 hours on 27th April 2004**

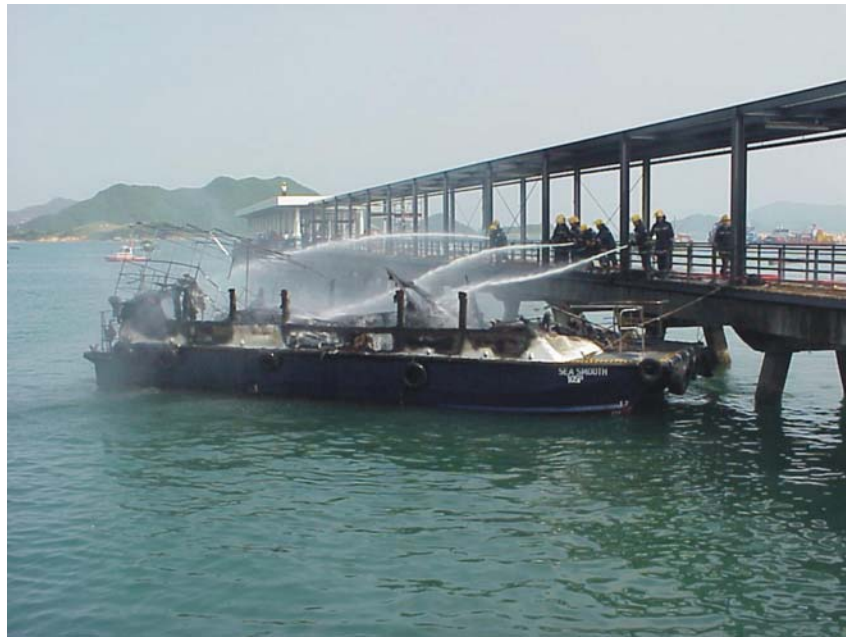
Fig. 1

1.1 At about 1440 on 27 April 2004, a fire broke out in the starboard engine room of the locally licensed motor launch Sea Smooth shortly after all passengers were disembarked at the HKJC Kau Sai Chau Golf Club Sai Kung pier, Sai Kung. Crewmembers attempted to extinguish the fire with portable extinguishers with no success. All the 3 crewmembers abandoned the vessel and escaped ashore. The burning vessel drifted to the nearby Sai Kung Public Pier, where the firemen extinguished the fire. As a result of the fire, the starboard engine room sustained fire damage and the fire engulfed the entire superstructure of the vessel (see Fig. 1). One crewmember was slightly injured in the incident.

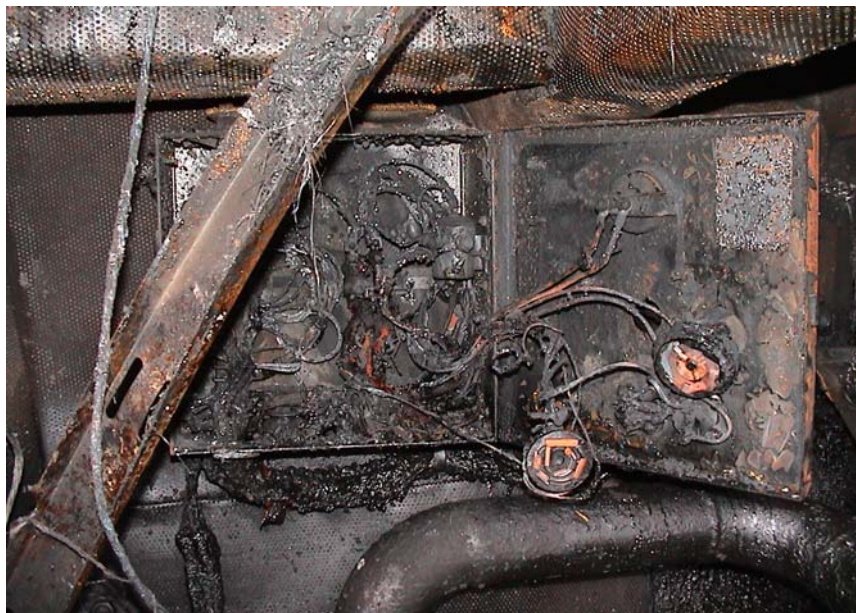
Fig. 2

2.1 The investigation establishes that the fire probably started in the starboard main engine starting control panel and spread throughout the aft portion of the engine room. The opened access hatches of the engine room then allowed the fire to spread to other areas of the vessel. While the fire damage to the interior of the engine starting control panel precluded any possible failure of circuitry to be identified, it is believed that an electrical fault, e.g. short circuiting or arcing in loose wiring connections, had attributed to the cause of the fire (see Fig. 2).

- (a) There was no specific inspection and maintenance programme for the low voltage electrical system on board.
- (b) The crews' handling of the fire was not effective and the instructions available on board contained no fire fighting procedures for opening a hatch into a space suspected of being on fire.
- (c) The lack of fire drills for crewmembers left them unprepared to handle fire emergency.
- (d) The lack of a fixed fire extinguishing system for the engine room had made it difficult for the crewmembers to contain and extinguish the fire.

- (a) the need for the specific inspection and maintenance programme for low voltage electrical system and equipment, the proper procedures for handling fire, and the need to conduct adequate fire drills on board, especially when new crewmembers are joining the vessel.
- (b) consultation with the relevant local vessels Associations for the provision of the fixed fire extinguishing system on their vessels as appropriate.
