## **Sinking of sampan resulting in fatality at Tai Long Wan on 29 April 2004**

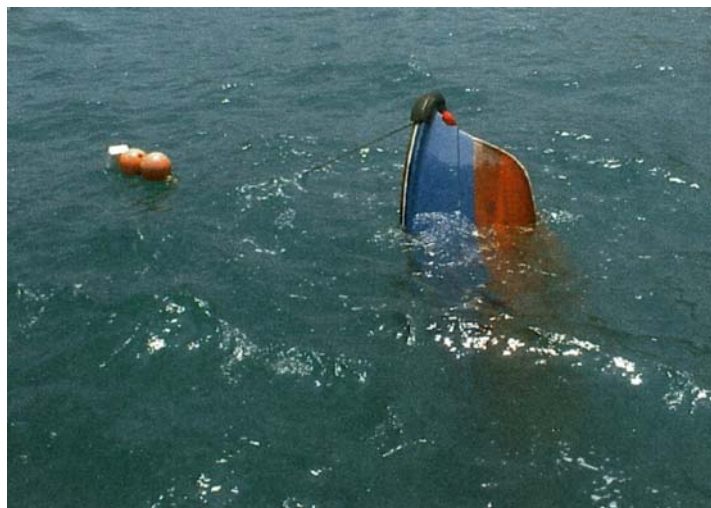
- 2.2 The sampan is a small open sampan. It is provided with built-in tanks integral to the hull for over half of the vessel's length at forward and amidships. These tanks can be used as holding tanks and, if secured by weather-tight lids, can also serve as buoyancy tanks. However, during this incident, the tanks were only covered by loosely fitted plastic lids that could be washed away by waves easily. Furthermore, the bottom plugs of two of these tanks were removed to bilge the tanks for the stowage of fish catches. This would further reduce the buoyancy of

the sampan and make it more susceptible to flooding and foundering.

- 3.1 The root cause of this fatal accident is identified to be the under-estimation of potential risks associated with operating small open vessel in exposed area. The sampan was operating with the covers of its buoyancy tanks not properly secured. Also two of these tanks were bilged for the stowage of fish catches. When the sampan encountered unexpected large waves, the tank covers were washed away and the inner hull together with the tanks were instantly flooded with seawaters. The reserved buoyancy was quickly lost which has lead to the sinking of the sampan.

The sunken sampan
