Fatality of person inside cargo tank on board the Hong Kong registered chemical tanker “Bow Wind” at Sut Sakra, Singapore on 12 June 2004

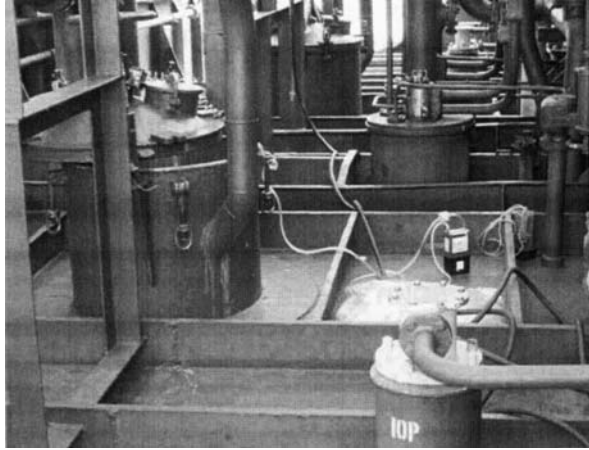
No. 10 P cargo tank dome

- 2.1 There was no witness of this incident. Shortly before the incident the cargo surveyor was taking sample with the Pumpman at the opened cargo dome of No. 10P tank. During the course the surveyor dropped his helmet into the tank. He however left the area after taking the sample. The surveyor stated that he had not seen the entry made by the Pumpman. The second officer and other crew were not staying in the vicinity.

- 2.2 The Pumpman was found collapsed at the upper ladder platform. According to the Company there was no evidence of any bleeding or signs from the body that he had fallen from height. Therefore it is reasonable to believe that the Pumpman had entered into the tank via the ladder. He was not wearing any safety apparatus.

- 2.3 Although the helmet was later found at the bottom of the cargo tank, it is believed that the helmet might have fallen first on the upper ladder platform which is located at a short distance immediately below the cargo dome. This might have prompted the Pumpman to enter the tank to retrieve it, believing that he would be able to return to deck by holding his breath. The helmet might have dropped to the tank bottom later on when the Pumpman collapsed at the

platform.
