Fire aboard the Locally Licensed Fishing Vessel “M63815A” in the waters near Tung Lung Chau at about 1500 hours on 11 July 2004

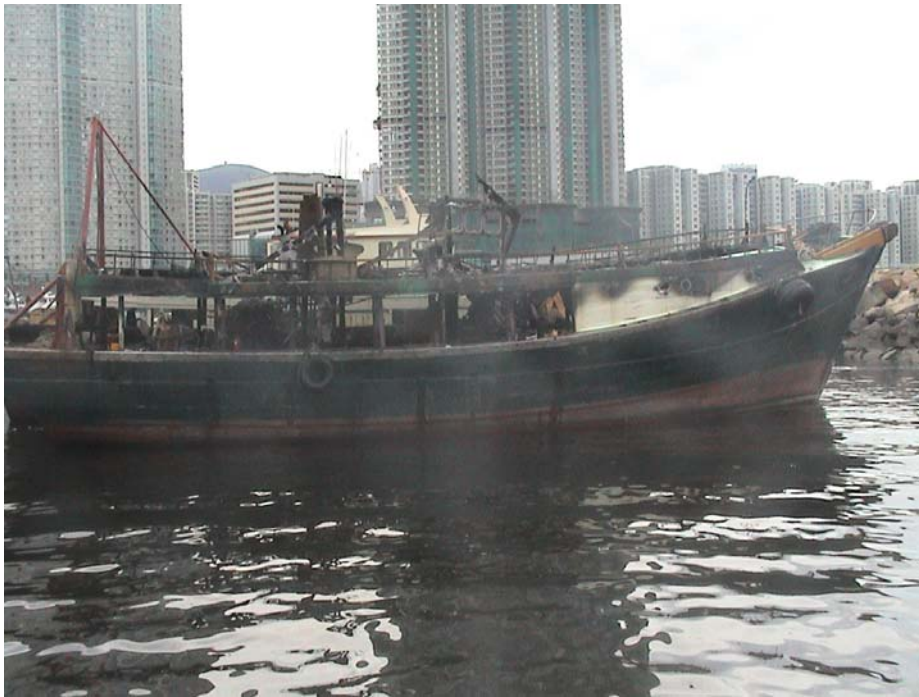
Fig. 1

1.1 At about 1500 hours on 11 July 2004, a fire broke out in the engine room of the locally licensed wooden fishing vessel “M63815A ” while it was, most probably, taking bunker from an oil barge in the waters near Tung Lung Chau. The fire spread rapidly and went out of control. The Master and the sailor managed to escape the fire and later boarded the oil barge. However, the Engineer was killed during the fire. The fire was later extinguished by the fire services launches after the vessel drifted and grounded at Luk Keng Wan (Fig. 1).

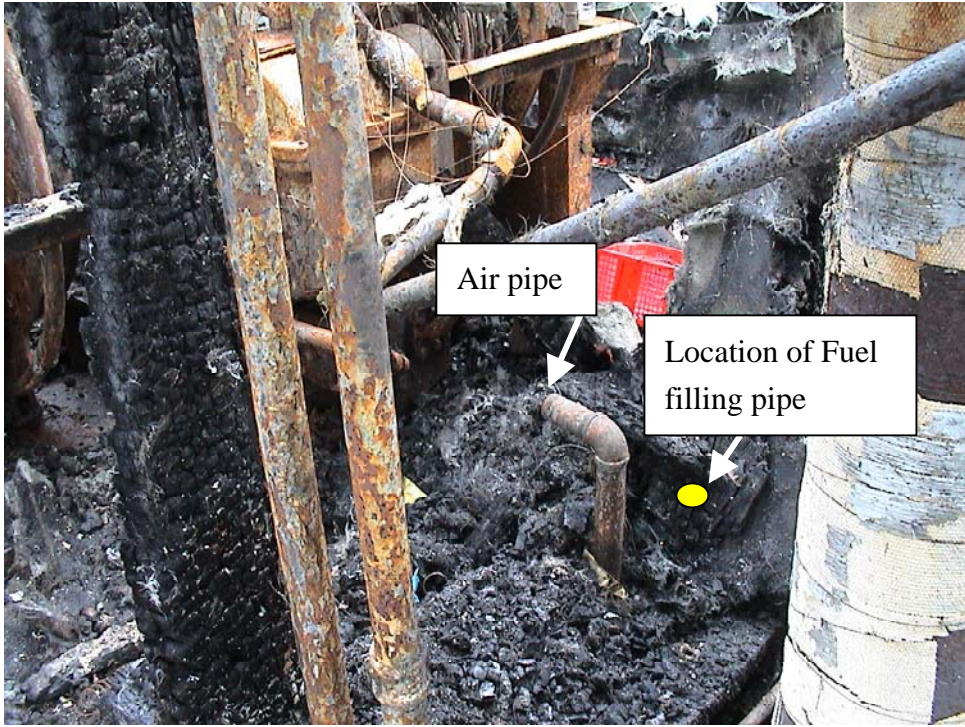
Fig. 2

2.1 The investigation has identified the most probable cause of the fire on the vessel was attributed to the faulty bunkering operation during which fuel was prematurely discharged from the bunker hose, probably due to unexpected sudden starting of the fuel supply pump on the barge, before the hose was properly connected to the fuel filling pipe in the engine room casing of the vessel. As a result, fuel was sprayed onto the hot surfaces of the exhaust pipes lying in the vicinity of the fuel filling point, causing the fire to initiate.

- (b) The designed fuel filling points on deck of the vessel was not used. Instead bunkering was carried out via a fuel tank pipe in the potentially fire hazardous area, namely, inside the engine room casing of the vessel (Fig. 2).

- (c) The exhaust pipes in the engine room casing were improperly maintained. The incomplete insulation laggings had led to exposure of hot surface which ignited the fuel sprayed on it during the faulty bunker operation.

- (a) In carrying out bunkering operation on board there must be proper coordination and effective communication between the parties involved ;
- (b) It is important that only proper filling points should be used for the fuel filling process on board ;
- (c) Machinery and equipment should be properly maintained and those not essential for fuel filling process should be shut down during the bunkering operation to minimize fire risk.
