Beaching of China Registered Bulk Carrier "Peng Yang" (鵬洋) East of Yam O, Lantau Island on 23 Aug 2004

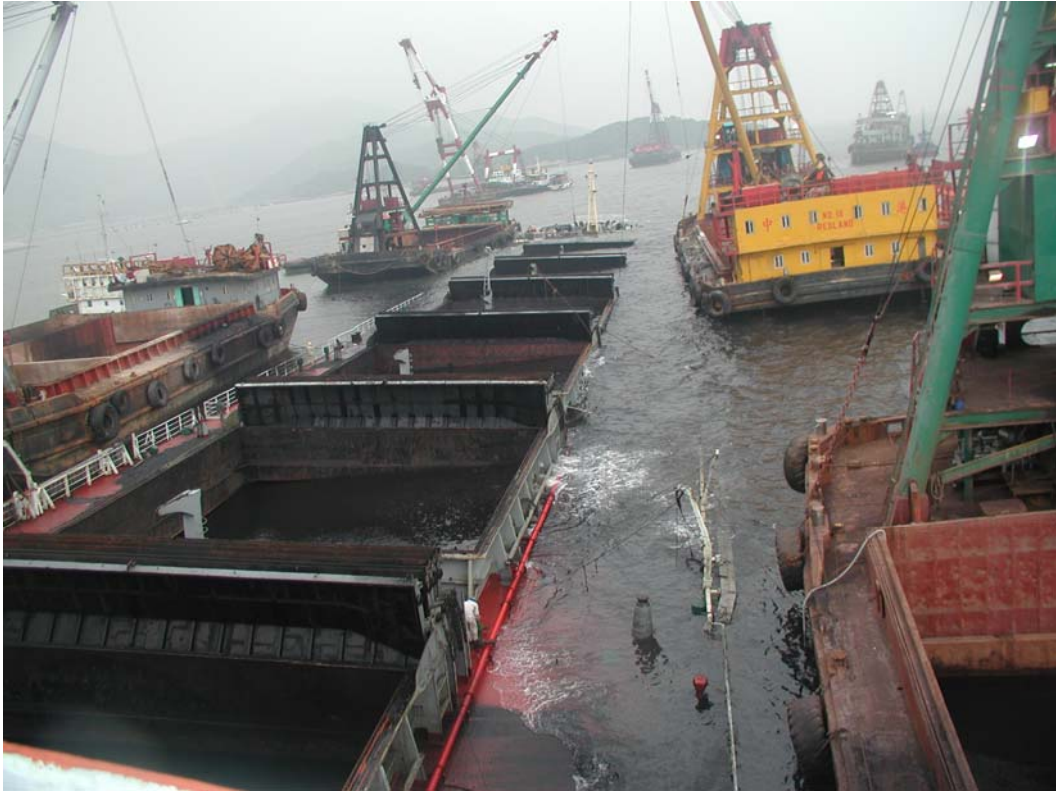
- 1.1 At about 1319 on 23 August 2004, a China registered bulk carrier "Peng Yang", while transiting the Ma Wan waterway to Shekou, hit the rocky shoal near Tsing Lung Tau which damaged and bilged its starboard double bottom tanks. The vessel developed a starboard list quickly. It was later beached at Yam O to avoid further deterioration of situation. The location of the beaching was in the approximate position of 22° 20.3'N 114° 01.8'E, which was about 0.4 of a nautical mile (nm) east of Cheung Sok Light, north-east of Lantau Island.

- 1.2 There were two harbour Pilots on board "Peng Yang". Visibility was good at time of the incident. "Peng Yang" sustained extensive damages to its hull in way of the starboard double bottom tanks. There were no report of casualty and oil pollution in this accident.

"Peng Yang" after grounding in Yam O
