Lifeboat accident on board M.V. "Lowlands Grace" on 7.10.2004 causing two fatalities

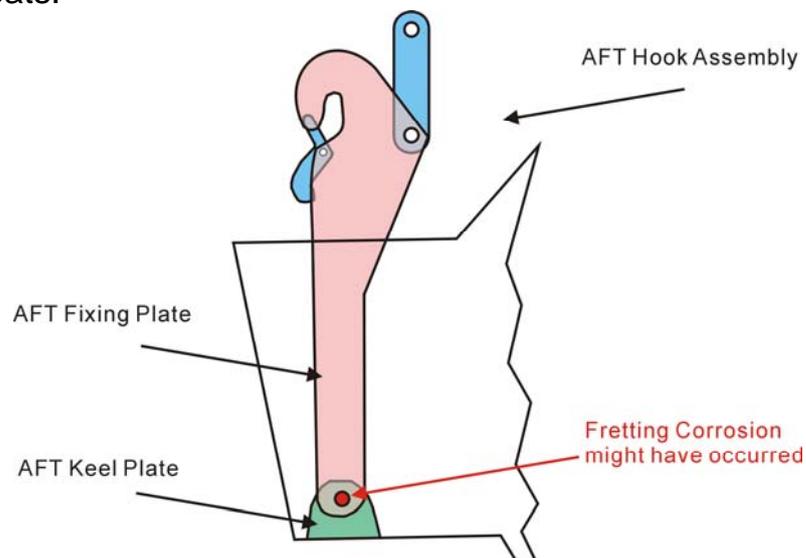
- c. Fretting corrosion might have also occurred around the securing bolt area of the fixing plates. The securing bolt was a full threaded bolt instead of a fit bolt. Fretting corrosion could have therefore occurred between the contact surface of the securing bolt and the lower part of the fixing plates.
- d. Metal defects, which may be hidden, has long been associated with failure of fabricated structures. The crack being suspected in this fatal incident, may have initiated when excessive stress encountered during the rough handling of lifeboat during launchings. The crack can, over some period of time, move slowly its way across the material as the part flexed or the stress is oscillated at different levels. The crack weakened the structure and subsequently tend to cause fractures or failure of structure.

Fretting Corrosion at Contact Surface of the Securing Bolt and the Lower Part of the Fixing plates

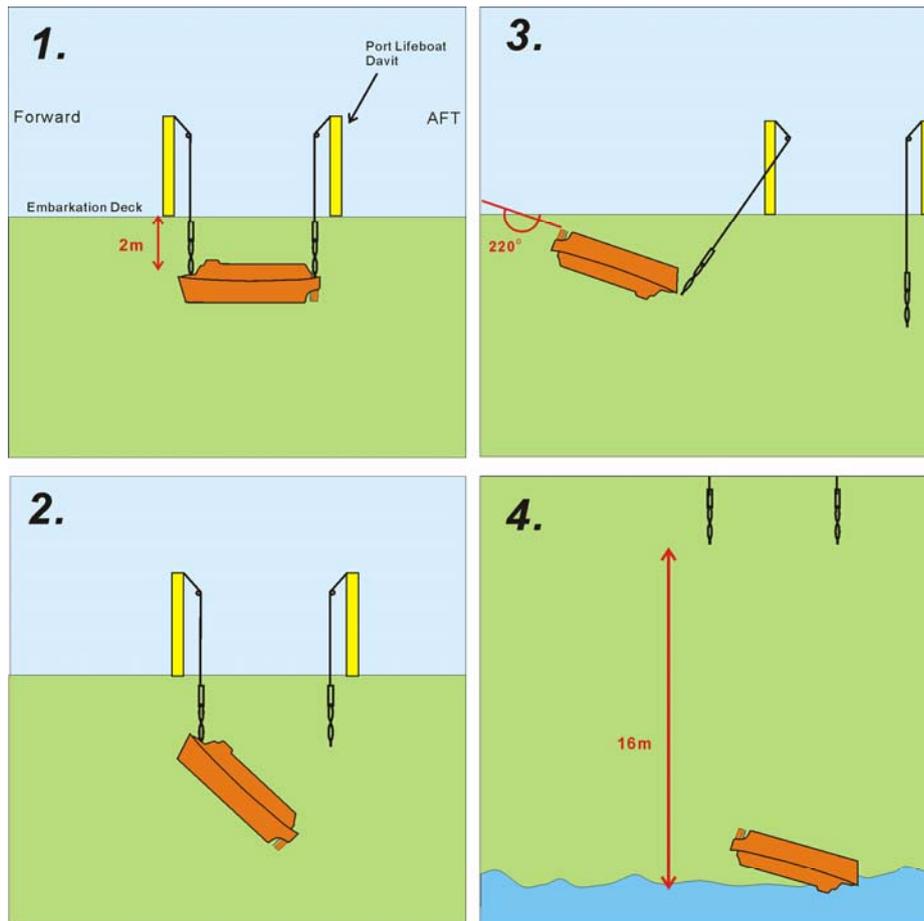
Sequences of Events Leading to the Dropping of Port Lifeboat into the Sea

1. The port lifeboat was launched by the 3/O using the remote control wire inside the lifeboat.
2. After the port lifeboat had travelled for about 2 m, the after part of the port lifeboat detached and the port lifeboat swung forward on the forward hook.
3. The forward hook opened at the top of the swing for about 220° and the port lifeboat started to plunge into the sea in an upside-down position.
4. The port lifeboat plunged into the sea from a height of about 16 m.
