Collapse of gantry crane trolley resulting in one death and two injuries.

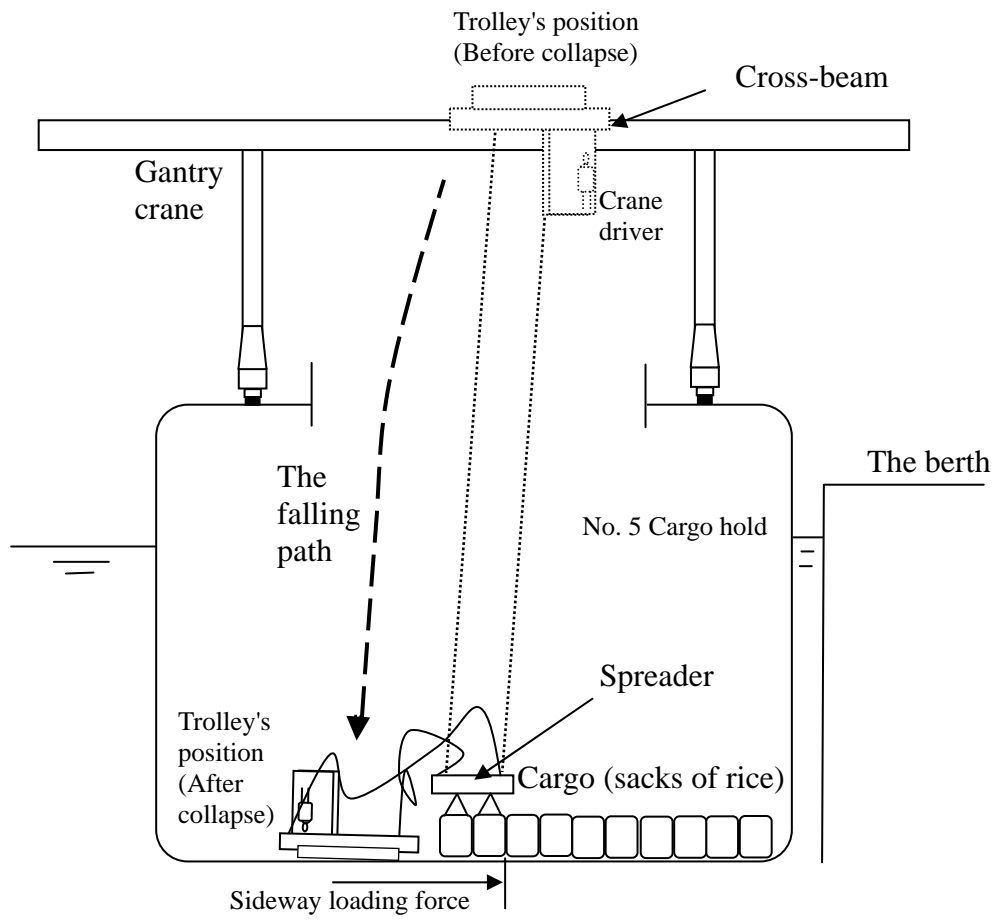
- 1.1 On 20 October 2004, the Hong Kong registered ship "*Indotrans Java*" berthed at a dock of Brazos Harbour, Freeport, U.S.A. for loading. A cargo of rice in sacks was loaded into the No. 5 cargo hold using the ship's gantry crane. A crane driver was inside the driver cab of the gantry crane trolley to operate the loading of cargo while the other two stevedores were working inside the cargo hold.
- 1.2 While sacks of rice were being loaded into the cargo hold, the supporting frames of the gantry crane trolley suddenly detached from the cross-beam of the gantry crane. The trolley and the crane driver fell down into the bottom of the No. 5 cargo hold (see figure 1). The accident caused the death of the crane driver and injury to the two stevedores.

- 2.1 The accident was probably caused by the failure of the mounting bolts at the supporting frames of the gantry crane trolley. Following contributory factors were identified to the failure of the mounting bolts:
 - a) Certain structural members of the trolley of the gantry crane such as the mounting surfaces, bolts and nuts of the support frames were seriously corroded;
 - b) Bolts with strength lower than the design value were fitted on the mounting flanges of the support frames; and
 - c) The malpractice of applying sideway loading force (see figure 1) on the cargo by the crane trolley caused uneven loading on the support frames and their mounting bolts.

Figure 1 : The scene of the incident
