# **Sinking of Chinese cargo vessel “Shun Feng 168” (順風168) East of Yin Tsz Ngam (燕子岩) on 30 December 2004**

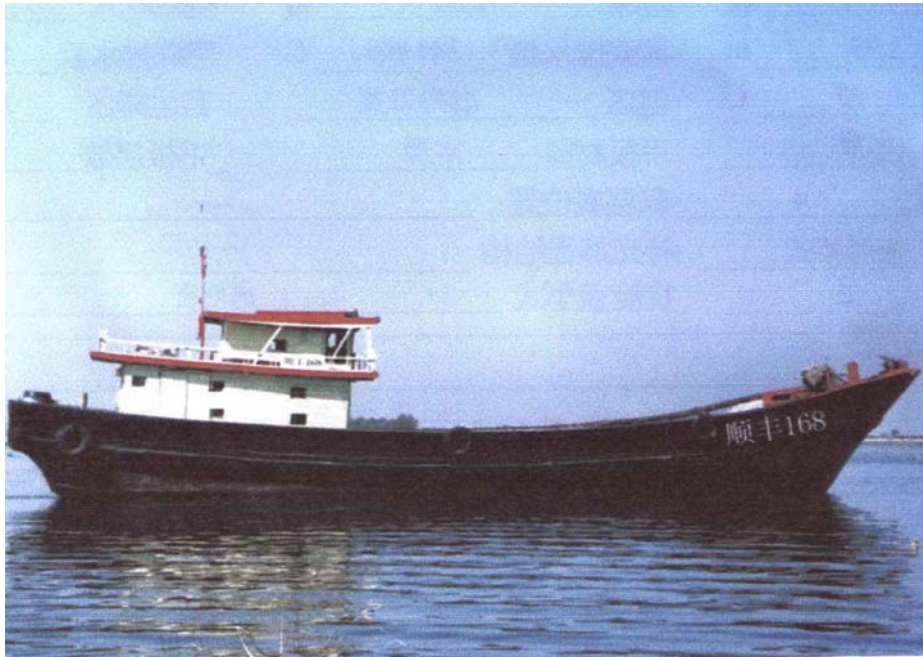
Fig. 1: “Shun Feng 168” before the incident
