Report of Investigation  
into the Man Overboard from  
the Local Fishing Vessel  
“M60643T” at Wong Chuk  
Kok Tsui on 12 January 2005

The Hong Kong Special Administrative Region  
Marine Department  
Marine Accident Investigation Section

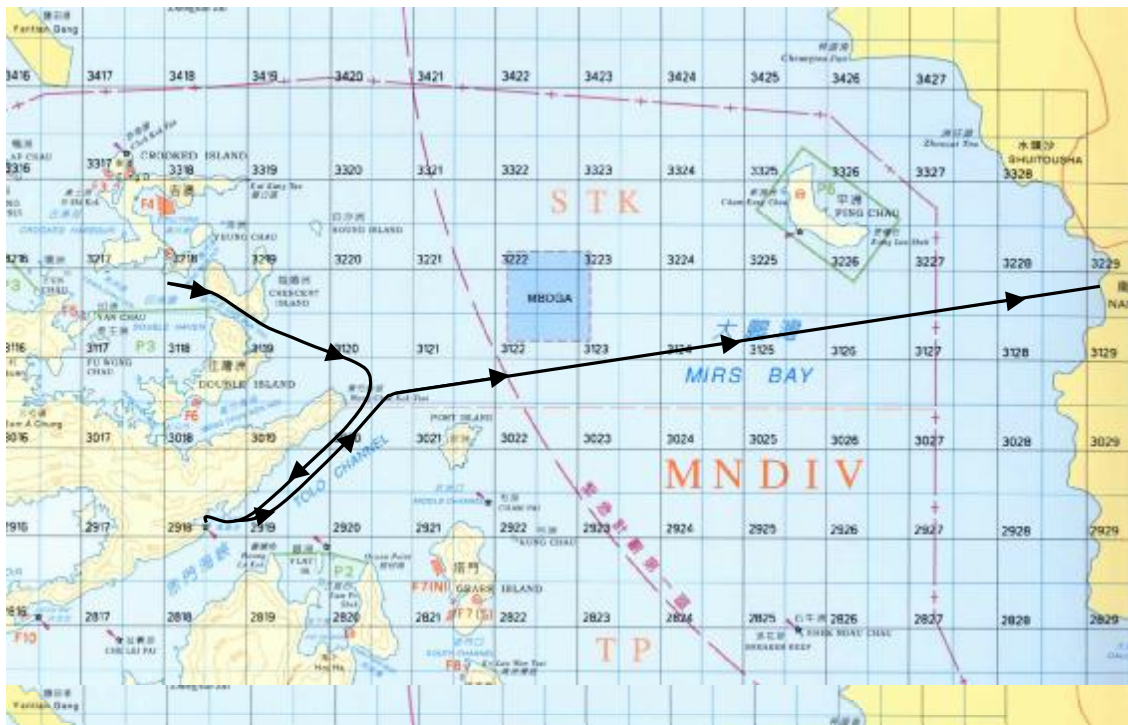
Figure 1: The route of the fishing vessel "M60643T" on 12 January 2005

- 4.1 At about 0000 on 12 January 2005, the fishing vessel "M60643T" with eight crewmembers was engaged in fishing operation at Double Haven (印州塘). At about 0400 they finished the fishing operation and departed for Nam Ao for selling the fish catches via Fung Wong Wat (鳳凰笏) ( fig. 1 )

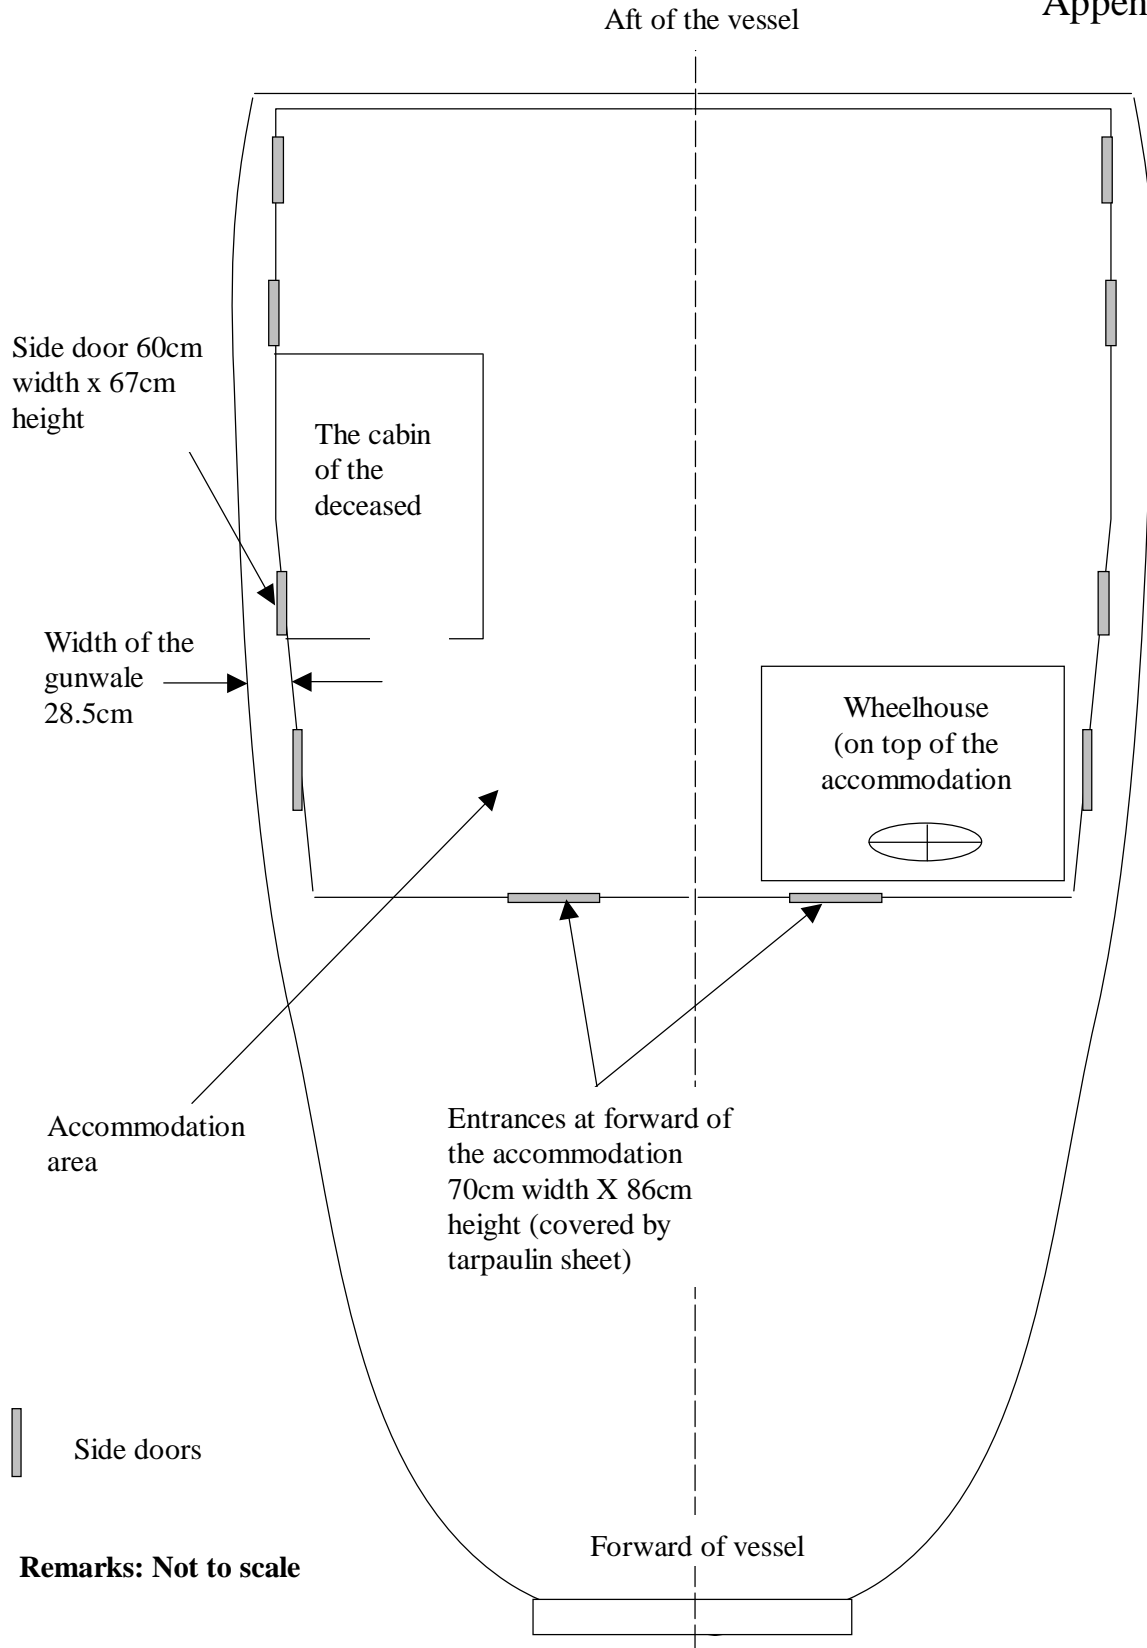
Sketch 1: Arrangement of the accommodation of the motor fishing vessel: M60643T

- 2.1 "M60643T" is a motor wooden fishing vessel of 53.1 nett registered tons. The vessel has a length of 15.66 m and breadth of 5.2 m. The propulsion engine was a 6-cylinder Gardner diesel of 80.6 kW. The vessel was first licensed on 24 July 1985. Its licence was last renewed on 20 September 2004 and will expire on 11 September 2005.
- 2.2 The vessel was manned by eight crewmembers, comprising the master and seven sailors. Two of the sailors including the deceased, Mr. SO Tin-po were the brothers of the Master, the other sailors of PRC nationals were employed by the Master of the vessel.
- 2.3 The accommodation is located at the aft of the vessel. There are two front access doors and eight side doors which can be used for accessing to the accommodation. (See figure in the appendix)

- 5.3 There were two main entrances at sizes of 70cm width x 86cm height located at the front of accommodation, however the front entrance was not used for entry because it was covered by tarpaulin sheet and obstructed by some crew working on the front deck. The tarpaulin was fitted to prevent any ingress of water into the accommodation whilst the vessel was at sea. In addition to the front entrances, there are also eight doors smaller in size located on both sides of the vessel. The side door can also be used for entry to the accommodation.

- 5.5 However it was not easy for the crewmembers to enter from the side doors to the accommodation, he was required to stand on the narrow gunwale with one hand holding the handrail in maintaining balance while using the other hand to open the side door. The gunwale was about 28.5 cm in width.

using these side doors. However the use of these side doors for making entry to the accommodation when the vessel is at sea is considered to be dangerous, as the vessel would be subject to complex rolling and pitching motions at sea. Furthermore, crewmember standing on a narrow and possible wetted gunwale could easily lose his balance, slipped and fell overboard. Crewmembers should be made aware of the possible danger and to avoid using the side door whilst the vessel is at sea.

- 7.1      A copy of the report is to be sent to the master of the local fishing vessel "M60643T" and the Fishermen Association drawing their attention of the possible dangerous situation when using the side doors for making entry to the accommodation during voyage. Fishermen are advised to use safe means of access to the accommodation at all times.
