# **Fatal incident on board general cargo vessel "*J Real*" at Suao, Taiwan on 21 January 2005**

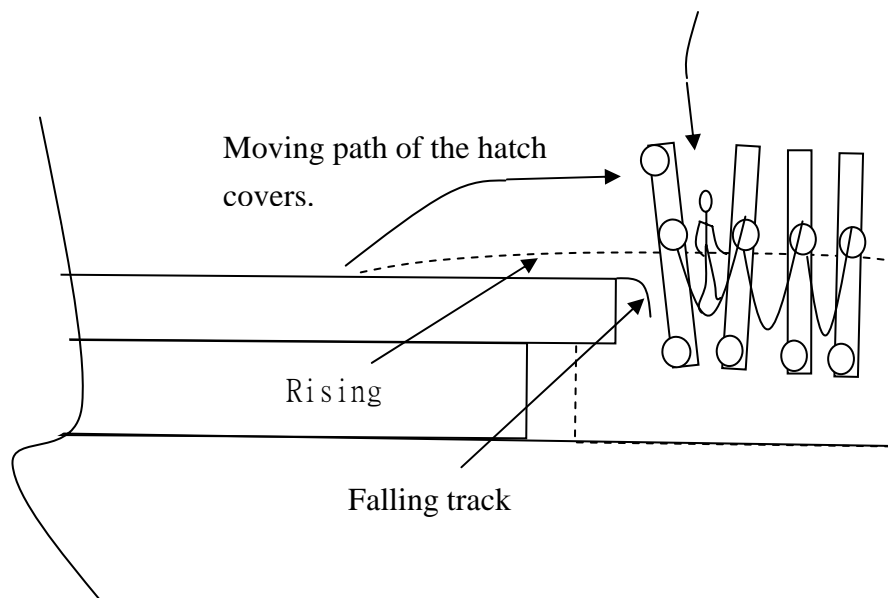
- 1.3 In closing the other half of hatch covers, the Bosun stood on top of the unsecured cover to give signal to the winch operator. During the hatch closing, the thin steel wire suddenly parted and the unsecured hatch covers started to roll backward. As a result the Bosun was trapped and was crushed as the covers slid further backward (See fig. 2). He was sent for medical treatment after the accident and was certified dead upon arrival to the hospital.

- 2.1 A trim of 2m by stern was reported at time of the incident. The slope of trim to the length of vessel was about 1 in 50. In such condition the hatch covers could slide to the aft of the vessel if it was not properly secured. Moreover, as the other section of hatch covers was closing, the movement between covers could cause vibration and further aggravate the situation.
- 2.2 The crewmembers had improperly used a thin steel wire rope instead of the stopper pin to secure the hatch cover.

Fig. 2: The Bosun was trapped and crushed between the foldable hatch covers.

- 3.1 It would be a dangerous practice for crewmember to stand on unsecured hatch covers for signaling operation.
- 3.2 Operation of hatch covers should take into account the excessive trim of the vessel. When necessary the trim of vessel should be suitable adjusted for safe operation of the hatch covers.
