Report of Investigation
into the Fatal Incident on
board General Cargo Vessel
“J Real” at Suao, Taiwan
on 21 January 2005

The Hong Kong Special Administrative Region
Marine Department
Marine Accident Investigation Section

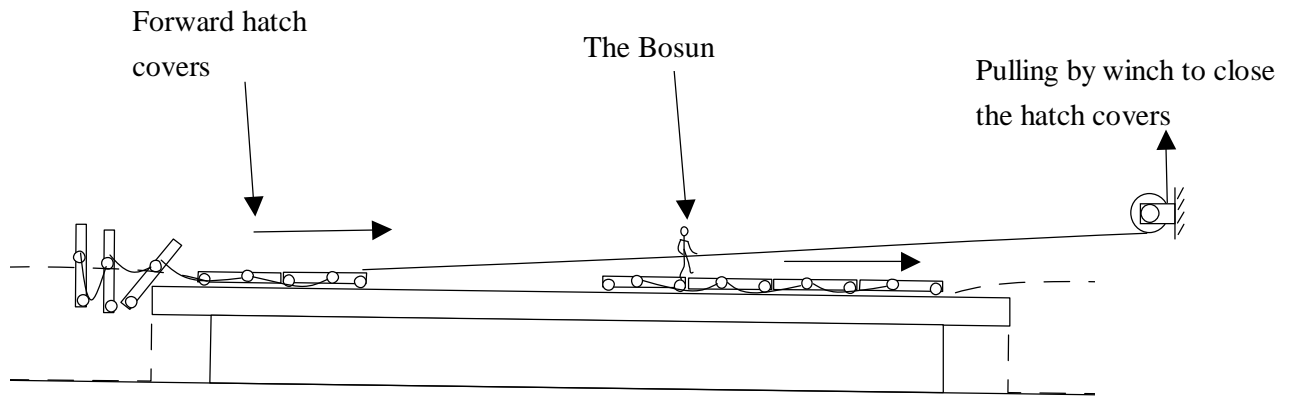
Fig. 3: Scene of the accident

- 4.3 At 1625, after closing the rear part of No. 2 hatch covers, it was found that the hatch covers was slightly misaligned that the pin stopper could not be inserted to the hatch coaming to secure the hatch covers in position. Therefore the crew members secured the hatch covers temporarily with a steel wire. They then started to close the forward hatch covers of the No. 2 cargo hold while the Bosun stood on the rear part of the hatch covers to signal the operation to the winch operator. (See fig. 3 for details)

Remarks: the Vessel trimmed with 2 m by stern

- 5.3 The forward draft and the aft draft of the Vessel was 3.1 m and 5.1 m respectively. With the 2 m trim by stern, the slope of the hatch was about 1 in 50 and the hatch covers would tend to move to the aft of the vessel. At the time of the accident, the forward part of the hatch cover was closing and

could cause vibrations to the hatch-coaming. Such vibrations may also trigger the rear part of the hatch covers which were not properly secured to slide backwards.

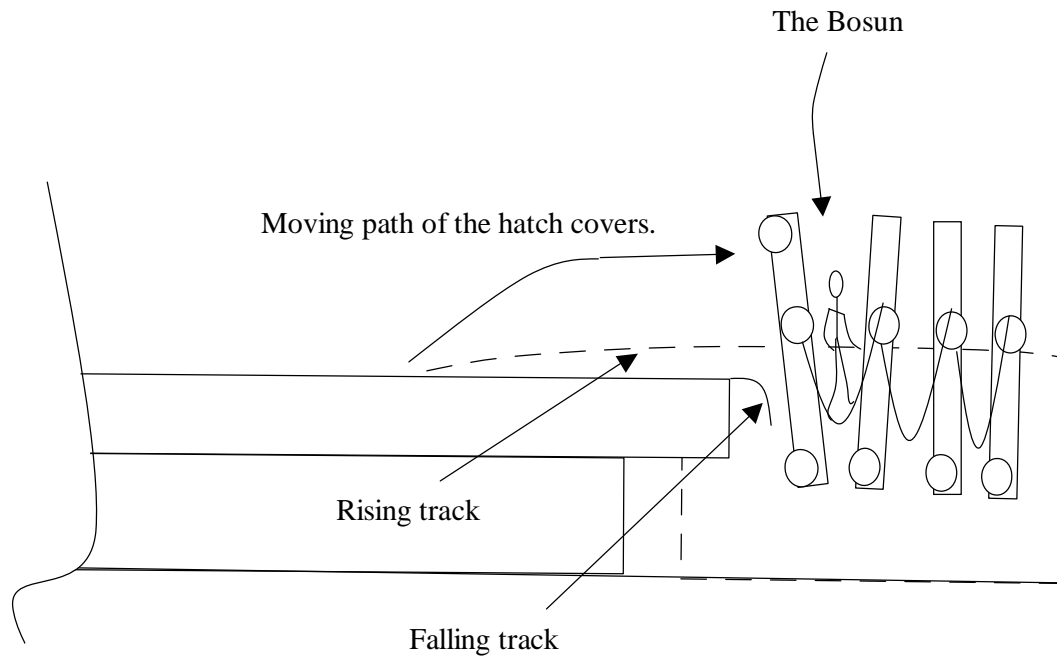
- 4.4 While closing the forward part of the hatch covers, the steel wire for securing the rear part of hatch covers was broken and the pontoons started to slide backwards. The Bosun tried to get off from the hatch covers, however, the hatch covers was moving fast and the Bosun was trapped and crushed between the foldable hatch covers. (See fig. 4 for details)

Fig. 4: The Bosun was trapped and crushed between the foldable hatch covers.

- i) Single thin and rusty wire was used to secure the heavy hatch covers;
- ii) Operation of hatch covers without considering the vessel was at 2 m trimmed by stern; and
- iii) Crew member stationed on top of the hatch covers for signalling.

7.2 A Merchant Shipping Information Note should be issued to promulgate the lessons learnt from this incident, and to remind seafarers and stevedores to follow safety procedures for hatch covers operations.

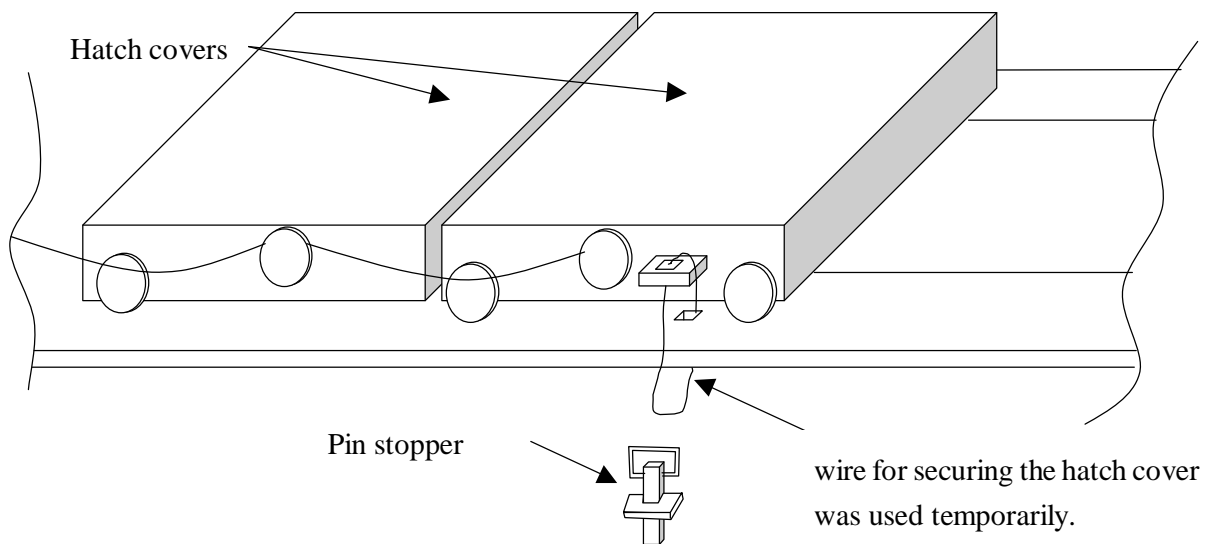
- 5.2 The first pontoon of the hatch covers had two pin stopper assemblies for locking the hatch covers at its close position and preventing any movement of the hatch covers. However, during the closing of the rear part of the No. 2 hatch covers, the crew members found that the pin stopper could not be inserted due to misalignment. So they used a steel wire to temporarily secure the hatch covers instead. (Please refer fig. 5 for details).

Fig. 5: Arrangement of the hatch covers and the pin stopper.

- 5.4 The crewmembers had used a steel wire rope instead of the proper stopper pin to secure the hatch covers to prevent the sliding movement of the covers. There was no information about the condition of the steel wire rope, however, the crew members described that the steel wire rope was thin and rusty. It appears that the wire rope was not strong enough to hold the great inertia of the moving hatch covers.
- 5.5 It was a poor working practice that crew members stood on the hatch covers for signalling to the winch operator. The Bosun climbed up to the top of the hatch covers for a better view in order to signal the winch operator. However, the views from the winch operator were unrestricted and it was not necessary for the Bosun to stand on the hatch covers for signalling to the winch operator.
