# **Sinking of local licensed vessel "M20242A" on 19 February 2005 causing two fatalities**

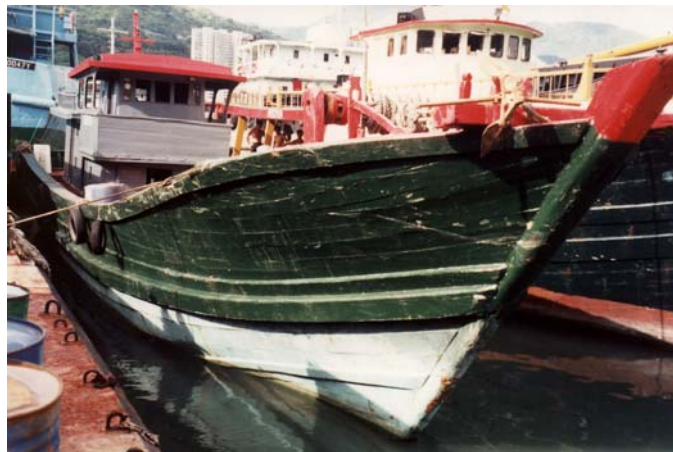
Fig 1 "M20242A" before the incident
