Report of Investigation
into the Sinking of Local
Licensed Vessel “M 20242A”
Causing Two Fatalities
on 19 February 2005

The Hong Kong Special Administrative Region
Marine Department
Marine Accident Investigation Section

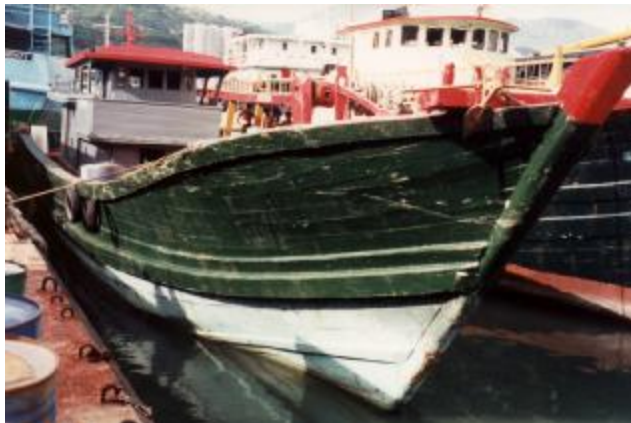
Fig 3 The hull of the vessel "*Chung Man*"

to Fook Hing Shipyard (Translation) in Shau Kei Wan for inspection by an owner representative on 18 February 2005, Mr. TAO told Mr. LAU over the phone that no abnormality was found on the Vessel. Mr. LAU did not know the details of the inspection as no inspection record could be produced. He knew only the cost of the inspection. The work of the inspection was in question. The damage due to the grounding of the Vessel could not easily be detected, as cracks on the hull and damage on the caulking would be propagated subject to vibration during voyages causing ingress of seawater.

- i The Vessel had run aground shortly before the accident, defects such as minor cracks and damage of the caulking has occurred but not easily be detected. These damages would be worsen during the voyages and caused ingress of water into the cargo hold and engine room of the Vessel.
- ii. The Vessel was fully loaded with cargo, flooding at early stage would not be detected by crewmembers. In addition, no room for portable submersible pumps to be lowered into the cargo hold for pumping out the seawater.

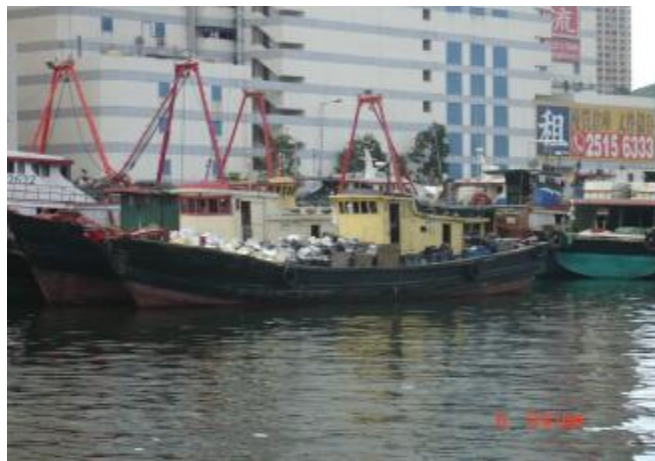
- 5.7 The Vessel was loaded with 320 sets of used television, 530 sets of used computer monitor and 290 sets of used computer case. The estimated weight of the cargoes was about 20 metric tons¹, such weight did not exceed the loading capacity of the Vessel. However, in case of water leaked into the cargo hold, it would not easily be detected as the cargo hold was filled up with the cargo. (See fig.4, the loading condition of the cargo of a similar vessel)

Fig. 4. The loading of used TV and computer monitor loaded to a similar type of vessel
Mr. LAU stated that the Vessel had run aground one day before the date of the departure of the vessel, however the grounding of the vessel was not reported to the Marine Department. Mr. LAU further stated that the Vessel was taken

5.9 Mr. LAU stated that the Vessel was equipped with three portable submersible pumps that could be used to pump out the water if flooding occurred in the cargo hold. However, the cargo hold without any bilge level indicating devices was fully stowed with cargo. Ingress of water in the cargo hold due to failure of the hull could not be easily detected. In addition, portable submersible pumps could not be lowered into the cargo hold as the space of the cargo hold was fully occupied by cargo.
