Preliminary Inquiry No.1 of 2005

Report of Investigation

into the Engine Room Fire

on Board M.V. "Fleet Trader 1"

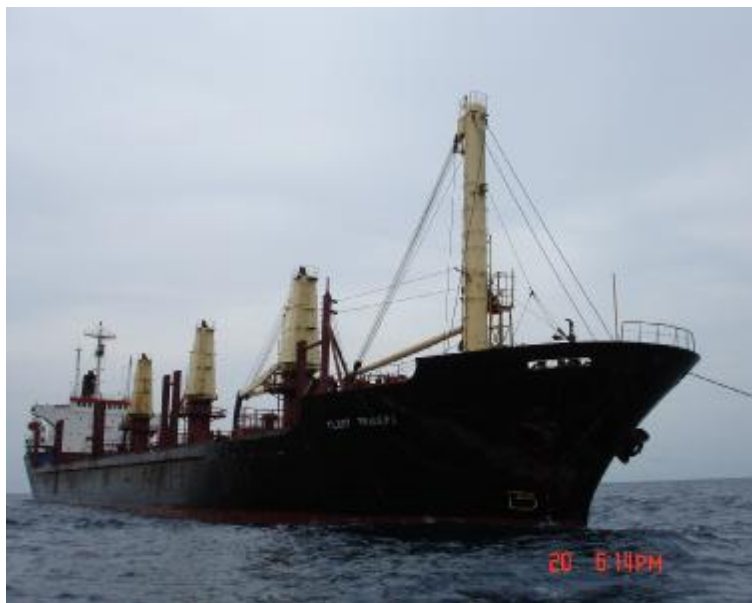
Fig. 1: "Fleet Trader 1" was towed to Lagos after the fire.

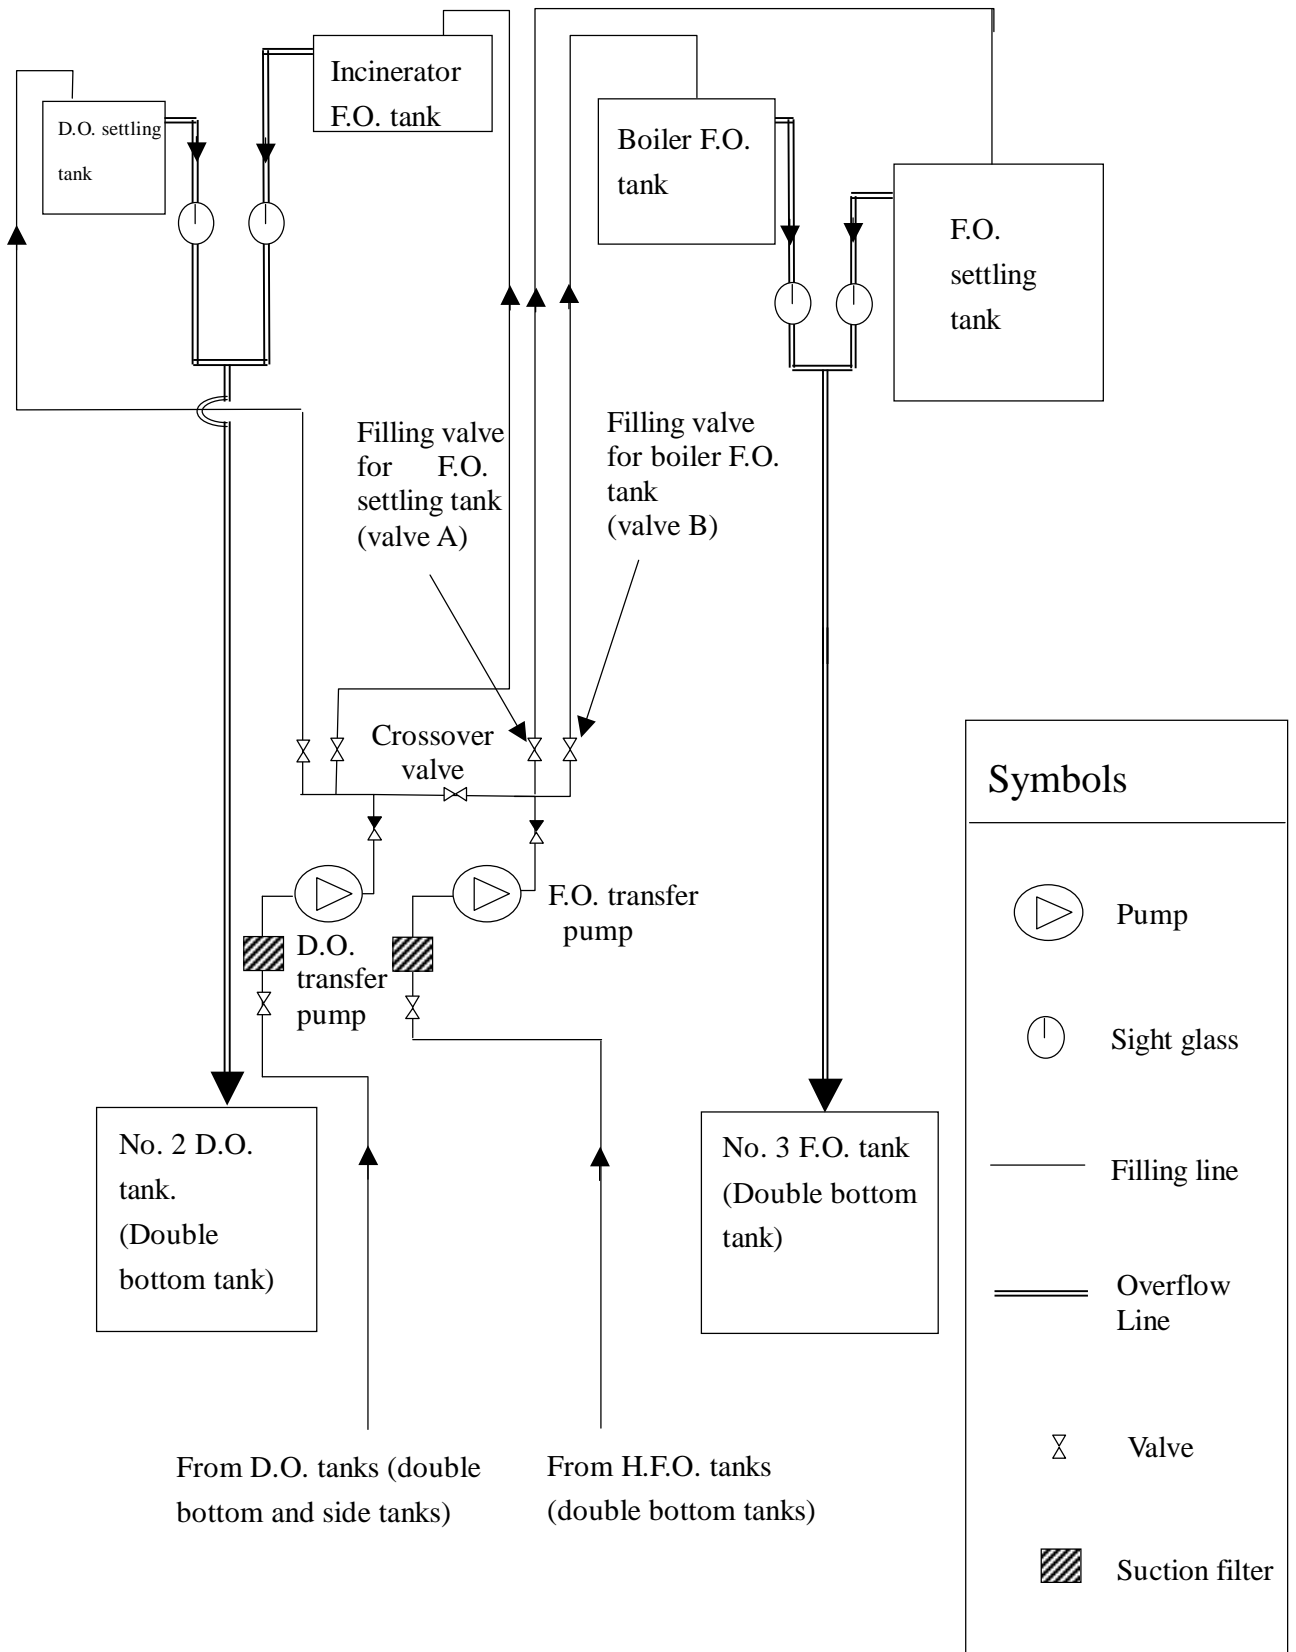
3.3.1 Fig. 2 shows a simplified diagram of the fuel oil transfer system on board the Vessel. The Vessel operated on two kinds of fuel, heavy fuel oil and diesel oil. The heavy fuel was delivered from the F.O. double bottom tanks to the F.O. settling tank and boiler F.O. tank by the F.O. transfer pump. The F.O. settling tank was required to be topped up every watch while the boiler F.O. tank was only to be topped up in port. On the other hand, the diesel fuel was delivered from the D.O. double bottom tanks to the incinerator F.O. tank and D.O. settling tank by the D.O. transfer pump. There was a crossover valve fitted between the delivery lines of both pumps to connect the heavy fuel and diesel oil systems.

3.3.2 All the F.O. tanks and D.O. tanks including the boiler F.O. tank were fitted with an overflow pipe, which acted as a protection device to allow excess heavy fuel oil and diesel oil to overflow back to the designated double bottom tanks of the Vessel.

Fig 2: Simplified diagram of fuel oil transfer system

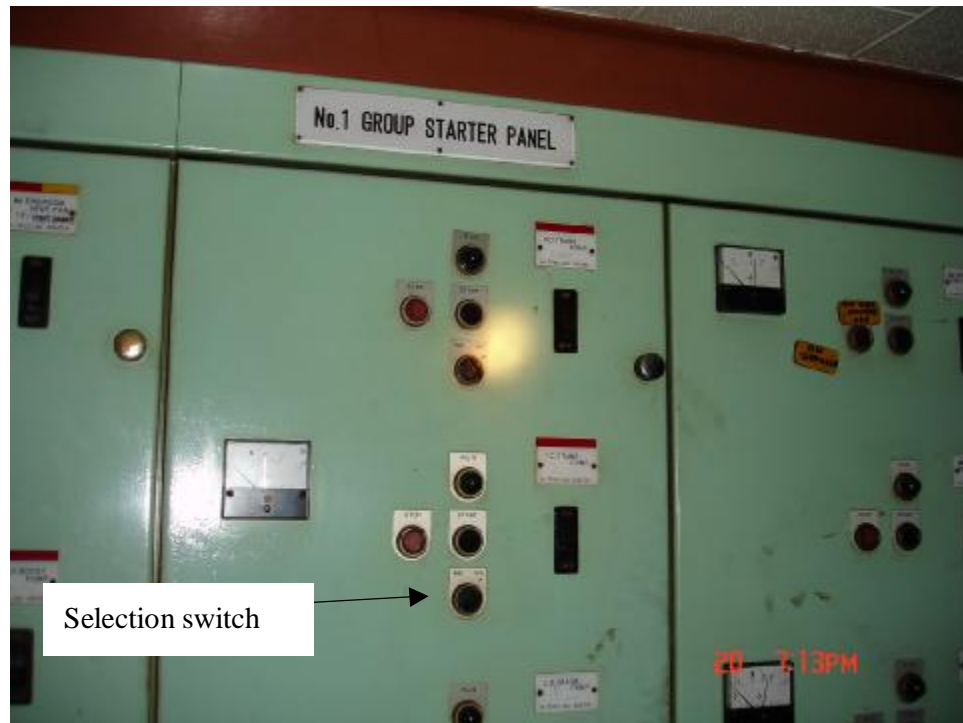
3.3.3 The starter panel (see fig. 3) of the fuel oil transfer pump is located in the engine control room with a selection switch on either manual or automatic mode for starting and stopping of the fuel oil transfer pump.

Fig 3: Starter panel for fuel oil transfer pump.

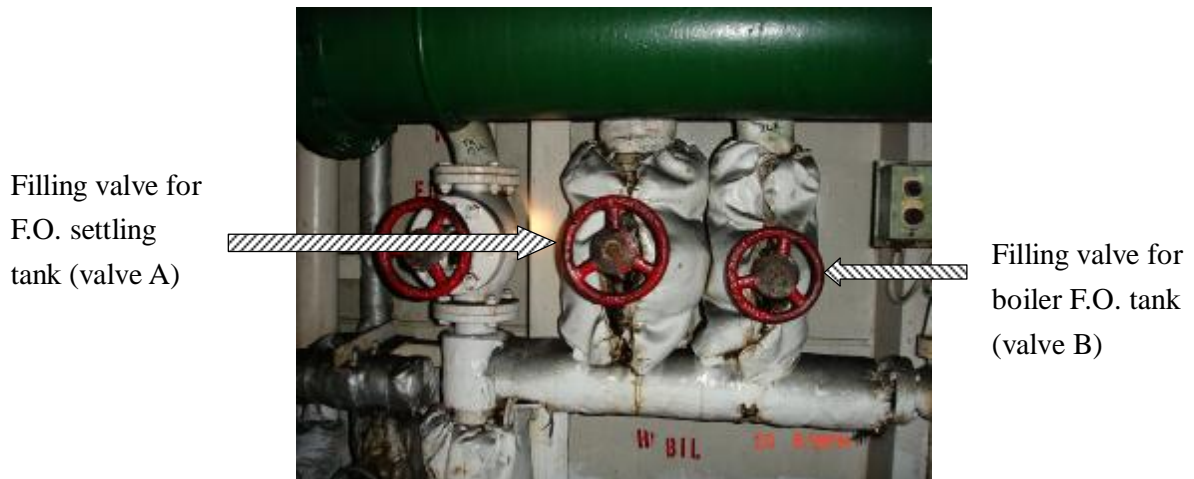
Fig. 4: Filling valves for F.O. settling and boiler fuel oil tanks.

5.4.3. At about 1000 on 24 March 2005, a mistake was made by the Junior Engineer. He opened the wrong valve after cleaning the filter of the fuel oil transfer pump. As a result, the boiler fuel oil tank was filled up instead of the fuel oil settling tank. When the boiler fuel oil tank was full, the fuel oil came out from the opening at top of the boiler fuel oil tank and ran down onto the hot exhaust trunk which ignited the fuel (see fig 7).

- ii) the pipe works should be properly maintained for the intended services;
  - iii) proper oil transfer procedures should be followed on board;
  - iv) no doors should be kept open by preventing proper function of the self closing devices; and

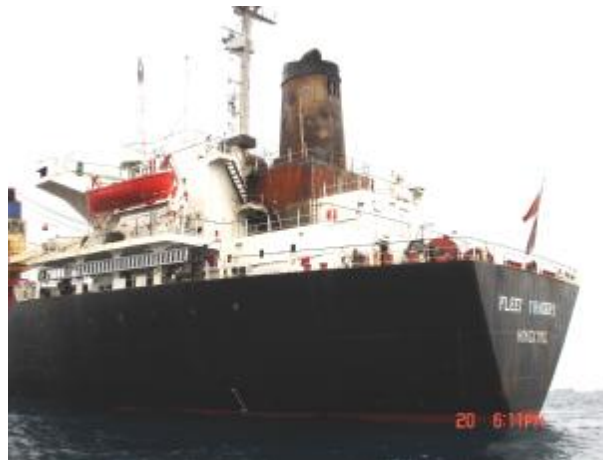
5.1 The investigating officer boarded the vessel on 20 April 2005 whilst the Vessel was at anchor in the port of Lagos awaiting discharging cargo (see fig 5). A site inspection was conducted and the witnesses were interviewed for the investigation.

Fig 5: Appearance of the accommodation area of the Vessel after the incident.

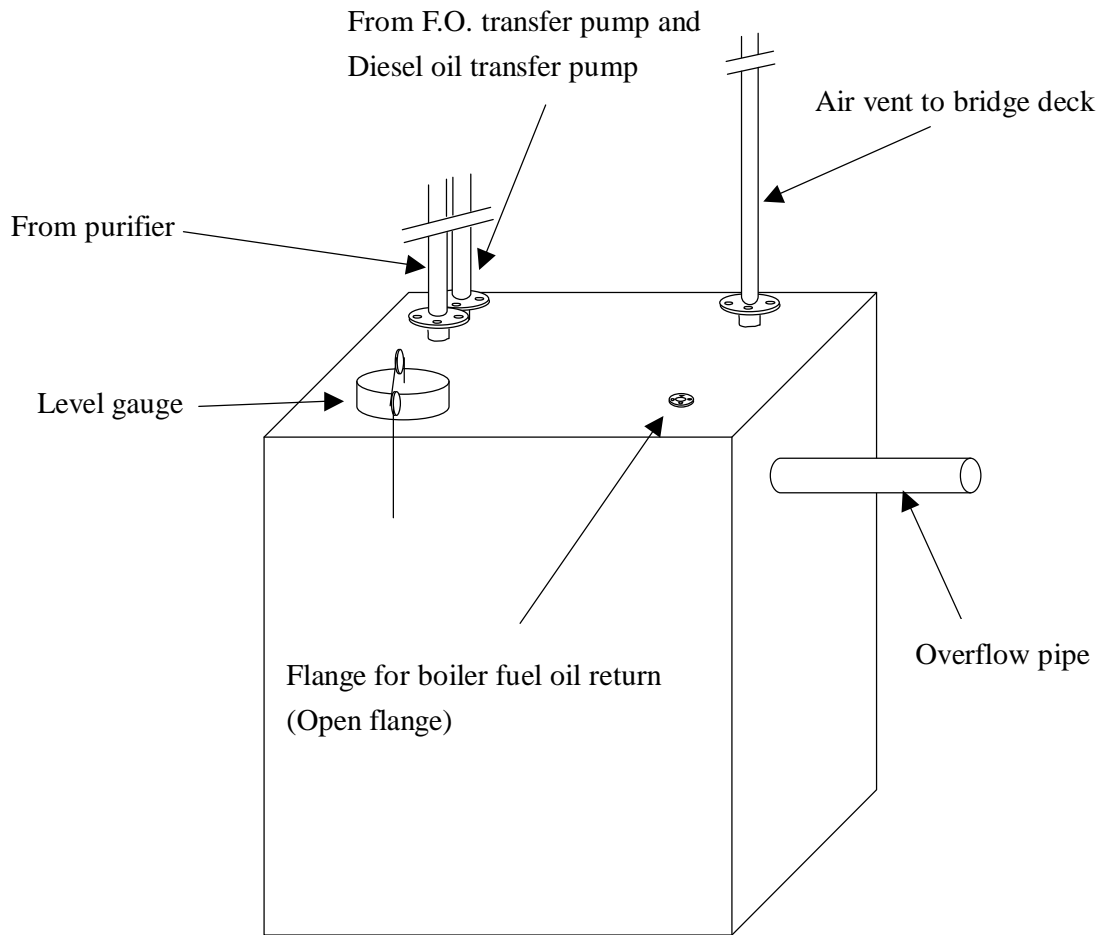
5.3.1. The boiler fuel oil tank (See fig. 6) had a capacity of 1.2 m<sup>3</sup>. Mounted on the top of the boiler fuel oil tank were the inlet pipe from fuel oil transfer pump and diesel oil transfer pump, inlet pipe from purifiers, float gauge and air vent. There should be a boiler F.O. return pipe fitted to the top of the boiler fuel oil tank. However

the pipe was not in place leaving only the opened flange on top of the boiler fuel oil tank. An overflow pipe was connected to side shell of the tank. Diesel oil was normally used as fuel for the boiler, the tank was said to contain about 600 litres of diesel oil before the incident.

Fig. 6: Sketch of the boiler fuel oil tank

- 5.5.4. An overflow line was fitted at the starboard side of the boiler fuel oil tank. The overflow line would allow excess fuel oil to be drained to the No. 3 double bottom fuel oil tank. The overflow line was opened up during the inspection and found blocked with rusty debris at the horizontal section above the purifier space. Under the circumstances, the excess fuel oil would not be able to drain back via the overflow line to the No.3 double bottom fuel oil tank but spilled out from the opened flange at top of the boiler fuel oil tank.

- 7.3 A copy of this Report is to be forwarded to the ship owner and ship manager informing them the findings in the investigation and reminding them:
  - i) No modification of the fuel oil system should be made without prior approval from Flag Administration or Classification Society;

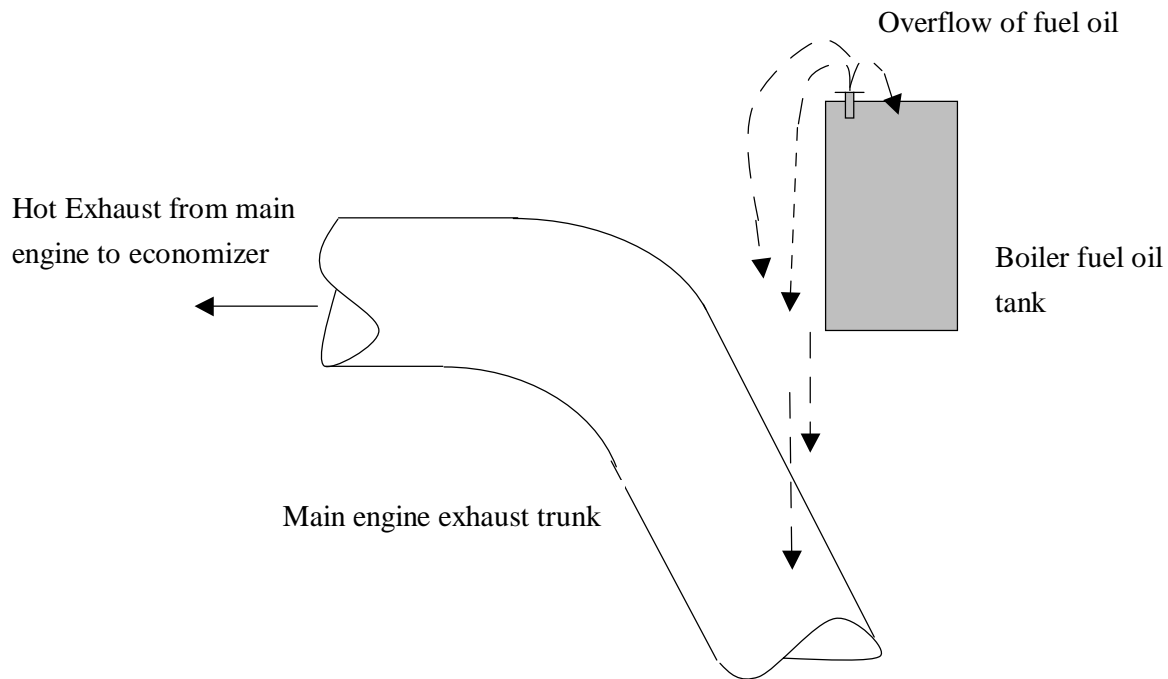
Fig.7: Scene of the incident

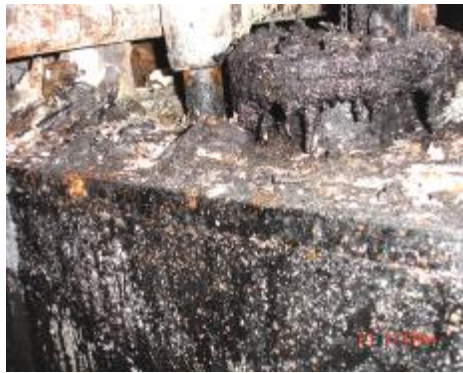
5.5.1. During inspection, signs of unburned and hardened heavy fuel was found on the top of the boiler fuel oil tank (see fig. 8), main engine exhaust trunk, main engine cylinder platform (see fig. 9) and its turbocharger. The trace indicated that oil leakage originated from the top of the boiler fuel oil tank and dropped down to the main engine cylinder platform.

Fig 8: Sign of fuel oil leakage from the top of the boiler fuel oil

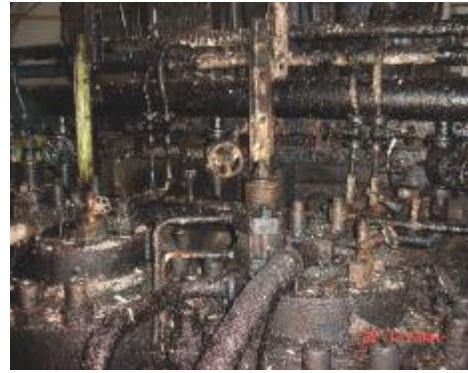
Fig 9: Top of main engine coated with heavy fuel oil.

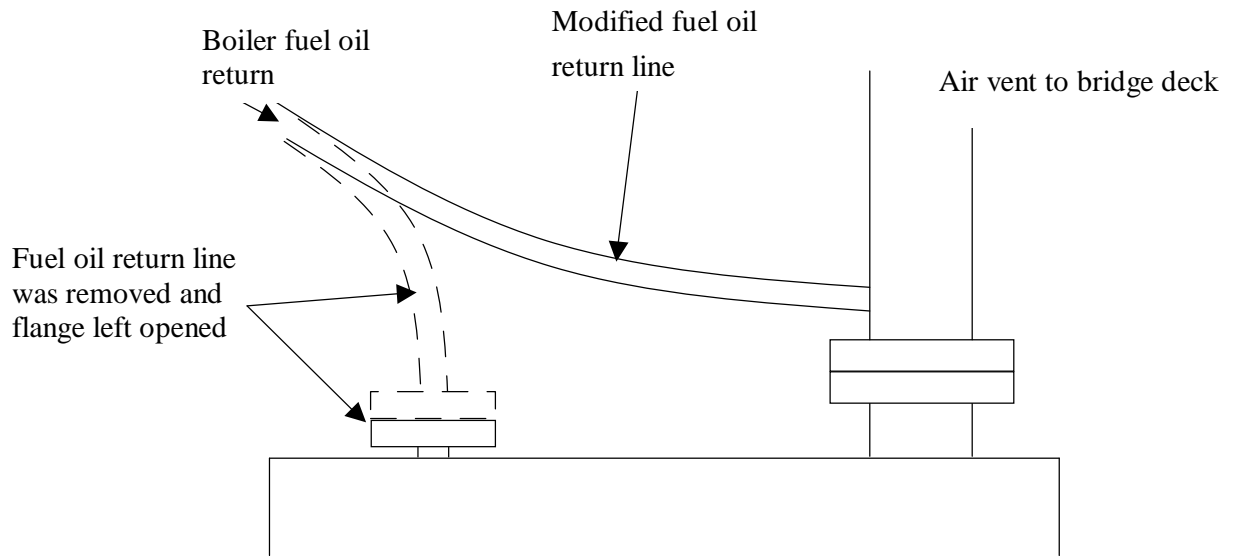
5.5.2. A fuel oil return line was fitted at the fuel oil burning system of the boiler to allow circulating fuel oil to return back to the boiler fuel oil tank. However, this return line had been modified. The length of the boiler return line at the top of the boiler F.O. tank was removed from the original 15 mm nominal diameter flange and connected to the air pipe of the tank. The ship's engineers did not know the purpose of such modification as it had been done a long time ago. However, the original flange opening was not covered and left open to the atmosphere. (See fig. 10)

Fig. 10: The modification of boiler fuel oil return line

- 5.5.3. According to the survey records provided by NKK, the boiler fuel oil tank was last inspected by NKK as part of the CSM (continuous survey of machinery) in December 2002. There were no records to show the modification which left an opening on the top of the boiler fuel oil tank, it appeared that the return line had been modified without the approval of the authorized body.

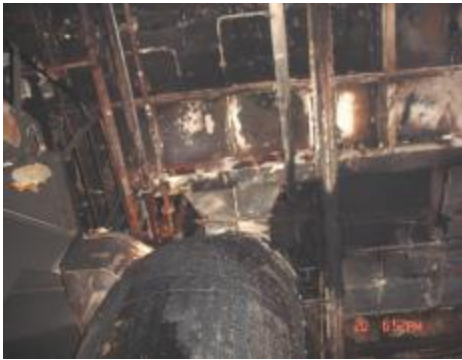
The upper part of the engine room was found badly burnt and darkened by carbon deposits from the level of main engine cylinder platform to the funnel top. Apparently, such damages were caused by the intense heat generated from the fire occurred down in the engine room. (See figs.11 to 14)

Fig. 11: The top of engine room was badly burnt.

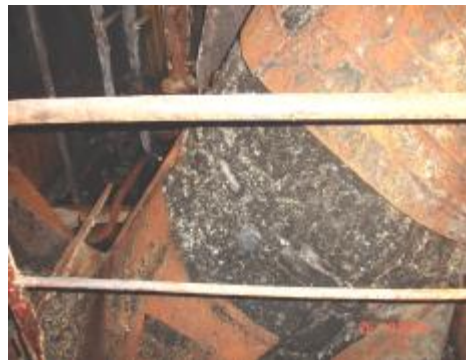
Fig.12: Metal shielding for exhaust M/E exhaust truck deformed and detached.

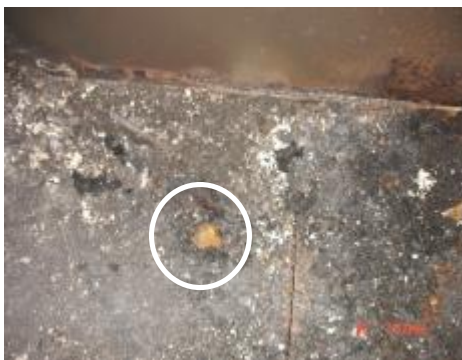
Fig. 13: Shoes of the Third Engineer was burnt, steel toecap remained on the floor.

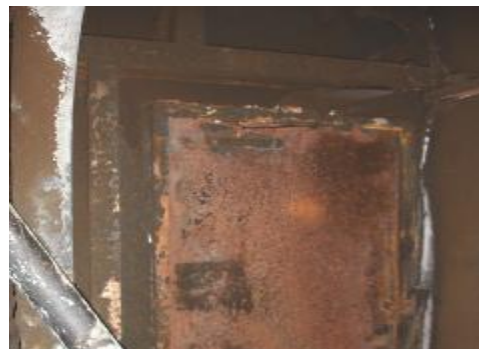
Fig.14: Engine room door at poop deck was badly burnt.

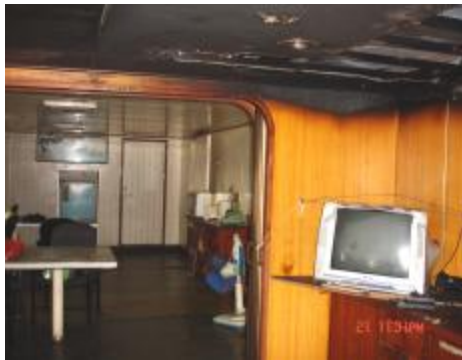
The intense heat transmitted through the bulkheads might have ignited the adjacent painted surfaces and the attached furnishings in the accommodation (see figs. 15 & 16). The safety equipment locker containing the fireman outfit and the SCBA sets was damaged by the fire (see figs 17 & 18). As this safety equipment locker was located adjacent to the engine room bulkhead, it is believed that during the outbreak of fire, smoke propagated to the storage space, deterring crewmembers from entering the space to fetch the fire fighting equipment. Furthermore, during the initial stage of the fire, the steering gear room in which another set of fireman outfit and the associated equipment, emergency fire pump and foam fire fighting system were located, had also been covered with smoke, thus the crewmembers were not able to get access to the emergency stations in the steering gear room. It is therefore apparent that after the onset of the fire in the engine room, the fire went out of control as the fire fighting appliances used for fighting the fire were out of reach by the crewmembers due to the presence of smoke.

Fig. 15: The roof of the officer's smoking room .

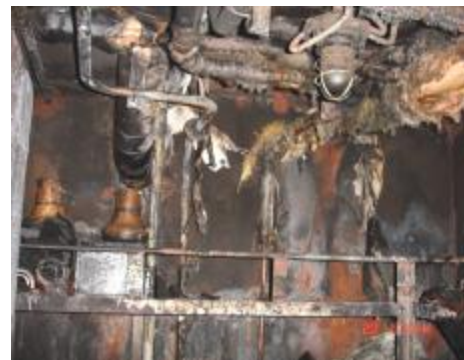
Fig. 18: Equipment in the safety locker were damaged.

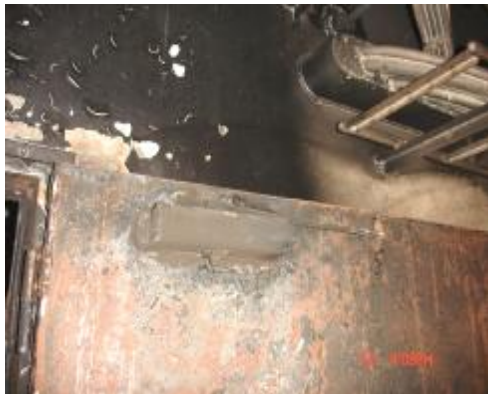
5.7.1. There were three fire doors for getting access to the engine room. Two were located at the upper deck level and the other one located at the poop deck level. The fire door located in the accommodation at the port side of the upper deck level was found seriously darkened by the fire and the smoke. According to the Junior Engineer, he had used this door during his escape. Inspection found that the door was equipped with a self closing device (see fig. 19). However, the setting of the self closing device appeared to have not been properly adjusted making the complete closure of the door difficult. Furthermore, a slightly bent padlock ring was found on the door frame which had prevented the door from closing completely (see fig. 20). In the incident, most of the ceiling light covers adjacent to this door were destroyed by the heat of the fire. Evidence therefore suggested that the alleyway of the upper deck had been filled with smoke, probably because the door at the port side of the upper deck had not been properly closed due to the aforementioned defects. Eventually, the vicinity of the emergency stop switch fitted adjacent to the fire door was engulfed with smoke and nobody could get access there to operate the emergency stop switch to deal with the fire. There was no abnormality found on the other two engine room doors.

Fig. 19: The connections of the door self closing device was detached.

- 6.4 The investigation has also identified the following factors that had contributed to the spread of the fire:
  - i) The engine room door at the upper deck failed to close properly during the fire due to the defective self-closing device and the bent padlock ring, thus allowed the spread of smoke into the accommodation spaces. The smoke further spread into the steering gear room due to its entrance door being kept open. The passage of smoke thus prohibited crewmembers to gain access to the emergency stations in the accommodation space and steering gear room to use the fire fighting equipment to tackle the fire.

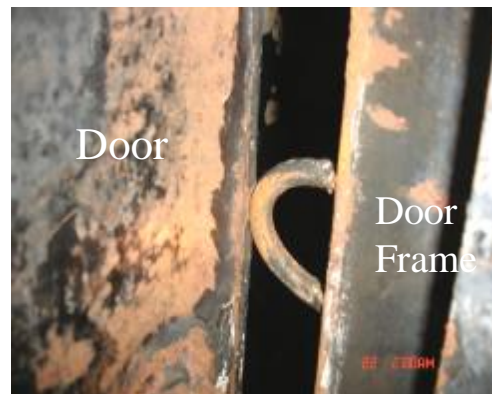
Fig. 20: The ring obstructed the closure of the door.

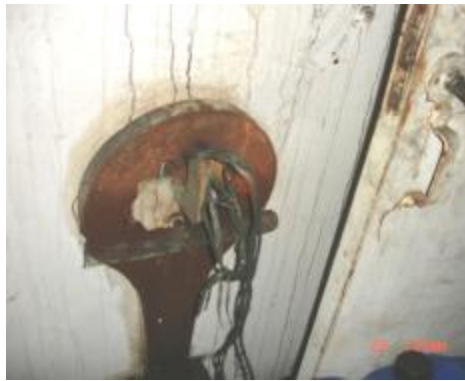
5.7.2. According to the information provided by the crew, the door leading to the steering gear flat had been kept open either by ropes or by drums during the fire (see figs. 21 & 22). The space would thus be filled up with smoke propagating from the engine room. The Second Engineer stated that the steering room door was left open for the sake of convenience. It is apparent that the fire fighting equipment there could not be used in the incident and had caused the fire to become out of control.

Fig. 21: Ropes used for securing the steering gear room door.

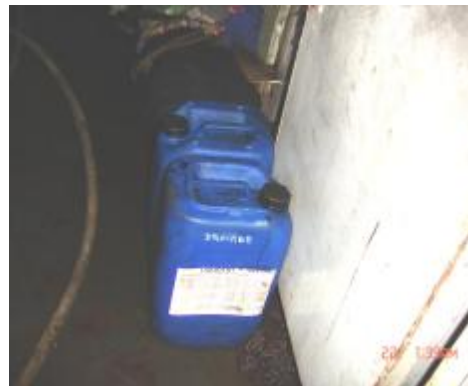
Fig. 22: Drum for keep the steering gear room door open.

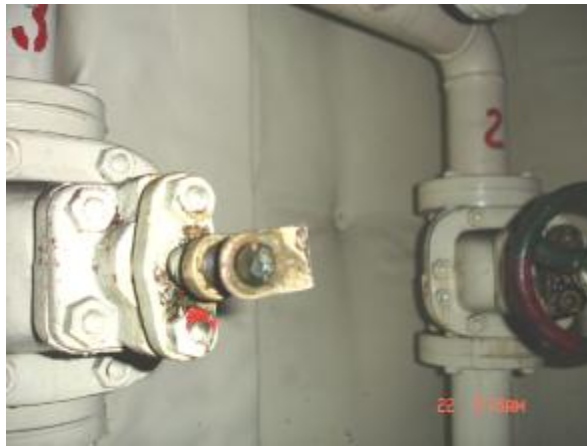
5.8.1. The Vessel was equipped with expansion foam system which was propelled by the emergency fire pump. After additional fire fighting appliances were sent from other vessel, the Chief Engineer attempted to start the foam system to extinguish the fire. However, the valve spindle of a discharge valve leading to the boiler space was broken (fig. 23) during the operation and the foam could not be injected to the boiler space.

5.8.2. During inspection to the spindle, signs of solder welding repair was observed at the parted section of the spindle. It appeared that welding repair had been carried out to the spindle by the ship's crew. As the valve spindle is designed to withstand high torsion during operation, welding should not be considered as a proper repair method for a broken spindle.

5.8.3. According to the survey records of N.K.K., last safety equipment survey was carried out on 2 March 2005. Apparently, the welding repair on the valve spindle was not detected during such survey.

Fig. 23: The valve for the injection of foam liquid to the boiler space was broken during operation.

- ii) When the Chief Engineer went to start the foam system, the spindle to the controlling valve for the boiler space was broken due to improper repair rendering the foam system to the boiler space inoperable.

- v) highly stressed components such as valve spindles of fire fighting system should not be normally repaired by welding. Such components should be replaced by spares.
