Collision Between High Speed Passenger Craft *Nan Hua* (南華) and Dumb Steel Lighter *Shing Wai No. 2* (成威2) On 28 March 2005

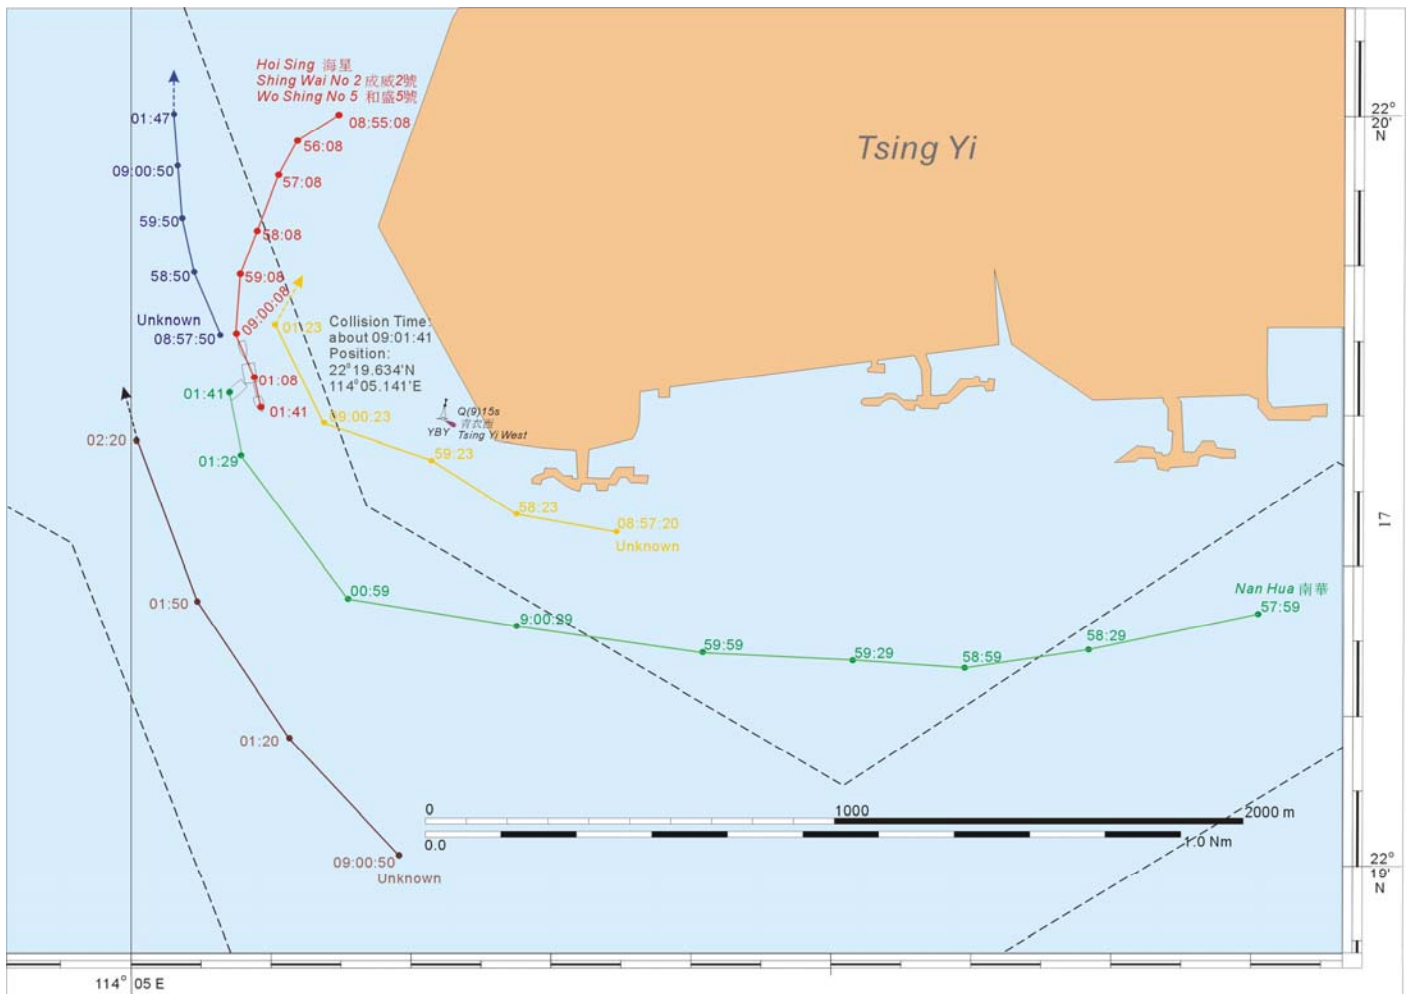
1. At about 0902 on 28 March 2005, the Chinese registered high speed passenger craft (HSC) *Nan Hua* collided with the Dumb Steel Lighter *Shing Wai No. 2* (成威2) which was under towed by the tugs *Hoi Sing* (海星) and *Wo Shing 5* (和盛5) (Figure 1). The collision occurred in the position 22° 19.6'N 114 5.1'E, 0.26 mile northwest of Tsing Yi West Buoy. At the time of the accident, the visibility was poor.
2. *Nan Hua* sustained structural damage to its bow while *Shing Wai No. 2* sustained a minor dent to its starboard side shell plating. The collision caused 10 passengers and 5 crew members of *Nan Hua* to suffer minor crash injuries. No injury on board *Shing Wai No. 2* was reported.

Figure 1 VTS System plots showing the tracks of Nan Hua and the tugs and tow
