Report of Investigation
into the Gas-cutting Accident
Onboard the Container Vessel
M.V. "Philippine Star" Causing
One Fatality on 11 April 2005

The Hong Kong Special Administrative Region
Marine Department
Marine Accident Investigation Section

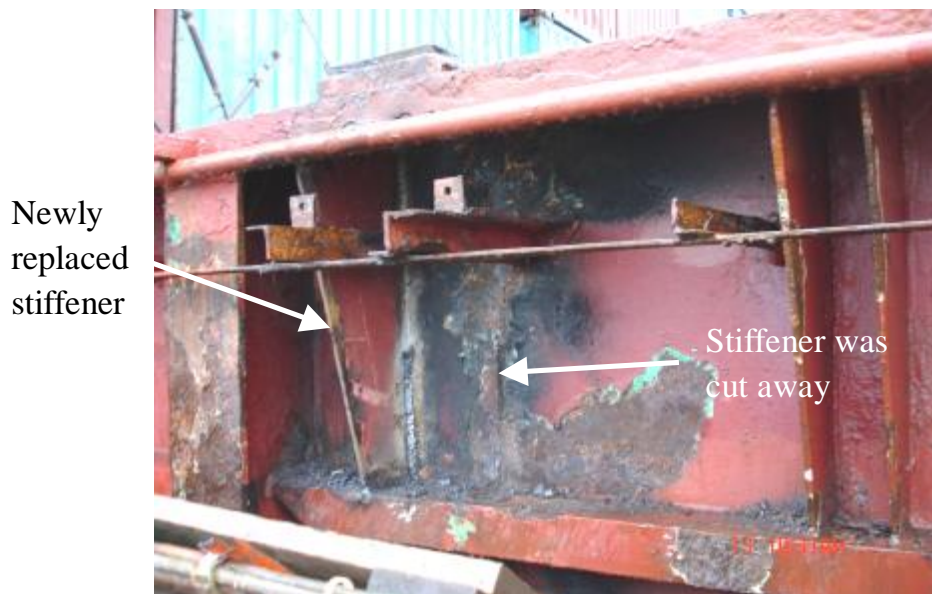
Fig. 2: Repair work on the hatch coaming

- 3.1 On the morning of 11 April 2005, the container vessel "*Philippine Star*" (the Vessel) arrived at Hong Kong from Manila for cargo work. At about 0312 the Vessel dropped anchor at North Lamma Anchorage awaiting cargo work.
- 3.2 Cargo work commenced at 0815 on the same day. Loading and discharging of containers were carried out onto the dumb steel lighters that moored alongside the Vessel.
- 3.3 The Chief Officer arranged work to replace stiffeners of hatch coamings. The Fitter (deceased) and an Able Seaman were assigned to work at the forward side of the hatch coaming of No. 4 cargo hold. The work involved the use of gas-cutting torch to cut away the worn stiffeners and replacement with new ones (see Fig. 2). They started their work after lunch at about 1300.

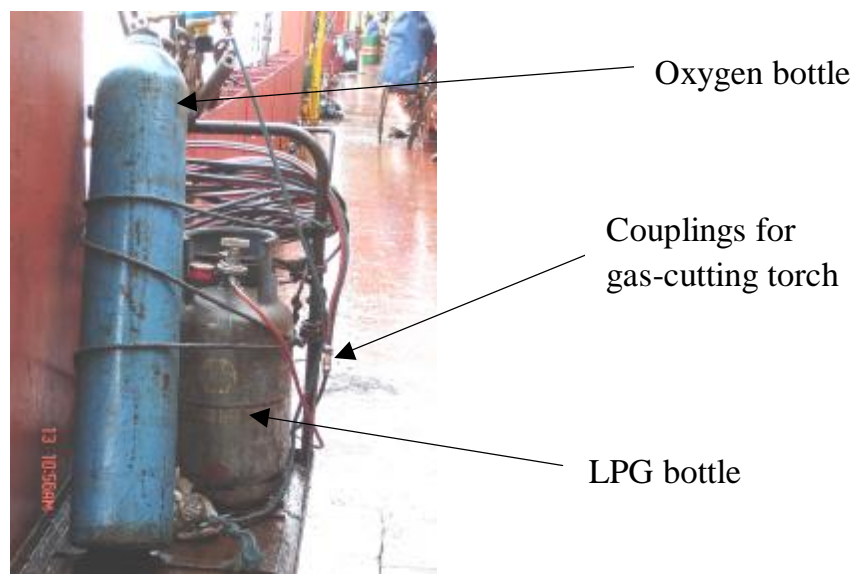
Fig. 3: Oxygen and LPG bottles for the gas-cutting work

- 4.3 Natural lighting was considered adequate in the work area.
- 4.4 The oxygen and LPG bottles for the gas-cutting work were secured at the starboard guardrail of the Vessel. (See fig. 3) Two long rubber hoses were found with one end connected to the bottles and the other end connected with two couplings for fitting on the gas-cutting torch. The rubber hoses were braided with rayon reinforcements and further enclosed with rubber covering.

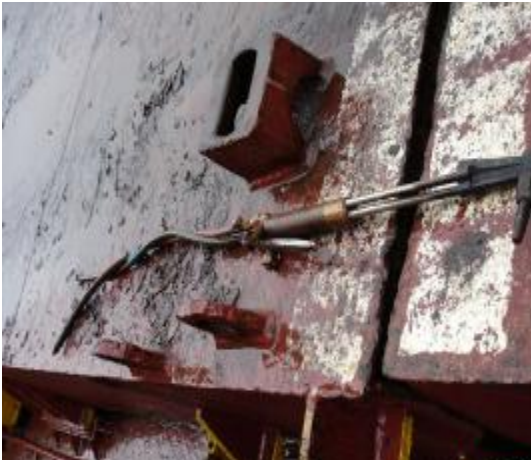
Fig.4: The gas-cutting torch

4.5 The gas-cutting torch was found damaged with the connecting hoses seriously burnt (See fig.4 & 5). Although the origin of the hoses were untraceable, it was apparent that the hoses had been used by the crew for a considerable period of time as some minor mechanical abrasions were observed along the length of the hoses. The deck structures of the vessel had a number of sharp edges. It is deduced that the rubber hoses might have been subject to mechanical abrasions and cuts while being tensioned over the sharp edges.

- 6.2.3 Rubber gas hoses and equipment should be maintained properly and the hoses should avoid passing sharp edges of the vessel's structures during the work. The gas-cutting equipment should be inspected before use to ensure that it is in a safe condition.

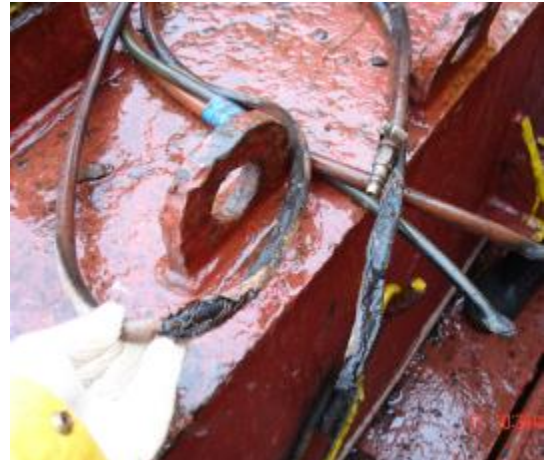
Fig.5: The burnt rubber hoses

4.6 During the gas-cutting process, hot molten metal oxide and sparks would be generated. Since no shielding arrangement was made, the hot molten metal oxide and sparks would melt the rubber hoses when they scattered onto the deck and came into contact with the rubber hoses.

- 5.3.3 The rubber hoses for the gas-cutting had not been properly maintained.

- 6.2.1 Fire watch should be maintained throughout the hot work process;
 - 6.2.2 Appropriate arrangements should be made to prevent rubber hoses from contacting with any hot objects during the work;

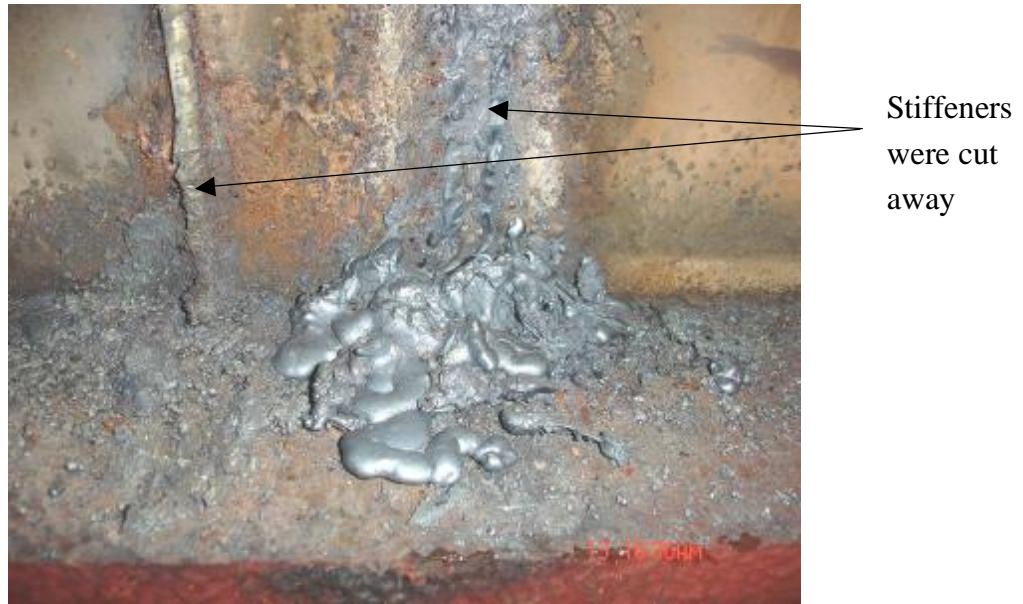
4.8 Two pieces of stiffeners had already been cut off from the hatch coaming. Hardened molten metal oxide were found accumulating on the lower part of the hatch coaming. Some of the molten metal oxide were also found scattering

on the deck. (See fig. 6)

Fig.6: A pool of hardened molten metal oxide below the removed stiffener

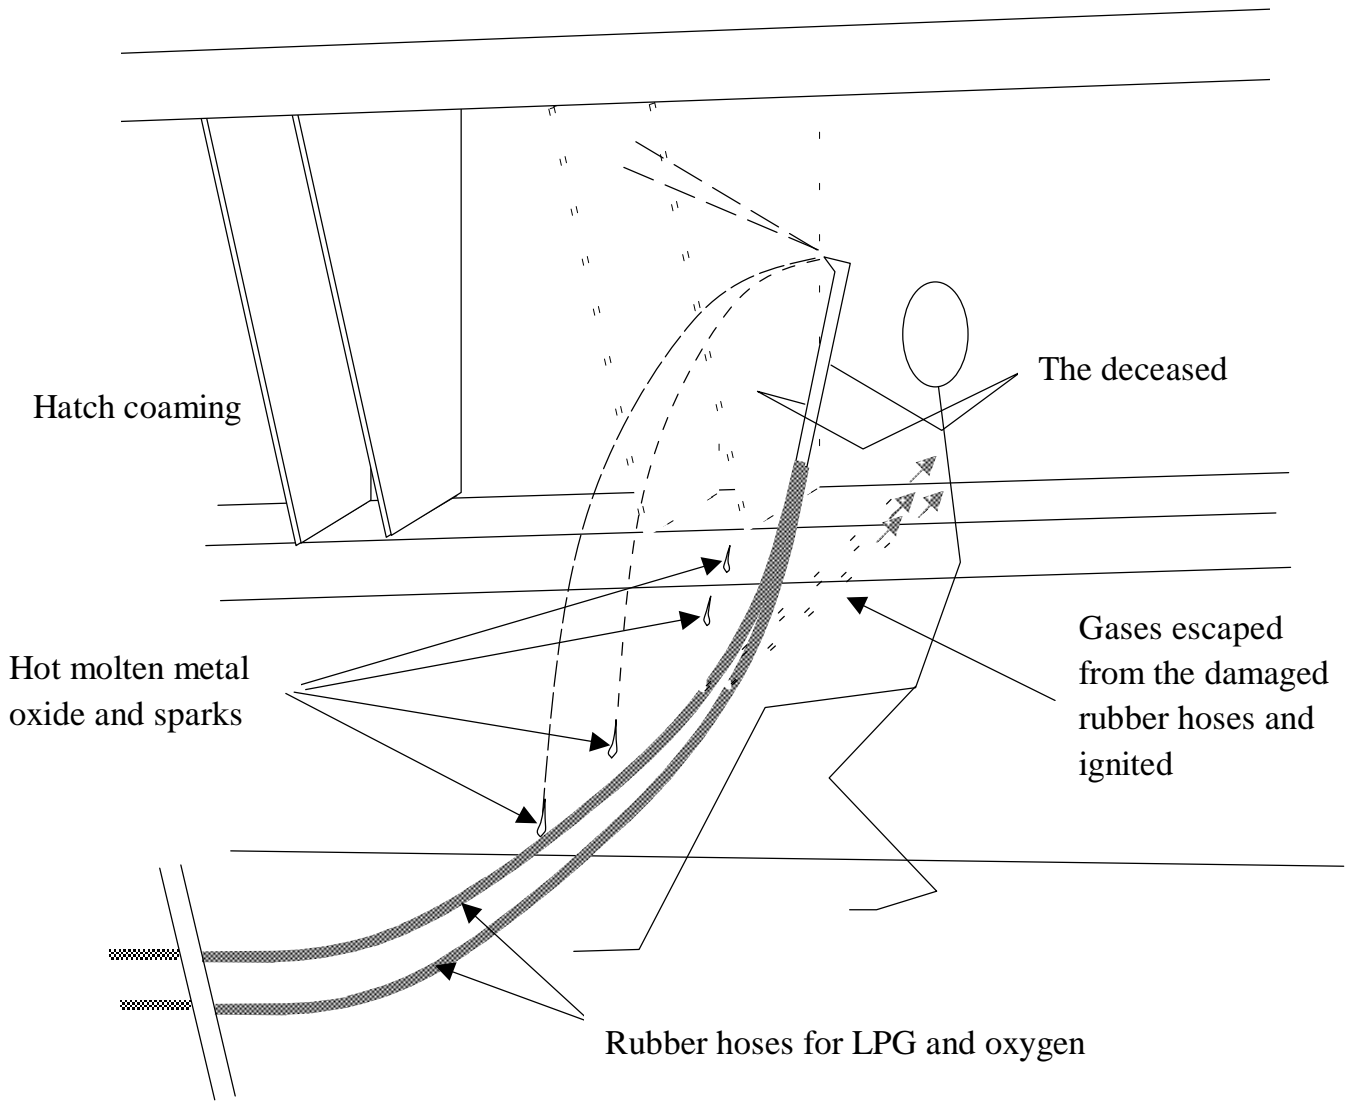
Fig. 7: Scene of the accident

- 5.2 The investigation establishes the probable cause of the accident was that hot molten metal oxide and sparks generated during gas-cutting process came into contact with the rubber hoses and subsequently caused a fire in the working area (see fig. 7). The body of the deceased was seriously burnt by the ignited LPG.
