Electrocution on board the dumb steel lighter “Sun Choi Lee 18” on 8 May 2005 causing one fatality

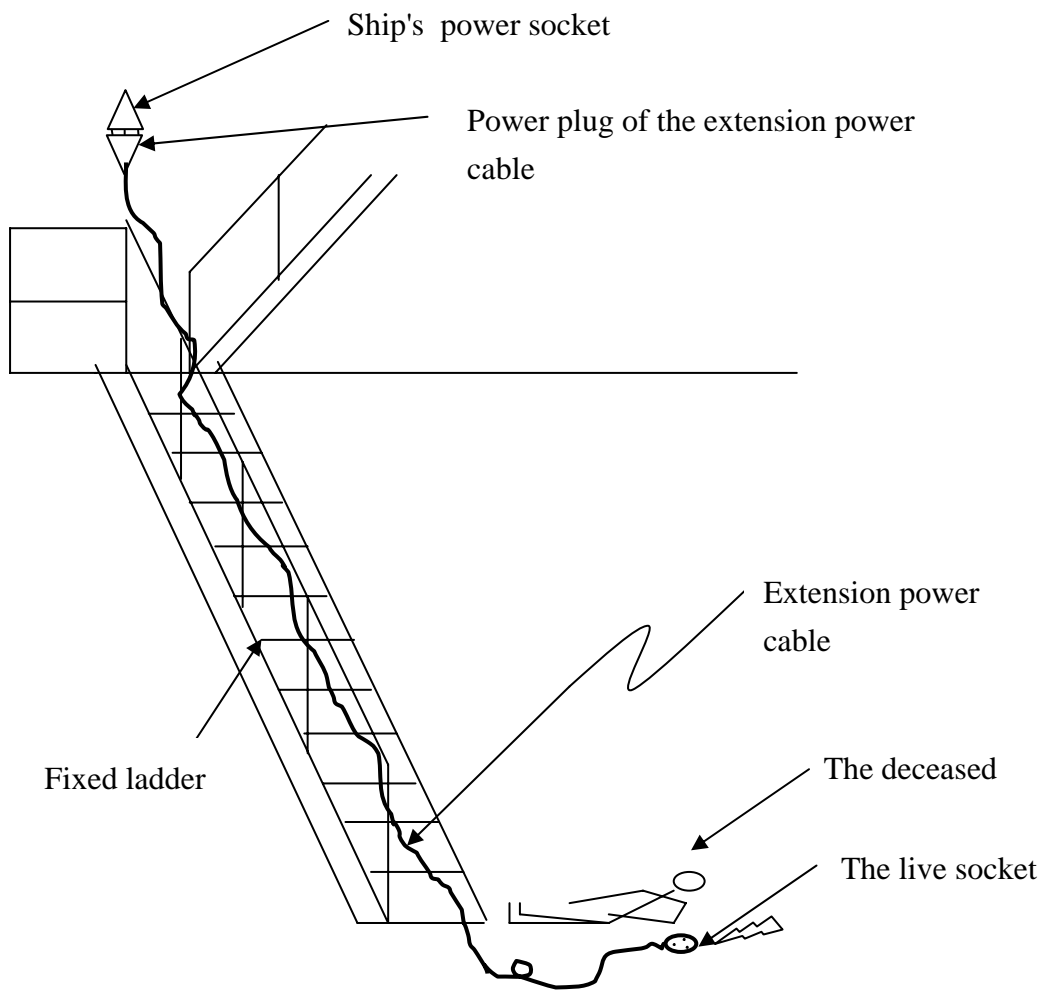
- 2.1 It was raining heavily at time of incident. The Lighterman was found lying on an unsheltered deck (fig. 1). His body was soaked with rainwater. At time of the incident he wore a pair of gloves and slippers. When handling electric equipment, the slippers offered little protection against electric shock.

Fig. 1: The scene of the accident

- 3.1 Workers should not be allowed to wear slippers while at work. Safety shoes should be worn.
- 3.2 Earthing wires in the electrical plugs and sockets should be properly connected using 3-core electric cable.
- 3.3 Electrical cables should be properly maintained.
- 3.4 Non-weatherproof electrical socket and wirings should not be used in a wet environment.

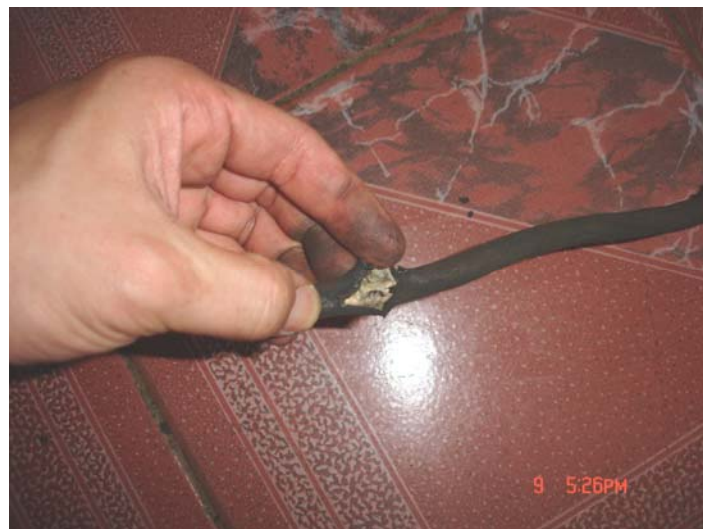
- 2.2 The electric extension cable used in the incident was about 13 metres long and made up of two rubber sheathed 2-core wires, no earthing wire was available. The general condition of the extension cord was not in a well-maintained condition. Numerous conspicuous cleavages (fig.2) were found on the cable sheath. Rainwater could get into the cable cores through the cleavages that short-circuit or electric shock would be liable to occur.

Fig. 2: One of the cleavages of the cable.
