Report of Investigation
into the Electrocution on Board
the Dumb Steel Lighter
“Sun Choi Lee 18” Causing
One Fatality on 8 May 2005

The Hong Kong Special Administrative Region
Marine Department
Marine Accident Investigation Section

FATAL ACCIDENT REPORT

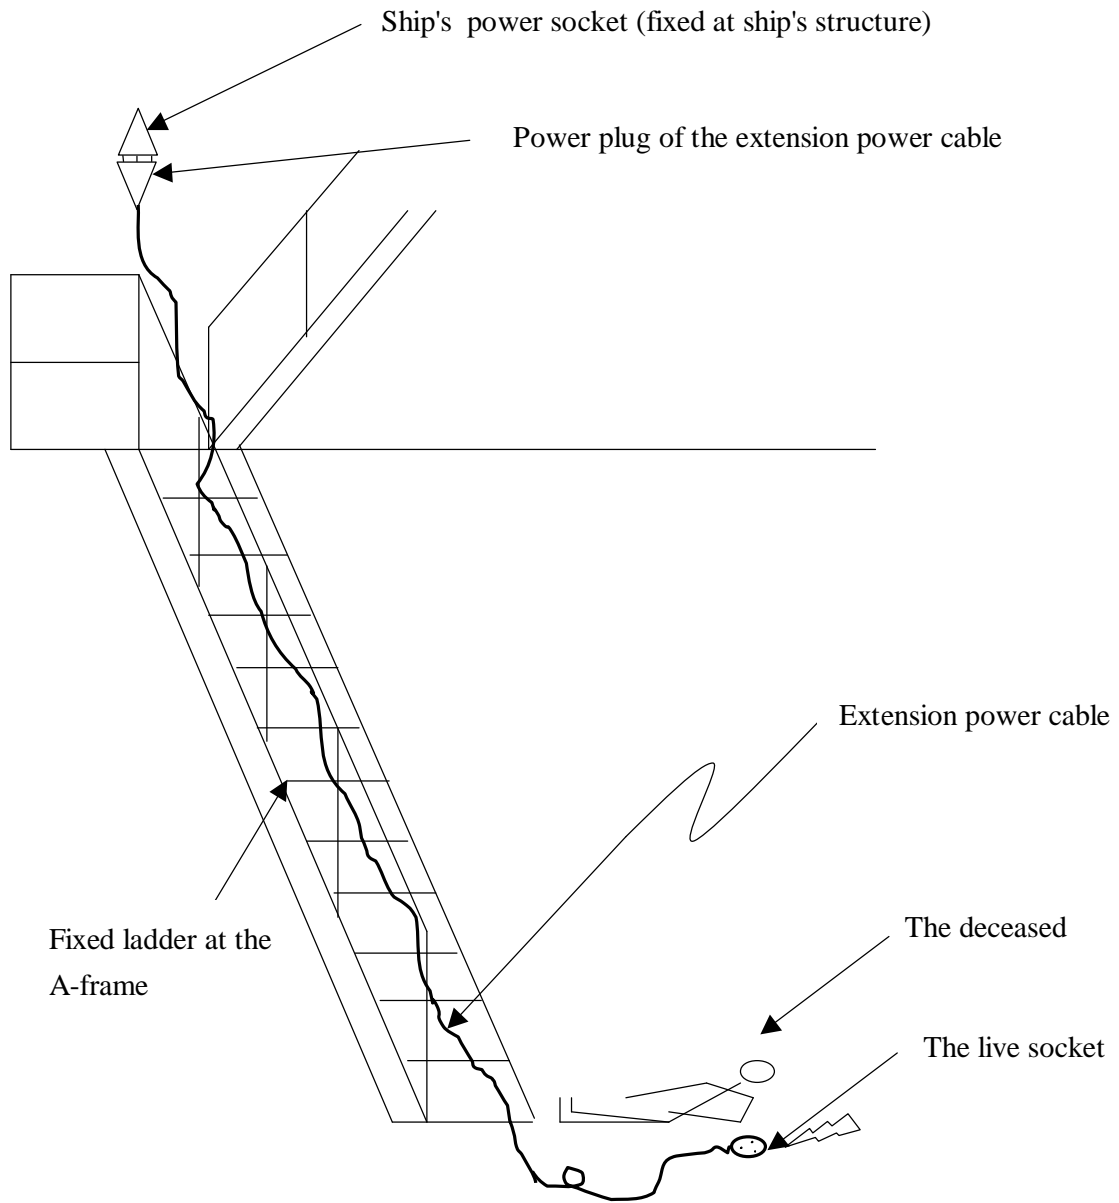
- 3.1 It was raining heavily at time of incident. Lighterman B was found lying unconsciously on an unsheltered deck (see fig. 2). His body was soaked with rainwater. At time of the incident he wore a pair of gloves and slippers.
- 3.2 According to the records, Lighterman B had been working as lighterman for more than twenty years. He had been employed on board this Vessel for six months. His duties included routine operation and maintenance of the Vessel.

Fig. 2: The scene of the accident

4.1 The body of the decease was found lying unconsciously adjacent to the live, wet and poorly maintained electric extension cable at the port forward of the Vessel. It is believed that the deceased was electrocuted when in contact with the live conductors of the defective electric extension cable. However, no body witnessed how the accident happened. Based on the available information obtained, the deceased might have to prepare or retrieve the electric extension cable for portable electrical appliances.

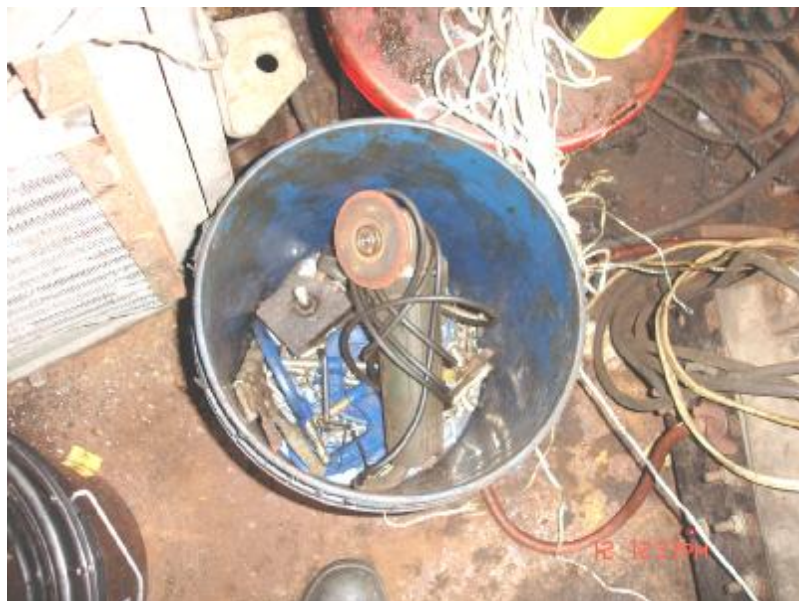
3.6 Some portable electrical appliances such as portable bilge pumps, an electric drill, and a disc cutter (see fig. 3) were found on board. In some cases, these electrical equipment required an electric extension cable for use in the remote locations. Two electric extension cables were found on board. However, only the electrical cable involved in the incident could be connected to the fixed weatherproof electric sockets of the Vessel. The other electric cable fitted with 13A power plug did not match the fixed weatherproof power socket.

Fig. 3: Portable electrical equipment that required electrical power from the extension power cable

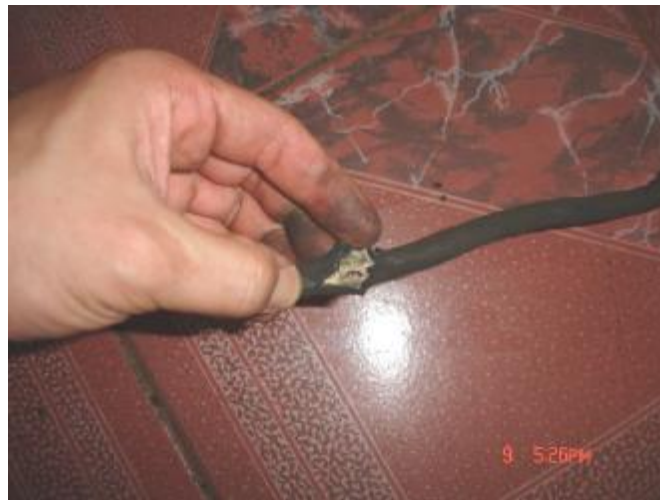
3.7 The electric extension cable used in the incident was about 13 metres long and made up of two rubber sheathed 2-core wires, no earthing wire was available. The cable was fitted with a power plug at one end and a socket at the other end. During inspection it was found that the general condition of the extension cord was not in a well-maintained condition. There were eleven conspicuous cleavages on the cable sheath. (fig. 4). Rainwater could get into the cable cores through the cleavages that short-circuit or electric shock would be liable to occur. Moreover, the electrical cable had been extended by a similar size of cable joining together at about 1.5 metres from the plug end. The joints were made by twisting each core wiring separately and wrapped with insulation tape. Such a way of joining two cables was a malpractice as the wirings might become loosen when the cables were subject to stress.

Fig. 4: One of the cleavages of the cable.

4.2.1. The electric extension cable was not properly maintained;

5.1.1. Electrical cables should be properly maintained;

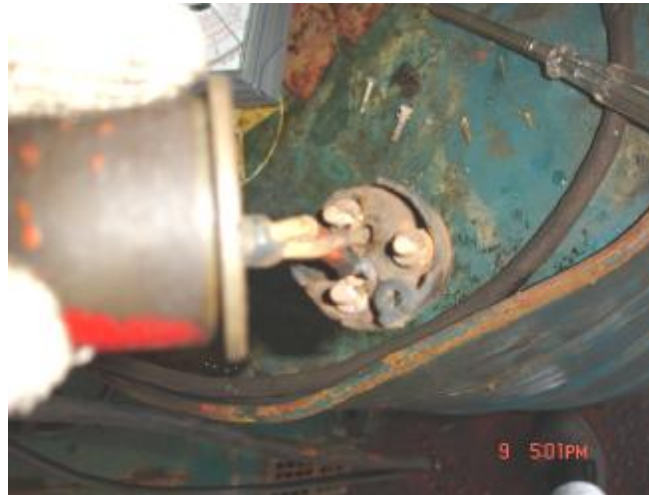
3.8 The plug of the electric extension cable was a weatherproof 3-connector type. It was plugged to the 220V fixed power socket located at the first deck of the A-frame. After the accident, the power plug was opened up for examination. It was found that the live and the neutral ends were connected but not the earth end because of the 2-core cable (fig. 5). Evidence suggested that the electric extension cable was deprived of earthing connection. In handling such a cable, one would be liable to electric shock, particularly in a wet condition, whenever an electrical fault occurs.

Fig. 5: No earthing line connected to the power plug.

4.2.3. A 2-core electric cable was used for making the extension power cord. No earthing connections to the plug and socket were provided; and

5.1.3. Earthing wires in the electrical plugs and sockets should be properly connected using 3-core electric cable; and

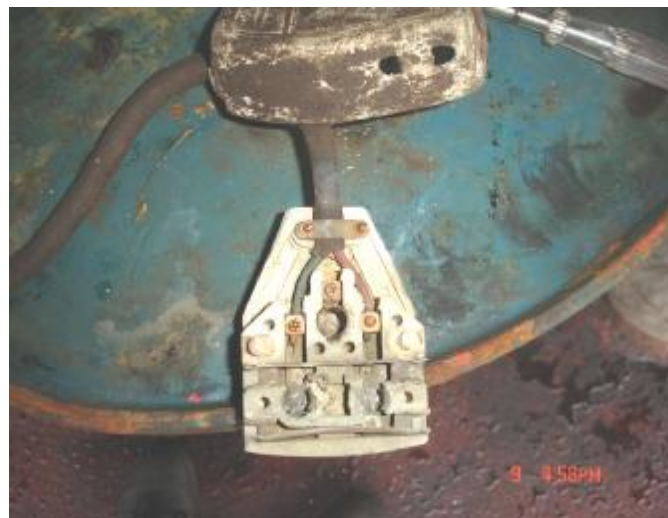
3.9 The power socket of the electric extension cable was of a multipurpose, 3-connector type (fig. 6). There were 2 two-pin and 1 three-pin plug slots at the socket. The socket was left unsheltered and it was wetted with rainwater. Although the case of the socket was made of rubber material, the socket itself was of non-weatherproof design. As it exposed to rainwater it became hazardous to persons working in the area.

3.10 The socket of the electric extension cable was also opened up for examination. Like the plug, no earthing wire was connected. At the time of the incident, the extension power socket did not connect to any electrical equipment.

Fig. 6: Internal inspection of the power socket

4.2.2. The non-weatherproof type socket was used in a wet environment;

5.1.2. Non-weatherproof electrical socket and wirings should not be used in wet environment;
