## **Sinking of M.V. Hui Long on 20.5.2005**

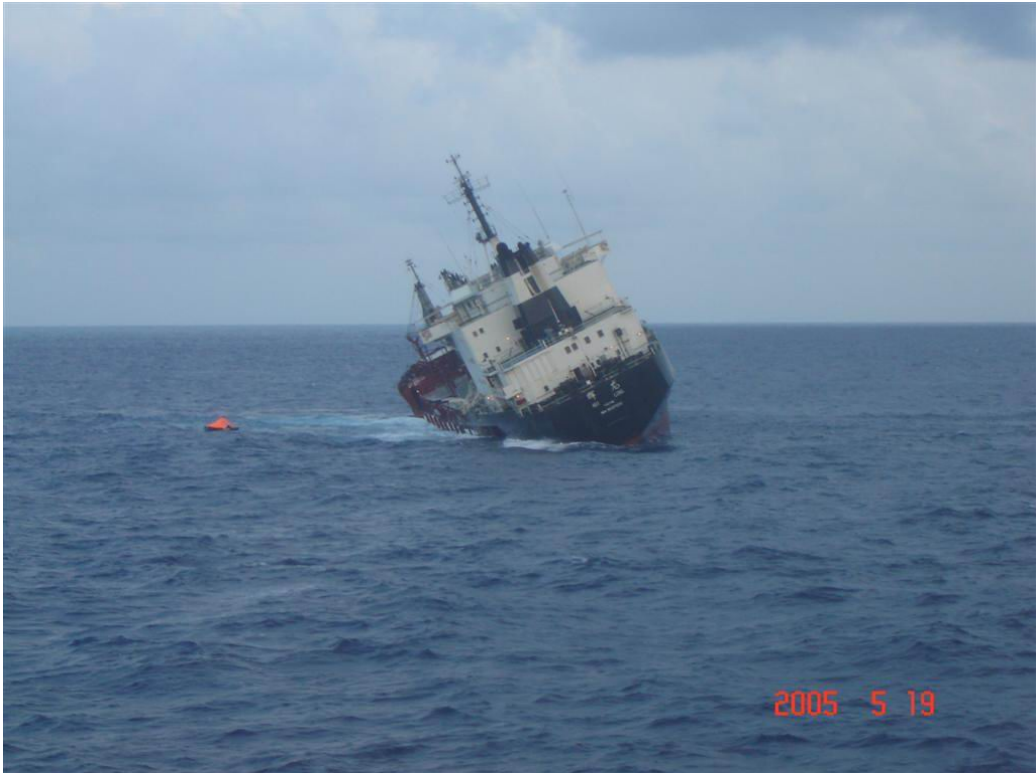
- 2.1 The exact cause of the sinking of 'Hui Long' could not be established as the vessel had completely sunk.
- 2.2 After investigation the probable causes of the accident, it is believed to be the liquefaction of the fluorspar cargo inside the No.1 and No. 3 holds. The flow state of the fluorspar cargo might have developed a list to the Vessel and caused it to capsize and sink.

M.V. 'Hui Long' after the initial listing
