Report of investigation
into the incident on
the electrocution of crew on board
the locally licensed split hopper barge
"Geoworks SB-4"
at the waters near Port Island
on 26 May 2005

The Hong Kong Special Administrative Region
Marine Department
Marine Accident Investigation Section

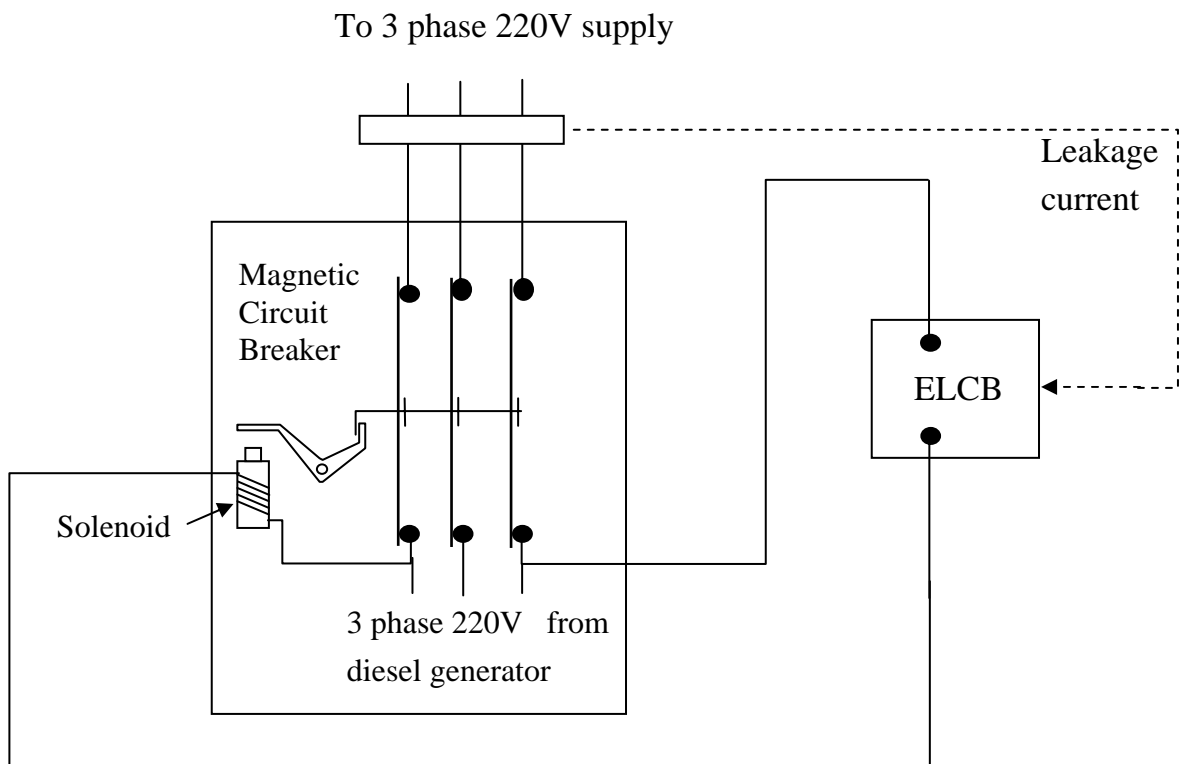
Fig. 3 ELCB System

- 5.5 The schematic diagram of the ELCB system of the diesel generator of the Vessel is shown in Fig. 3. The ELCB is a device to detect the leakage current of the loads of the Vessel. When the leakage current reached the level of 30mA, the ELCB would be activated to energise the solenoid to open the magnetic circuit breaker and cut off the electric supply.

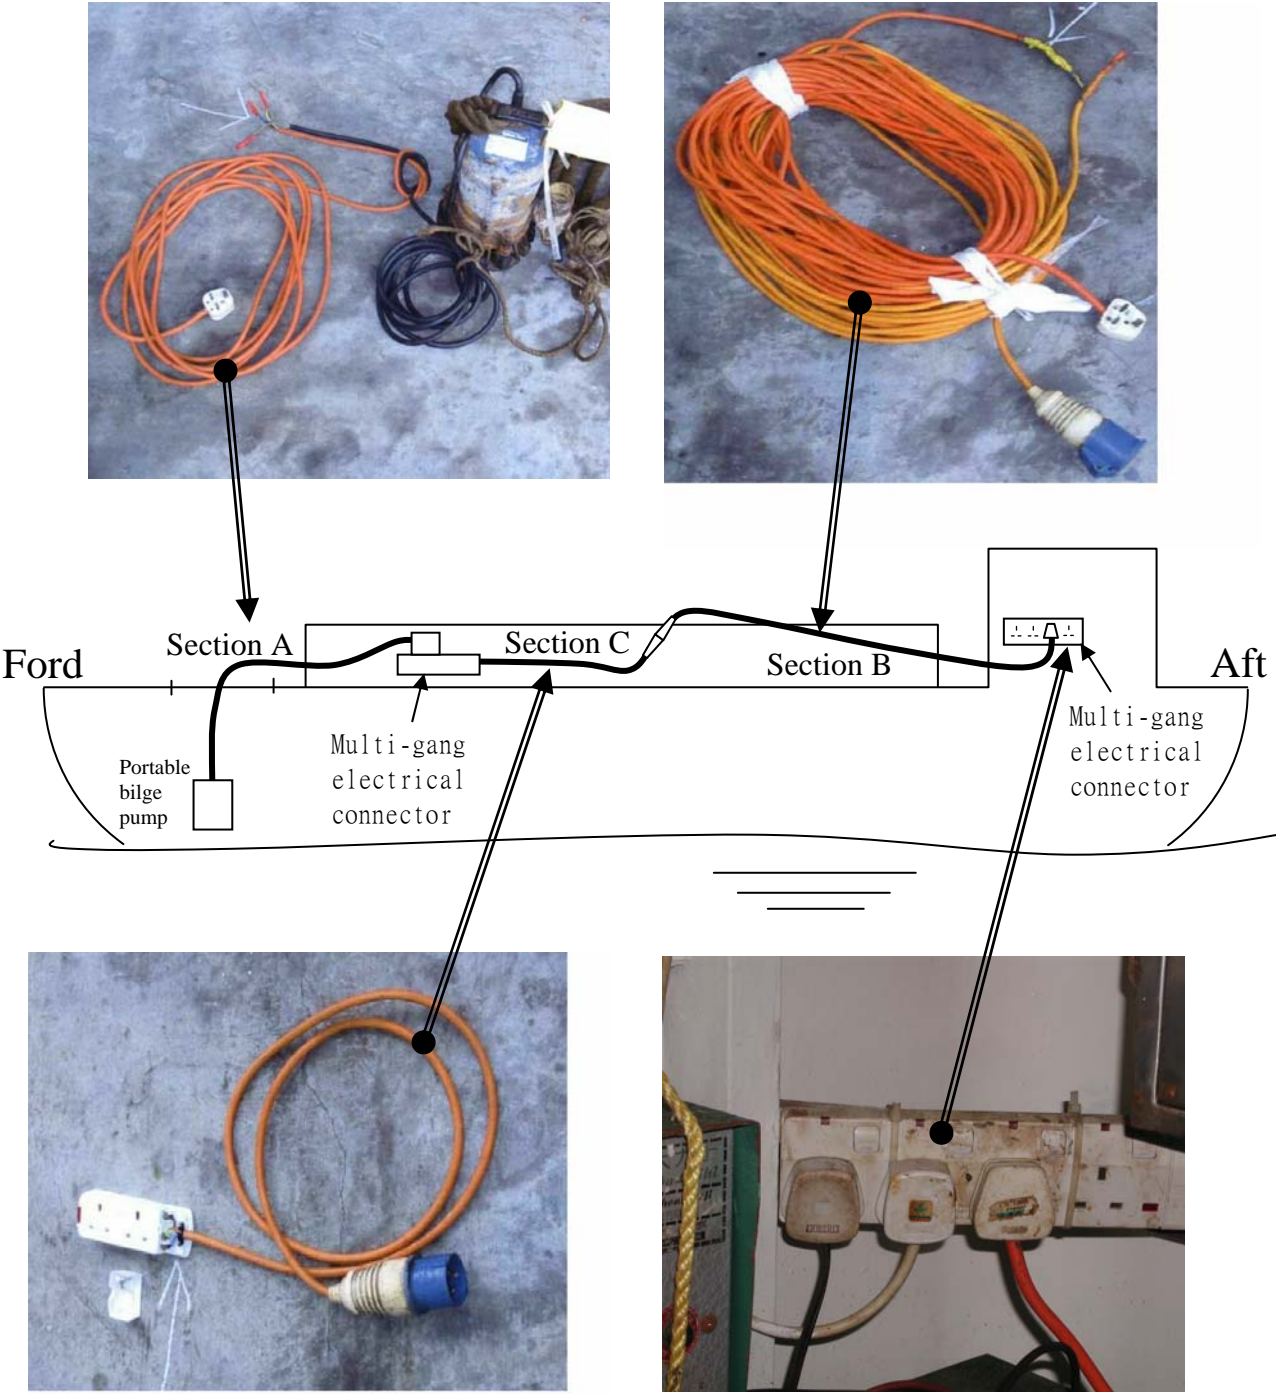
Fig. 4: Cable connections of the portable bilge pump.

5.6 The diesel generator supplied electrical power to the lightings and various power sockets of the Vessel. The portable submersible bilge pump took the electrical power from one multi-gang electrical connector in the machinery space via two long extension power cables (Sections B and C) as shown in fig. 4.

5.7 Section A were cables connected to the submersible bilge pump. Section B was a long extension power cable connected to the Vessel's power socket in the machinery space. Section C was a short extension power cable connecting Section A and Section B.

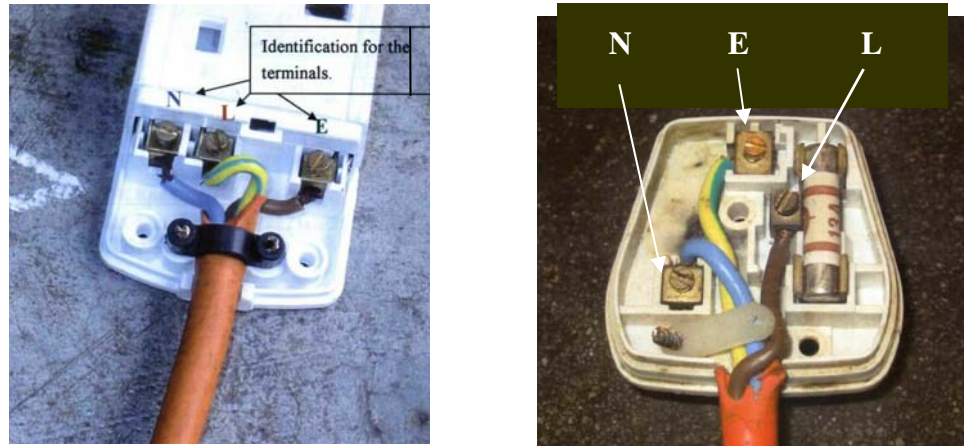
Fig. 5: The wrongly connected extension power cable section C

The short extension power cable was a 3-wire rubber shielded cable of about 1.9 m in length. The ends were connected to a 13A plug and a 13A multi-gang electrical connector. The polarity of the wiring connection at the 13A plug was correct. However, the polarity of the wiring connection at the multi-gang electrical connector was wrong. It was found that the 'Live' and 'Earth' poles were swapped (See fig. 5). Apparently, someone had mistakenly connected the wiring at the multi-gang electrical connector. As such, the enclosure of the submersible bilge pump would become "live" during the operation.

A trial run was conducted with the above arrangement and the voltage readings at the multi-gang electrical connector of the cable Section C were recorded as follows:

<u>Polarities</u>	<u>Voltage / Volts</u>
Live-Earth	130
Earth-Neutral	225
Neutral-Live	130

The electrical distribution of the Vessel was a 3-phase, three wire 220V system. The system provided 220V phase to phase voltage and 127 V line voltage. Obviously, the Earth and the Neutral connections were connected to the phase voltages source of the diesel generator, while the Live connection was connected to the Earth point of the hull of the Vessel.

- 6.2 Contributing to the accident was the 3-wire cable in one of the multi-gang electrical connectors for which the 'earth' terminal had been wrongly connected to the 'live' wire. This mistake caused the enclosure of the pump without earthing protection and subject to the live terminal of 130V line voltage. Furthermore, the ELCB system which provided earth fault protection was not in a working condition. As a result, the circuit breaker of the ELCB system was not triggered resulting in the electrocution of the deceased.

- 7.1 A copy of this report should be sent to the owner/operator of the Vessel advising them the findings of this incident.
- 7.2 The owner/operator of the Vessel are reminded that:
 - a) Internal connections of extension power cable should be connected in correct polarity. Such work should be done by a competent person.
 - b) Inspection of the electric circuit protection devices such as ELCB system should be conducted periodically by a competent person.
- 7.3 A Marine Department Notice (MDN) should be issued to draw the attentions to all concerned parties the lessons learnt in the incident.
