Sinking of local cargoboat "M20229A" on 4 June 2005 causing one fatality

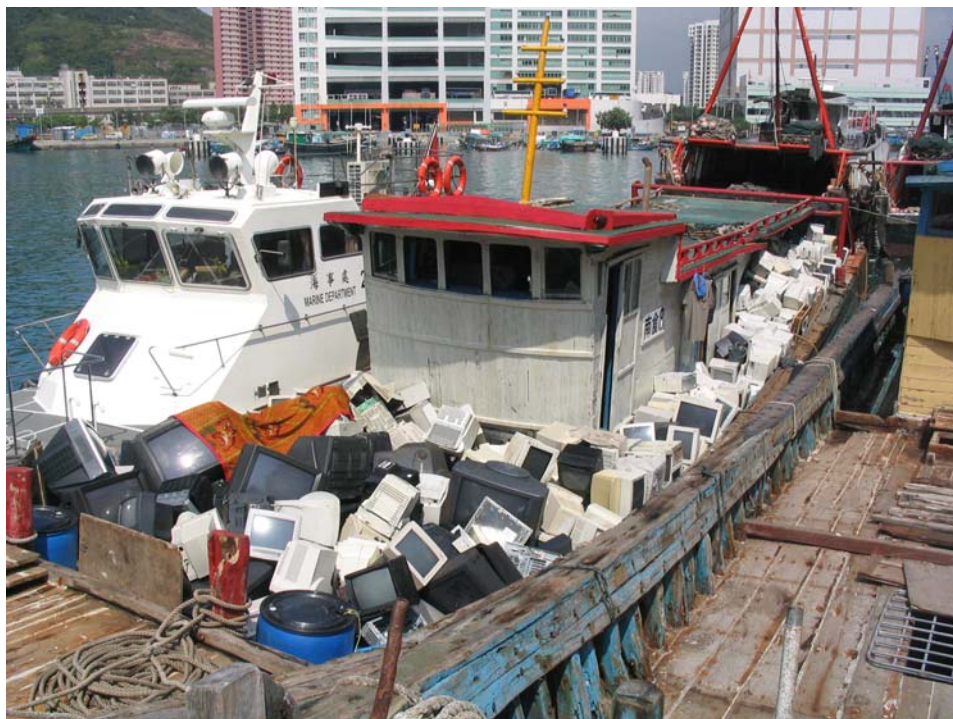
- 2.1 The Vessel was loaded with about 1,400 used television sets. The survived crewmembers stated that the cargo was loaded on deck with cardboard rigged on both sides similarly to those shown in the figure below. The under deck compartments had no cargo.
- 2.2 It was estimated that the average weight of a medium size television was about 25 kg, thus 1,400 used television sets weighed approximately 35,000 kg. The cargoes were all loaded on deck which would reduce the metacentric height.
- 2.3 Since the cargo could not be tidily stowed and secured, there were lots of broken

space in between the cargo. As a result the cargo was liable to shift at sea. When several consecutive huge waves struck from the starboard bow, the cargo would shift to the side causing the vessel to heel heavily to the port side.

- 2.4 Once the deck edge was submerged, the water quickly entered the cargo compartment as the cargo hatch covers were not completely watertight; hence the stability would diminish, leading to the capsizing and sinking of the vessel.

- 3.1 The investigation established the sinking of the vessel was probably attributed to the shifting of the cargo which had been improperly loaded on board. The vessel heeled and sustained considerable diminution of stability after water found its way into the cargo compartments.

A wooden cargo vessel with the cargo loaded on deck on both sides
