# **Manoverboard accident on board Local Dumb Steel Lighter "順發 18" on 30 June 2005 causing one fatality**

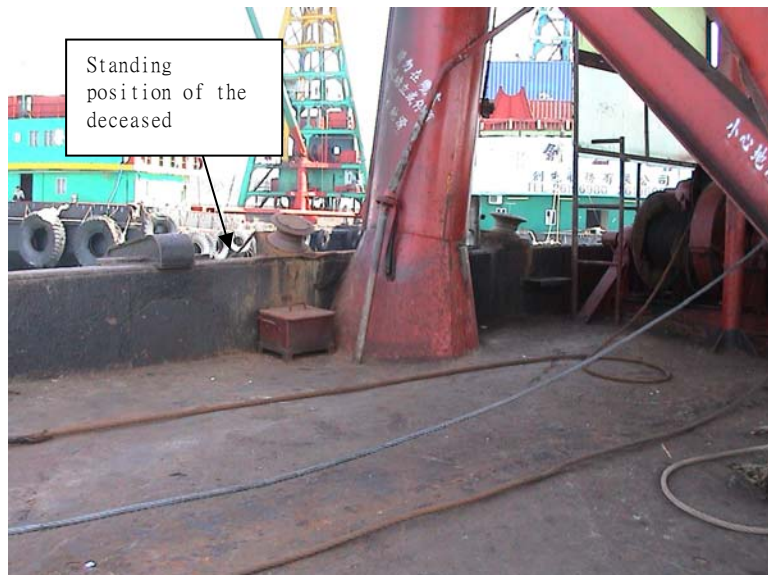
- 1.2 At time of the incident, the weather condition was cloudy with southwesterly wind force 2. The visibility was about 10 km.
- 1.3 After sailing, the workers got ready wire ropes for mooring at the fore deck. The deceased stood on the gunwale at the port side of the stem tendering a wire rope (figure).

- 2.1 It was stated by other crewmembers that the deck was slightly wet and slippery. It is probable that the deceased lost his balance, slipped and fell overboard while standing on the gunwale.
- 2.2 The deceased had not worn a lifejacket at the time of the accident. As the freeboard height of the DSL was about 3.5 m, the deceased who was a non-swimmer, when fell from such height into the sea would probably sink quickly and be drown.

2.3 The probable cause of this fatal incident is that when the deceased was tendering the wire rope, he accidentally slipped and lost his balance. As a result he fell overboard and was drown.

The stem of DSL 順發18

3.1 Workers on board DSL should take extra precaution against the risk of falling overboard while working on deck. They should also observe the Local Vessel Safety Practice i.e. wear a lifejacket when working or walking on the deck during rough seas, rain or whenever the deck is wet.
