Crew fatality during mooring operation on board the sand barge "Jian Hang 029" on 2.7.2005

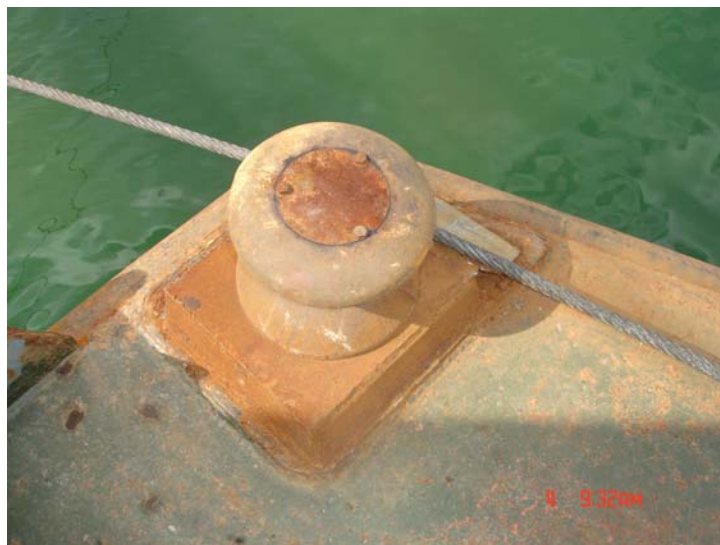
Fig. 1: A similar fairlead roller assembly

2.3 The investigation revealed that the design, fabrication and the installation of the new fairlead roller assembly was not in accordance with proper procedures. The workmanship of the roller pin was found to be poor and the diameter of the pin was undersize. In the accident, the roller pin sheared off at the undersized section near the lower end of the roller pin.

3.1 Roller pin of the fairlead is a critical component subject to high load and it should not be modified. The fairlead roller assembly should be designed, fabricated and installed by competent person and inspected by the ship registration administration or the recognized classification societies.
