Report of Investigation  
into the Crew Fatality During  
Mooring Operation on Board  
the Sand Barge “Jian Hang 029”  
on 2 July 2005

The Hong Kong Special Administrative Region  
Marine Department  
Marine Accident Investigation Section

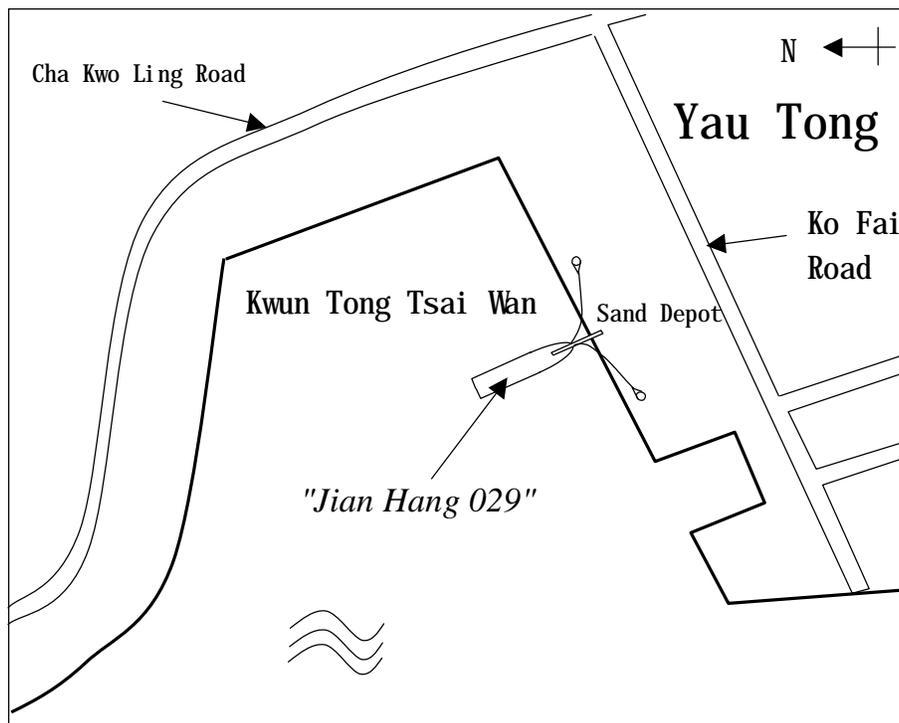
Fig. 2: The position of *the Vessel* at the time of the accident

- 4.1 In the evening of 30 June 2005, *The Vessel* fully loaded with sand cargoes in bulk, sailed from Zhuhai to Hong Kong for discharging. At about 1800 on 1 July 2005, *the Vessel* arrived at Kwun Tong Tsai Wan, Yau Tong and waited for berthing. At about 0600 on 2 July 2005, *the Vessel* shifted to the Sand Depot off Ko Fai Road, for berthing. (See fig. 2)

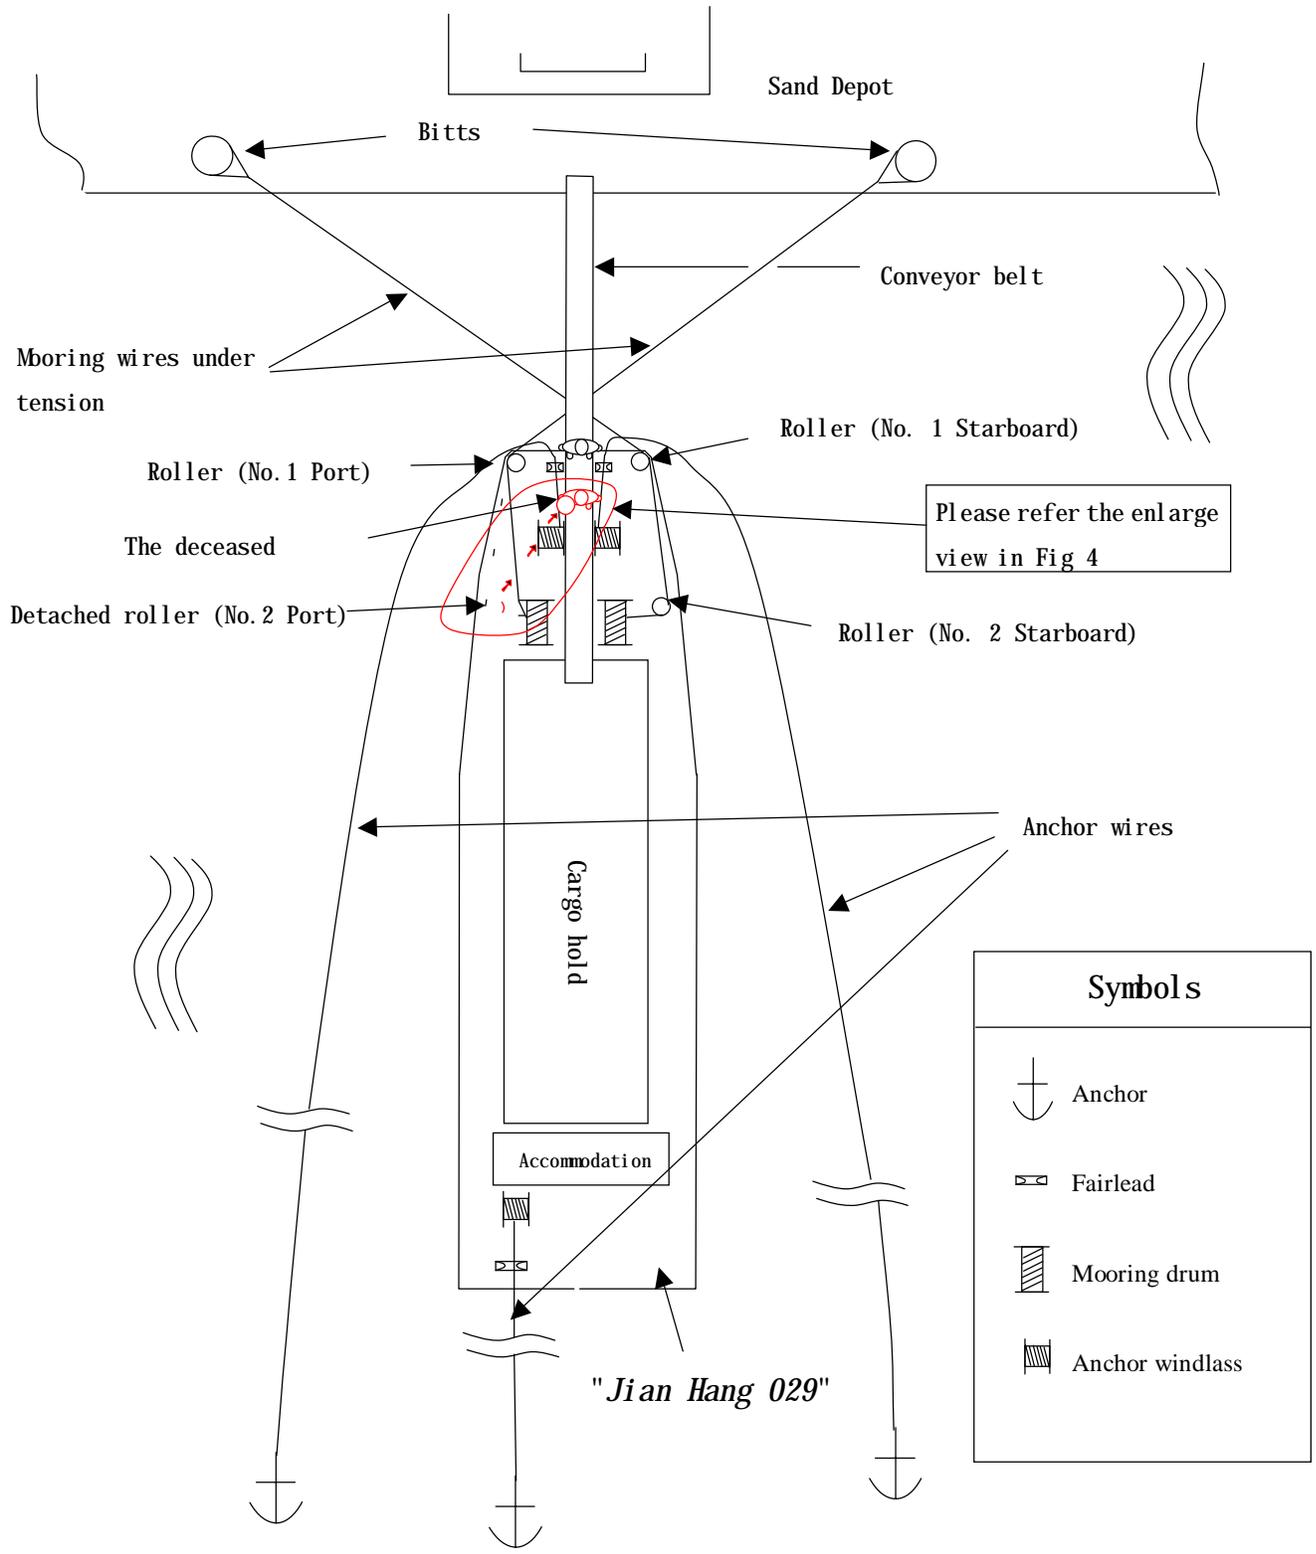
Fig. 3 The mooring arrangement of the Vessel

- 5.5 Three anchors were lowered into the water and two mooring wires were rigged to the berth to secure *the Vessel* as shown in fig. 3. The mooring operation was done by adjusting the length of the mooring and anchor wires. In order to adjust the position for discharging, the crewmembers required to heave in the mooring and anchor wires which might cause the fairleads to be subject to heavy stress and bending moment.

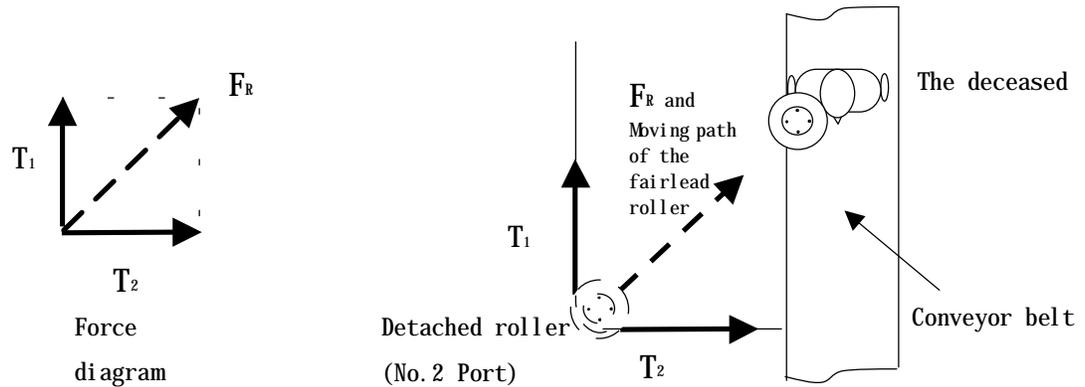
Fig. 4: The fairlead roller assembly detached and hit the head of the deceased.

- 5.6 While the deceased and another Seaman were walking back to *the Vessel* via the conveyor belt, the No. 2 Port fairlead roller together with the broken roller pin detached and thrown out to the direction of the deceased. (See fig. 4). The roller hit the head of the deceased in the incident.

- $T_1$ : Force on mooring wire in the forward direction  
 $T_2$ : Force on mooring wire in the direction of the mooring winch drum  
 $F_R$ : Resultant force of  $T_1$  and  $T_2$

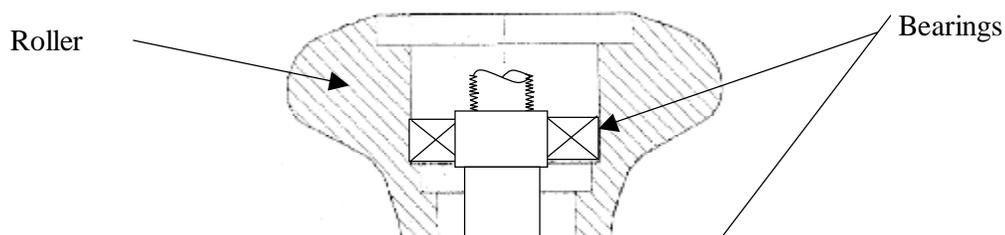
Fig. 5: Re-constructed drawing of the fairlead roller assembly

- 5.8 After the incident, the fairlead roller assembly was lost in the water. Based on the information of the assembly provided by the owner, a drawing was re-constructed to show the welding arrangement of the assembly to the ship's structure (see fig. 5). The assembly consisted of a bedplate, a roller pin and roller casting. The roller pin was fitted onto the bedplate and reinforced by four stiffeners by welding. The assembly was fixed to the deck by welding at the base of the bedplate. Two bearings were fitted for reducing the friction of the rolling motion of the roller. The roller pin was found broken at the stepped section near the lower end of the pin (see fig. 5).

- 5.9 According to the fabrication drawing (see appendix), the lower portion of the roller pin was supposed to be uniform in diameter of 75mm. However, for an unknown reason, the end of the roller pin was lathed down from 75mm to 47mm (see fig. 5). With the reduction of the cross sectional area, the strength of roller pin was greatly reduced. Besides, no fillet radius was found at the step that would create a stress raiser resulting in localize stress concentration with further strength reduction.

- 5.10 The roller pin was fixed to the bedplate by fusion welding. There was no measures such as inspection and test to ensure the quality of the work. It was found that the workmanship of the welds was poor. The welding did not penetrate and melt into the base metal sufficiently, thus the strength of the welds to the bedplate was too weak to withstand the large pulling force of the mooring wire during the mooring operation.

- 7.1 A copy of this report should be sent to the concerned parties such as the Guangdong Maritime Safety Administration, PRC China, the operator and the owner of *the Vessel*, advising them the findings of the of this incident.
- 7.2 The master, the owner and the operator and *the Vessel* are reminded that the roller pins of the fairleads were high load bearing equipment. The fairlead roller assembly should be designed, fabricated and installed by competent person and inspected by the Administration or the Recognized Organization.
