Report of Investigation  
into the Crew Fatality During  
Mooring Operation on Board  
the Sand Barge “Jian Hang 029”  
on 2 July 2005

The Hong Kong Special Administrative Region  
Marine Department  
Marine Accident Investigation Section

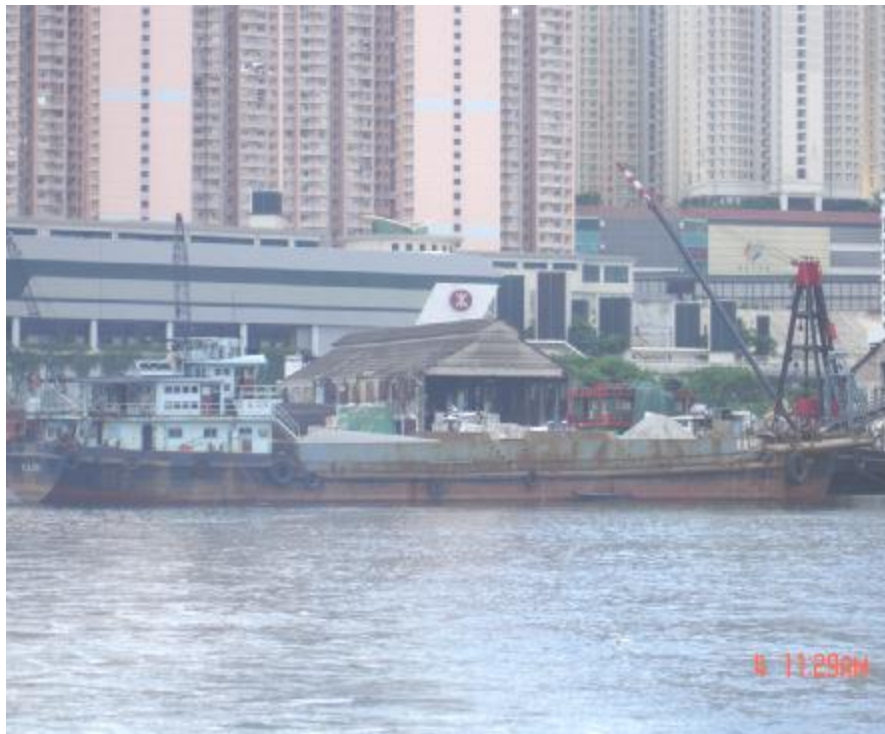
Fig. 1: Sand barge "*Jin Hang 029*" at the Sand Depot

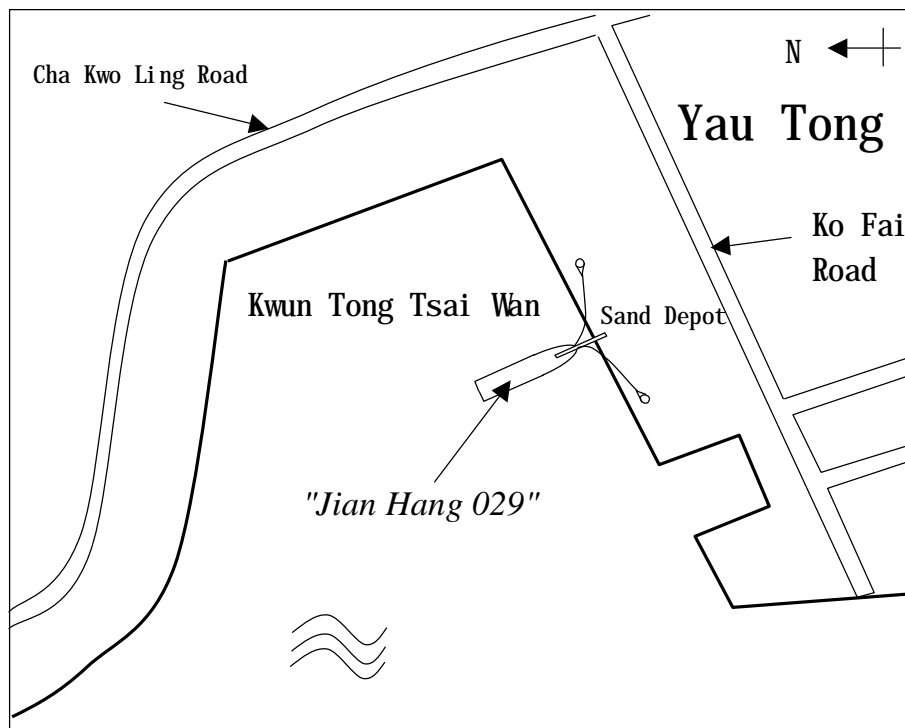
- 4.1 In the evening of 30 June 2005, *The Vessel* fully loaded with sand cargoes in bulk, sailed from Zhuhai to Hong Kong for discharging. At about 1800 on 1 July 2005, *the Vessel* arrived at Kwun Tong Tsai Wan, Yau Tong and waited for berthing. At about 0600 on 2 July 2005, *the Vessel* shifted to the Sand Depot off Ko Fai Road, for berthing. (See fig. 2)

Fig. 2: The position of *the Vessel* at the time of the accident

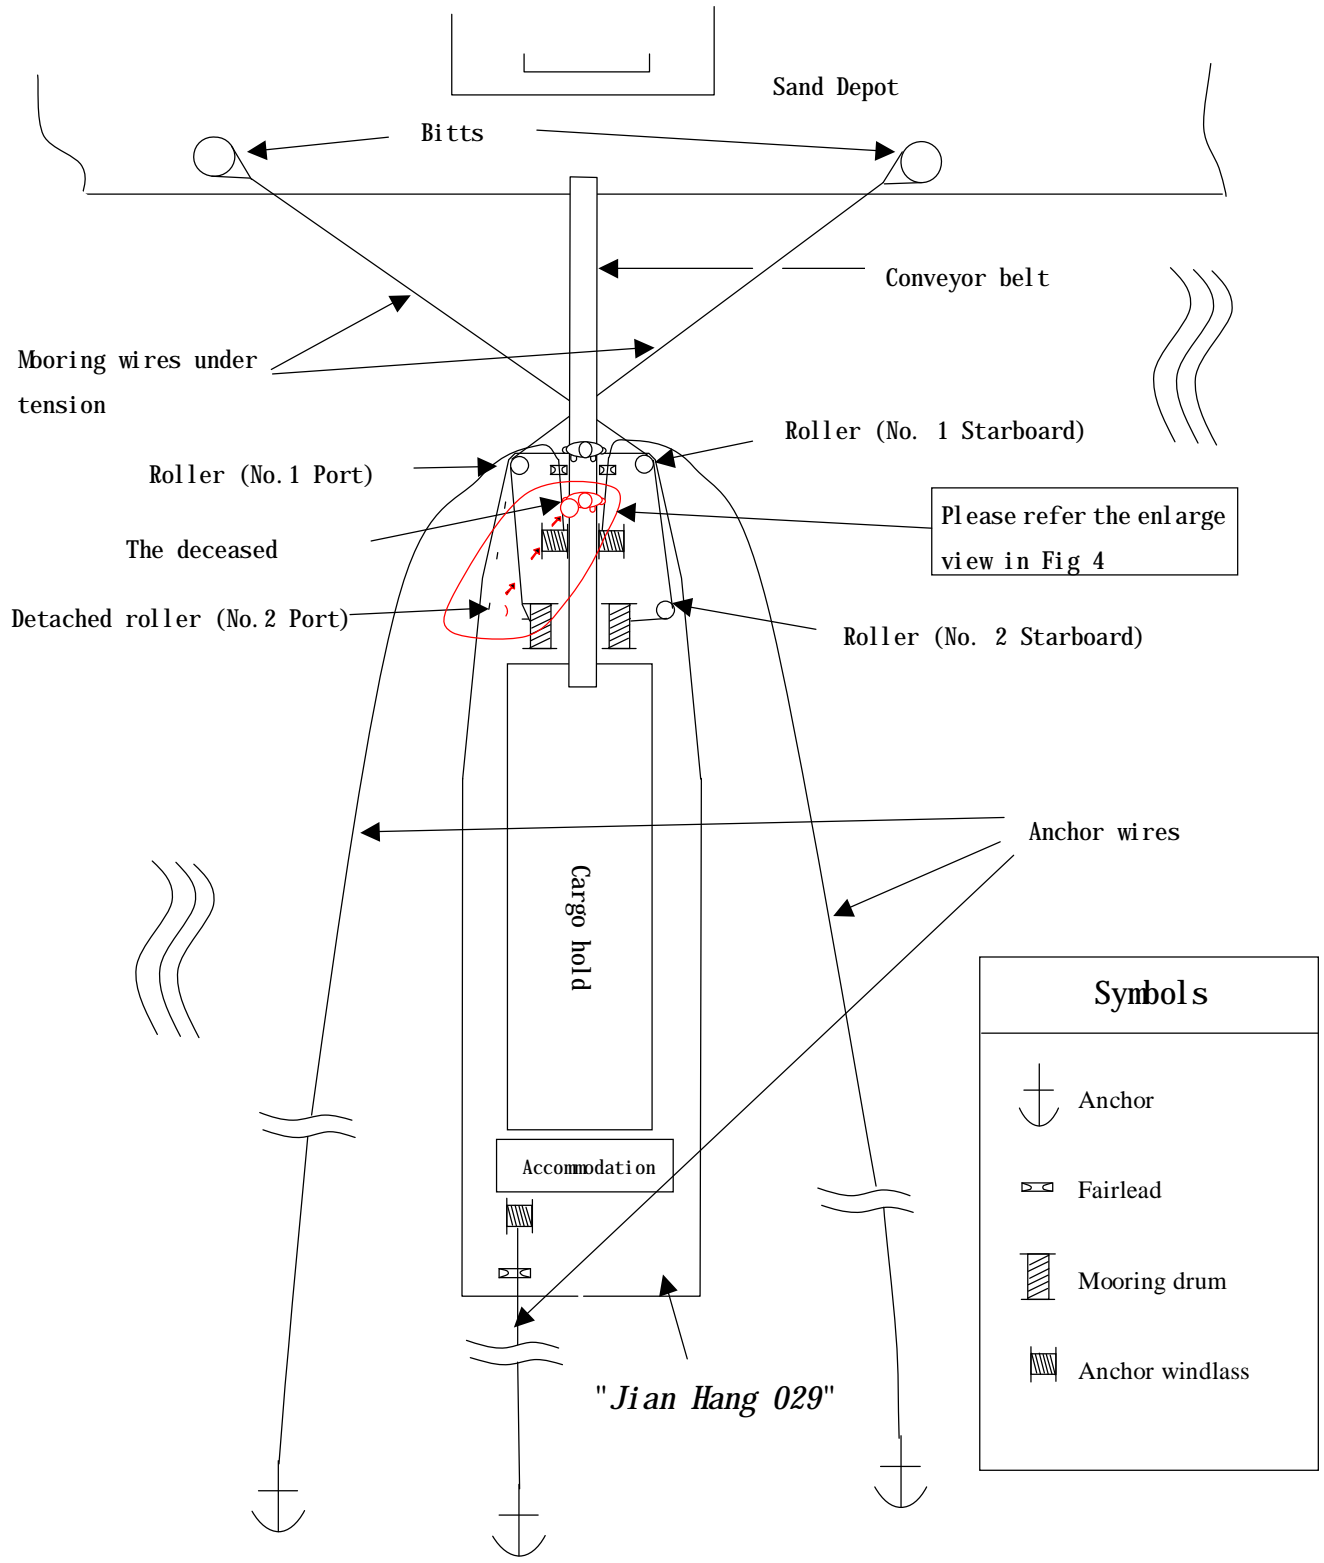
- 5.5 Three anchors were lowered into the water and two mooring wires were rigged to the berth to secure *the Vessel* as shown in fig. 3. The mooring operation was done by adjusting the length of the mooring and anchor wires. In order to adjust the position for discharging, the crewmembers required to heave in the mooring and anchor wires which might cause the fairleads to be subject to heavy stress and bending moment.

Fig. 3 The mooring arrangement of the Vessel

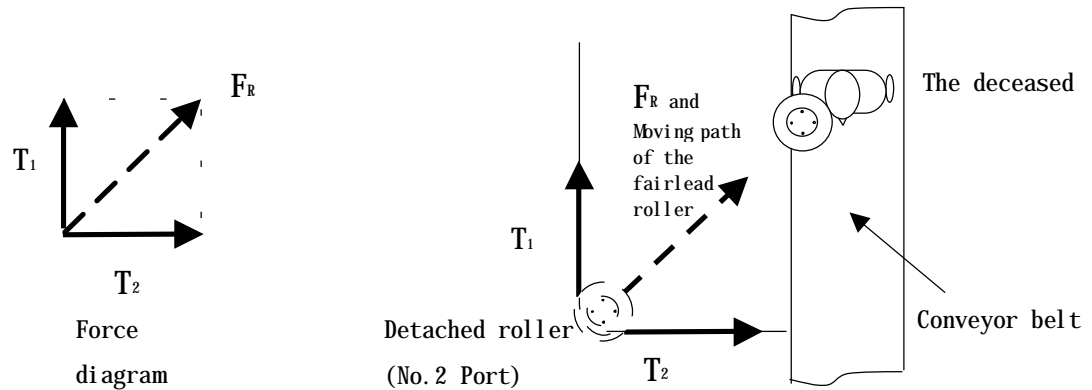
- 5.6 While the deceased and another Seaman were walking back to *the Vessel* via the conveyor belt, the No. 2 Port fairlead roller together with the broken roller pin detached and thrown out to the direction of the deceased. (See fig. 4). The roller hit the head of the deceased in the incident.

- $T_1$ : Force on mooring wire in the forward direction  
 $T_2$ : Force on mooring wire in the direction of the mooring winch drum  
 $F_R$ : Resultant force of  $T_1$  and  $T_2$

Fig. 4: The fairlead roller assembly detached and hit the head of the deceased.

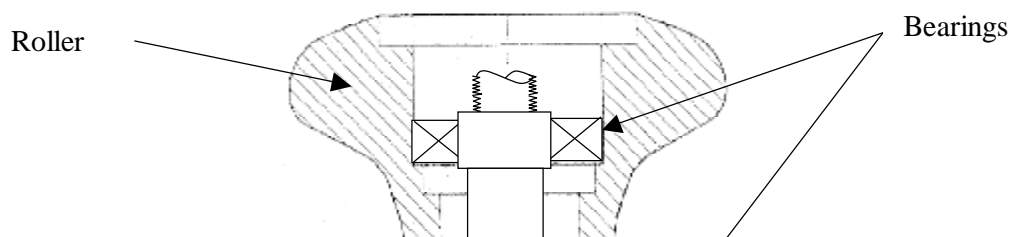
- 5.8 After the incident, the fairlead roller assembly was lost in the water. Based on the information of the assembly provided by the owner, a drawing was re-constructed to show the welding arrangement of the assembly to the ship's structure (see fig. 5). The assembly consisted of a bedplate, a roller pin and roller casting. The roller pin was fitted onto the bedplate and reinforced by four stiffeners by welding. The assembly was fixed to the deck by welding at the base of the bedplate. Two bearings were fitted for reducing the friction of the rolling motion of the roller. The roller pin was found broken at the stepped section near the lower end of the pin (see fig. 5).

Fig. 5: Re-constructed drawing of the fairlead roller assembly

- 5.9 According to the fabrication drawing (see appendix), the lower portion of the roller pin was supposed to be uniform in diameter of 75mm. However, for an unknown reason, the end of the roller pin was lathed down from 75mm to 47mm (see fig. 5). With the reduction of the cross sectional area, the strength of roller pin was greatly reduced. Besides, no fillet radius was found at the step that would create a stress raiser resulting in localize stress concentration with further strength reduction.

- 5.10 The roller pin was fixed to the bedplate by fusion welding. There was no measures such as inspection and test to ensure the quality of the work. It was found that the workmanship of the welds was poor. The welding did not penetrate and melt into the base metal sufficiently, thus the strength of the welds to the bedplate was too weak to withstand the large pulling force of the mooring wire during the mooring operation.

- 7.1 A copy of this report should be sent to the concerned parties such as the Guangdong Maritime Safety Administration, PRC China, the operator and the owner of *the Vessel*, advising them the findings of the of this incident.
- 7.2 The master, the owner and the operator and *the Vessel* are reminded that the roller pins of the fairleads were high load bearing equipment. The fairlead roller assembly should be designed, fabricated and installed by competent person and inspected by the Administration or the Recognized Organization.
