Lifeboat accident on board M.V. "Tiara Ocean" 18.7.2005

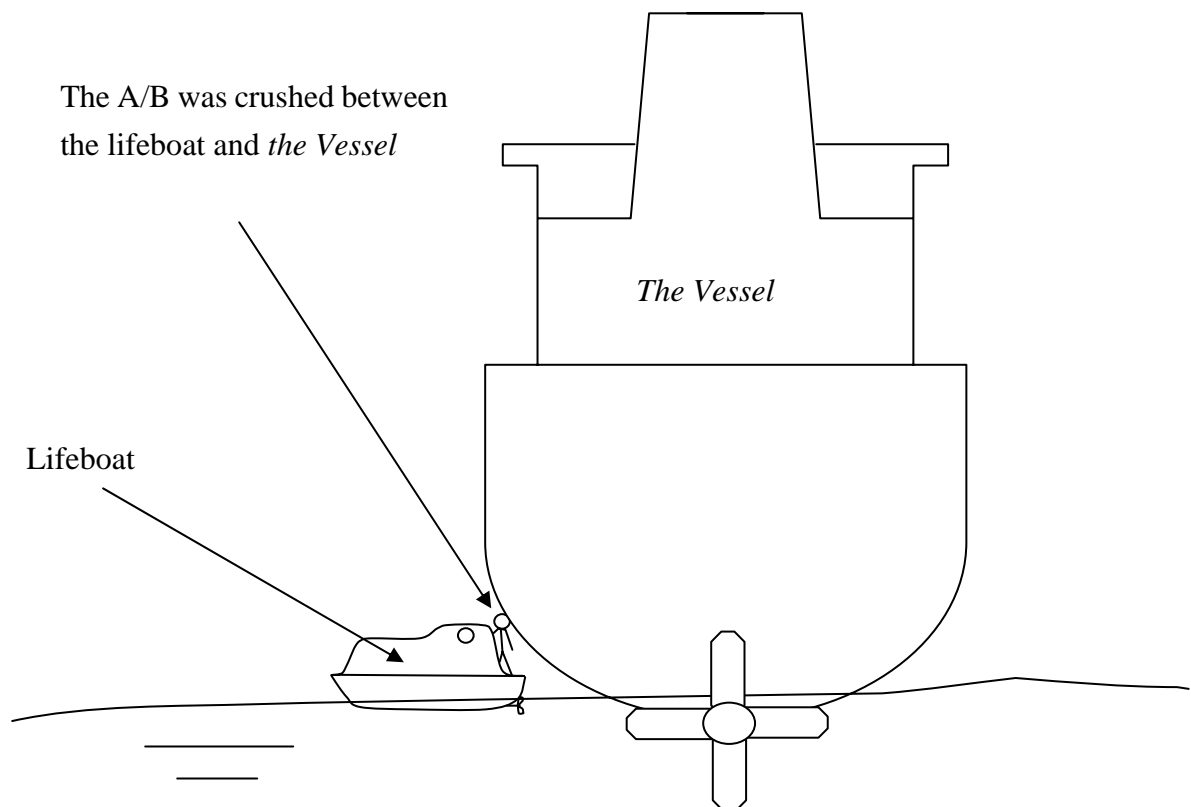
- 1.1 On 18 July 2005, a lifeboat drill was conducted on board m.v. "Tiara Ocean" (*the Vessel*) which was moored alongside the Port Phoades, Jamaica. The No.2 lifeboat at the ship's port side was launched at 0815. The lifeboat manoeuvred in the water for about 15 minutes
- 1.2 After the manoeuvring, the crew prepared to recover the lifeboat back to the ship's davit. At 0832, the Third Officer (3/O) and the Able Seaman (A/B) stationed at the forward and aft lifting hook positions for recovering the lifeboat.
- 1.3 While the A/B was connecting the floating block onto the hook at the aft deck, the lifeboat drifted by the water current and a gust of wind into the curvature area of the aft side shell. During the impact, the A/B was crushed between the canopy of the lifeboat and the side shell of *the Vessel*. He fell into the water after the incident. (See attached sketch)

construction of *the Vessel* the side shell at the aft quarter was in large curvature. If not controlled properly, the canopy of the lifeboat would be easily wedged under the curvature of the aft shell plating of *the Vessel* during recovering of the lifeboat.

3.1 The helmsman of the lifeboat did not maintain an all-round lookout during the recovering process. Neither the top hatch of the canopy was used, nor a designated crew was assigned to keep a proper lookout while the C/O was manoeuvring the lifeboat. As a result he was not able to assess the situation and react promptly to manoeuvre the lifeboat.

Sketch showing the scene of the accident
