Report of Investigation  
into the Lifeboat Accident  
on Board M.V. "Tiara Ocean"  
on 18 July 2005

The Hong Kong Special Administrative Region  
Marine Department  
Marine Accident Investigation Section

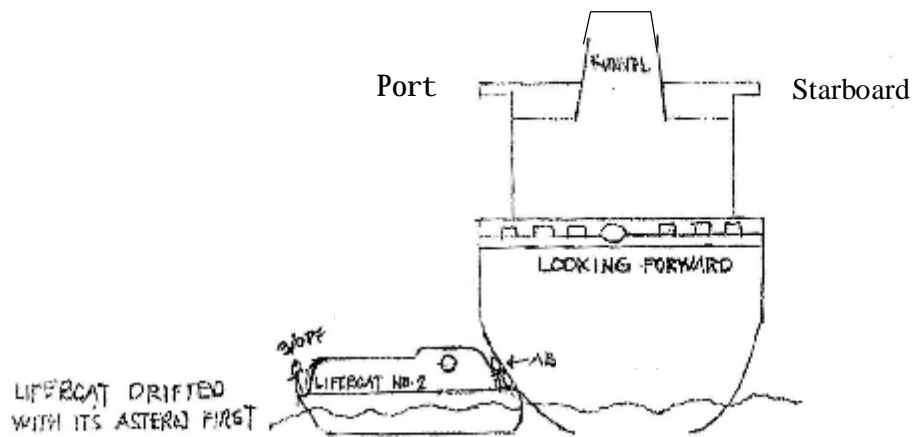
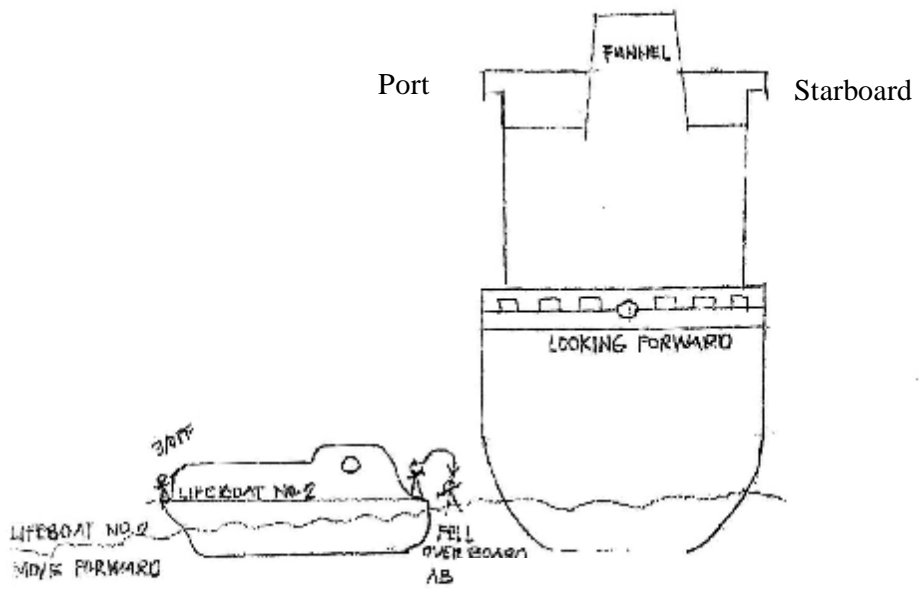
Fig.2: Sketch showing the sequence of the accident  
(Provided by the Master of the Vessel)

- 4.5 While the A/B was connecting the floating block onto the hook at the aft deck, the lifeboat drifted by the water current and a gust of wind into the curvature area of the aft side shell. During the impact, the A/B was crushed between the canopy of the lifeboat and the side shell of *the Vessel*. He fell into the water after the accident. (See fig. 2)

- 5.8 The stowage position of the lifeboats was closed to the aft of *the Vessel* (at frame No. 30). Due to construction of *the Vessel* the side shell at the aft quarter was in large curvature. If not controlled properly, the canopy of the lifeboat would be easily wedged under the curvature of the aft shell plating of *the Vessel* during recovering of the lifeboat.

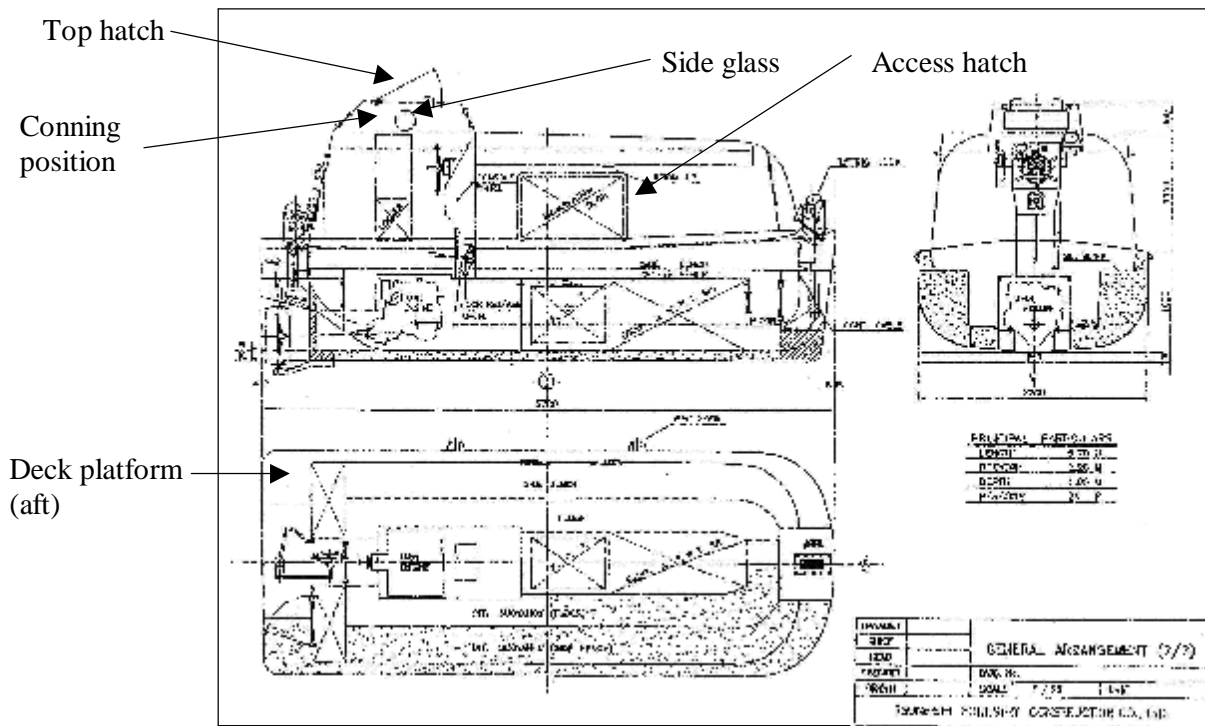
Fig.3: General arrangement of the lifeboat

- 5.3 A deck platform of about 0.5 m width was provided at the aft for facilitating the crew to engage the floating block to the hook of the lifeboat. Griprails were fitted around the canopy of the lifeboat. At the time of the accident, the deceased stationed at the aft deck platform and concentrated on the connection of the floating block onto the hook of the lifeboat. The aft deck platform provided limited space for the A/B to move about when the lifeboat made contact to the side shell of *the Vessel*.

- 5.4 The lifeboat was under the command of the C/O and he was acting as the helmsman to maneuver the lifeboat. The steering position was fitted with four windows around the helmsman to enable the helmsman to have an all-round view. A hatch was also fitted at top of the helmsman to allow him to stand up to obtain an unobstructed view.

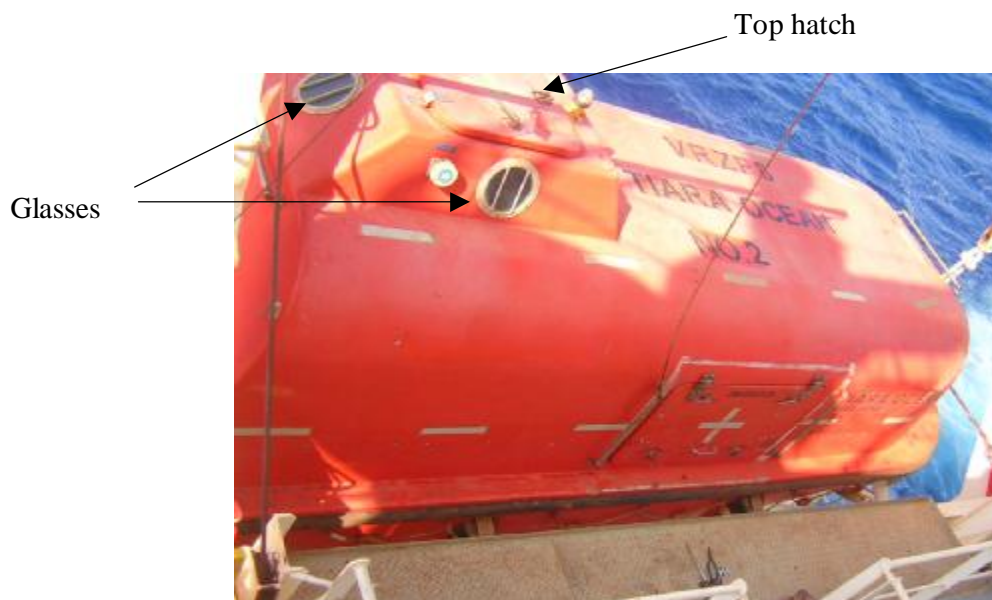
Fig.4: Photo of the lifeboat

- 5.5 However as the windows were small in sizes (at about 0.25 m in diameter) they did not provide a good view to the outside environment. The top hatch was to be used to ensure the helmsman to have a clear view but it was not opened during the maneuver. To maintain a vigilant lookout, alternatively, a crew could be assigned to maintain an all-round and unobstructed view for any irregularity.

- 5.6 Throughout the lifeboat drill, the top hatch was not opened and there was no designated crew assigned to keep a lookout. The steering position inside the lifeboat did not given an unobstructed view to the helmsman. As a result, the Chief Officer was not able to assess the situation outside the lifeboat and react promptly with the manoeuvring when the lifeboat was drifted to the side shell of *the Vessel*.

- 7.1 A copy of this report should be sent to the concerned parties such as the Master, Chief Officer and the Operator of *the Vessel*, advising them the findings of the of this incident.
- 7.2 A Merchant Shipping Information Note is to be promulgated to alert the crew of the Hong Kong registered ships the potential hazards in carrying out lifeboat drill. A proper lookout should always be kept to ensure safe handling of the lifeboat.
