Report of investigation

into the fatal incident

m.v. *"Tai Ping"*

on 22 July 2005

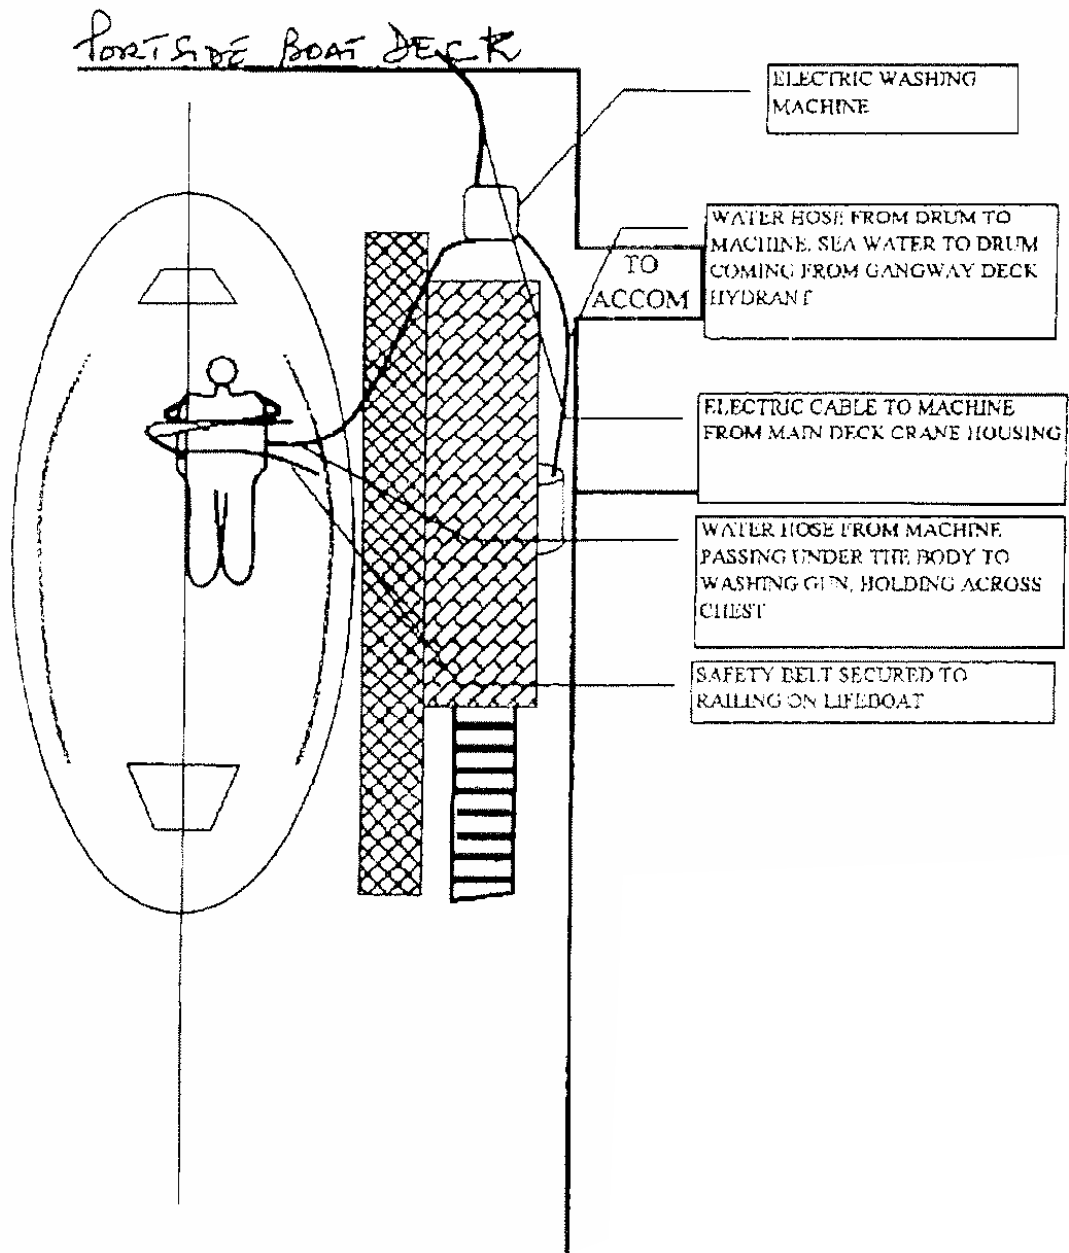
Fig. 2: Sketch showing the scene of the incident

- 4.3 At about 1153, the Bosun called the AB for lunch break. He found that the AB was lying unconsciously on top of the port lifeboat, holding the jet gun of the high-pressure water jet cleaning machine with the water hose wrapped around his body. (See fig. 2)

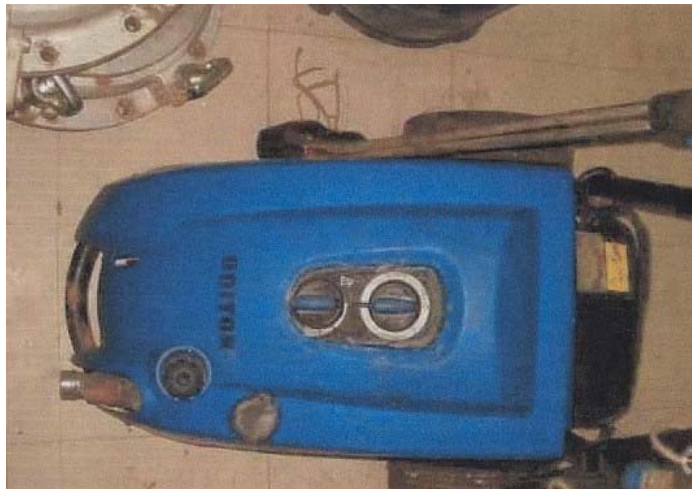
Fig. 3 The high-pressure water jet cleaning machine

Insulation test on the equipment was conducted by the Electrical Officer at 1600 on 22 July 2005 (four hours after the incident). The test results were as follows:

Item	Relay	Motor	Power Switch	Power Switch	Plastic Body
Insulation Resistance (MΩ)	8	10	3	1	0.5

According to the test result, the insulation resistance of the plastic casing of the high-pressure water jet cleaning machine was rather low and was considered unsafe to operate. Apparently, there were surface deposits of dirt or film of moisture on the plastic casing of the machine. A rough calculation on the leakage current passing through the AB is made based on the following data:

- 6.2 At the time of the accident, the deceased was operating a high-pressure water jet cleaning machine which was placed underneath the portside lifeboat. Water could have got into the machine and damaged its insulation. Insulation test of the machine was conducted and found that the insulation resistance was low and considered unsafe to operate.

As to the probable causes of low reading of the machine after the unfortunate incident of the 22-July-2005, the machine was wet when reading were taken after the incident.

- 7.1 A copy of this report should be sent to the concerned parties such as the Master and the Operator of *the Vessel*, advising them the findings of the of this incident and urging them to ensure the following safety precautions in order to reduce the risk of electric shock to personnel:
- a. Electrical equipment should be maintained in good working order for the intended purposes. The insulation resistance should be tested regularly or before use; and*
 - b. Safe operation procedures should be established for the use of electrical equipment, especially for those electrical equipment working under humid environment.*
