Report of Investigation
into the Explosion on Board
the Dangerous Goods Carrying
Barge “Cheung Kam Shui No. 2”
on 22 August 2005

The Hong Kong Special Administrative Region
Marine Department
Marine Accident Investigation Section

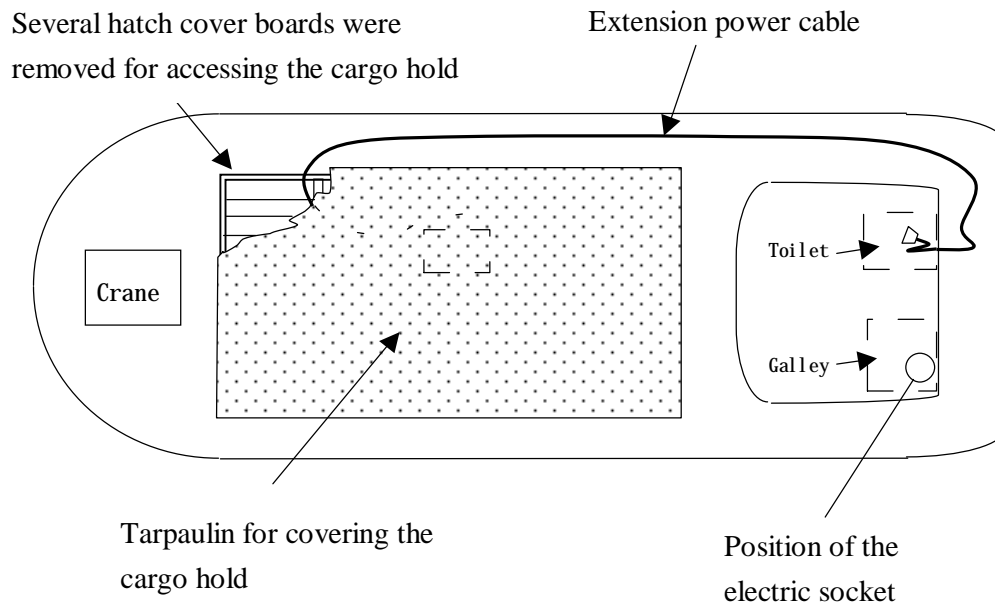
Fig. 2: The rigging of the extension power cable

- 5.9 The diesel generator was running to facilitate the repair work inside the engine room at the time of the accident. An extension power cable (see fig. 2) was found to have been rigged from the aft of *the vessel* to the cargo hold. Although the extension power cable was not connected and the plug end was left inside the toilet close to the galley, the cover of the socket was opened at the time of the investigation. It was believed that someone had unplugged the cable during the fire. Apparently, a crewmember had connected the electric power from the electric power socket at the galley to an electrical appliance in the cargo hold in the morning of 22 August 2005. To operate any electrical appliance inside the cargo hold loaded with DG was extremely dangerous as heat and sparks would be generated to ignite the PSEM.

- a) no electrical machinery should be used in cargo hold when carrying DG;
 - b) *the Vessel* must be under command of a competent Coxswain;
 - c) all DG and other goods should be properly segregated and secured;
and

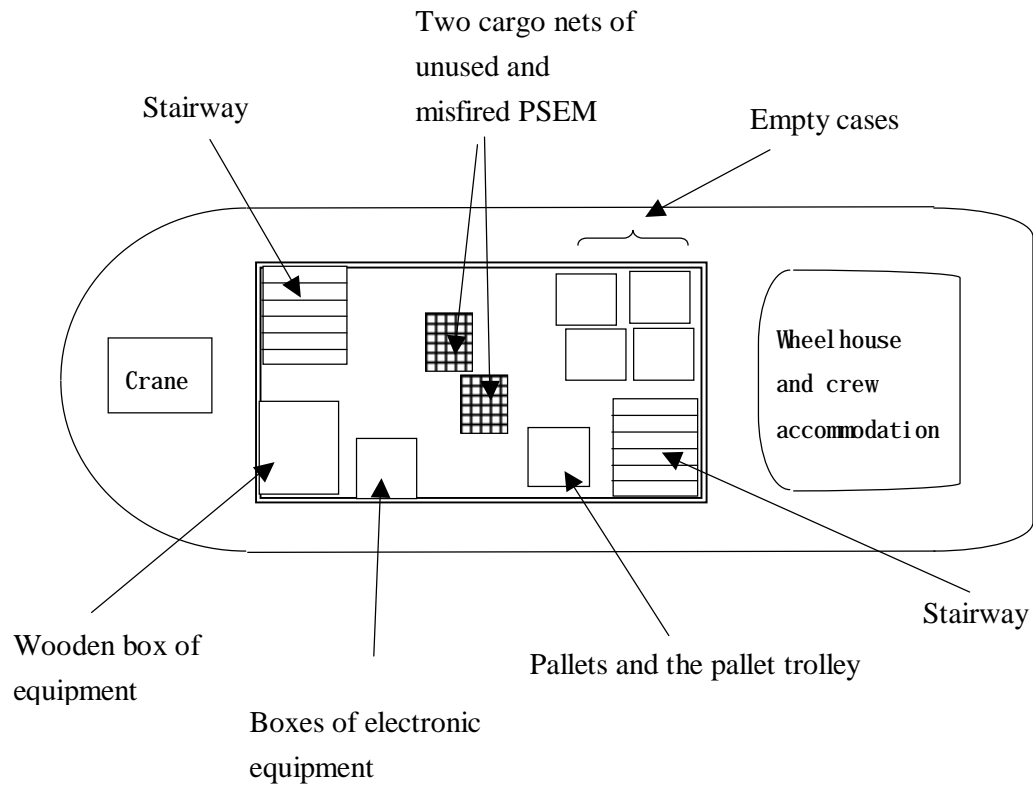
Fig. 3: Stowage arrangement of the PSEM and various equipment in the cargo hold of *the Vessel*. (Based on the description of the witnesses and site investigation)

5.10 The cargo hold of *the Vessel* was loaded with 28 cartons (482 pieces) of unused and misfired PSEM. Apart from the PSEM, lots of equipment were stowed inside. The stowage arrangement of the PSEM and various equipment is shown in fig. 3.

5.11 The unused PSEM were packed in cartons and the misfired PSEM were put in plastic bags. The cartons and plastic bags were stowed in two cargo nets and placed near the centre of the cargo hold. However, some other boxes of equipment were also placed adjacent to the PSEM. There were no securing arrangement to prevent the movement of cargoes during voyage.

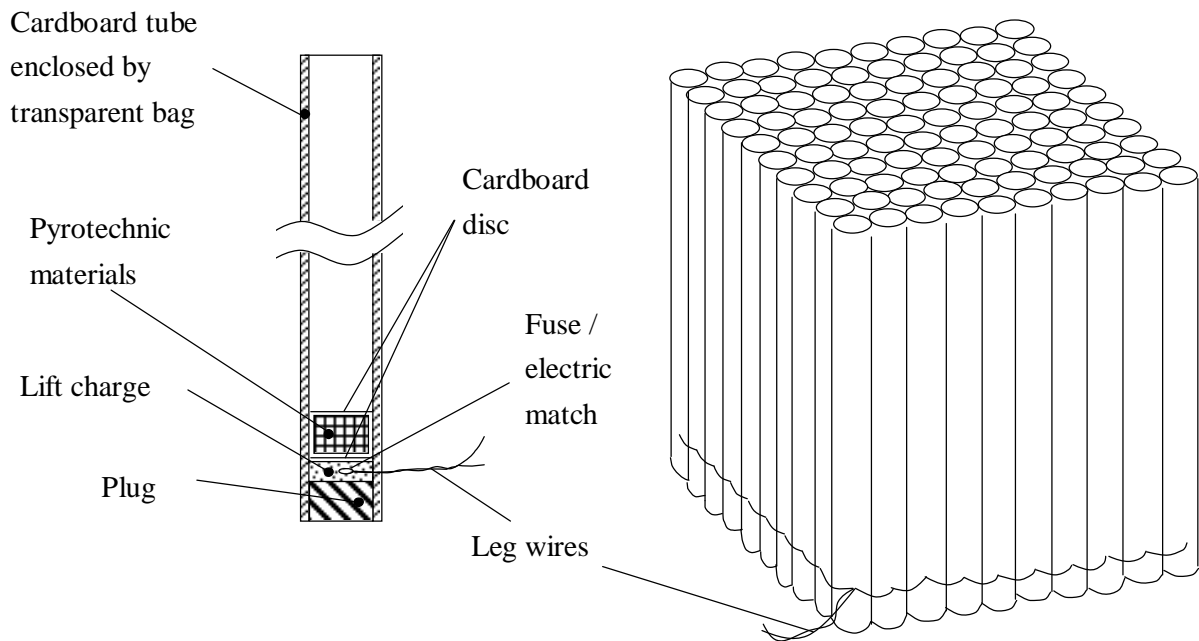
Fig. 4: Sketch of the PSEM in the cargo hold.

5.12 The PSEM (see fig. 4) were manufactured in Mainland China by "廣東惠州土產進出口公司" and consisted of a number of cylindrical cardboard tubes of sizes 30mm and 50mm in diameters. The tubes were sealed at the base by plugs that made of wood or sand clay. Inside the tubes, there were lift charge and pyrotechnic materials which were explosive and inflammable materials. Electric matches and fuses were placed inside the cardboard tubes for activating the lift charge during the PSEM displays.

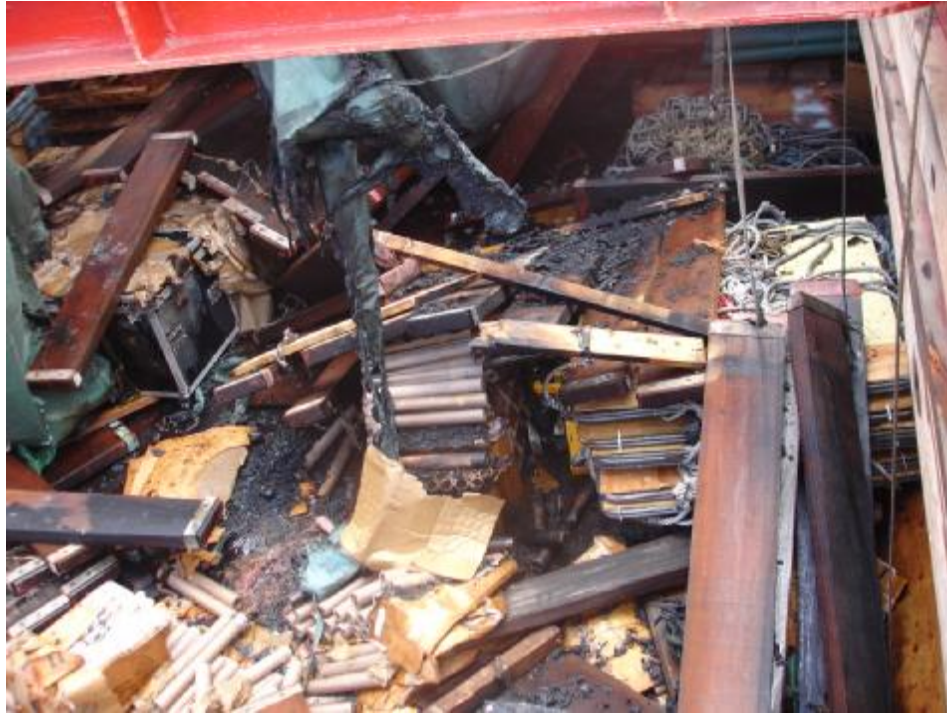
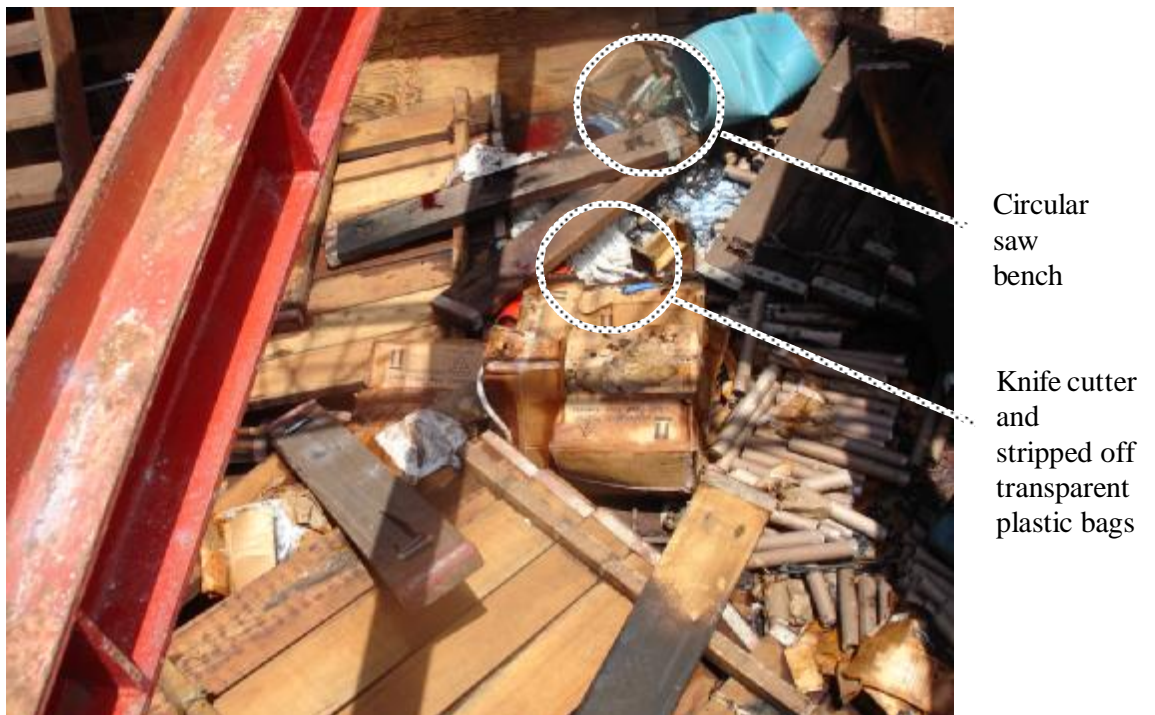
5.13 The explosion caused almost all hatch cover boards fell into the cargo hold (see figs. 5a & 5b). The tarpaulin sheet was burnt with a large hole near the centre position. The stacking of the PSEMs was collapsed, part of them were burnt and darkened by the fire. The Coxswain was found dead inside the cargo hold. A circular saw bench and the socket end of the extension power cable were found near the deceased. Some transparent plastic bag (see fig. 5b) used for covering the PSEM were found stripped off and scattered on the floor. It was also noticed that a knife cutter (see fig. 5b) was found on top of a box of the PSEM. It is believed the knife cutter had been used by the deceased for cutting off plastic bags of the PSEM.

Fig. 5a: Condition of the cargo hold after the fire and the explosion

Fig. 5b: Condition of the cargo hold after the fire and the explosion

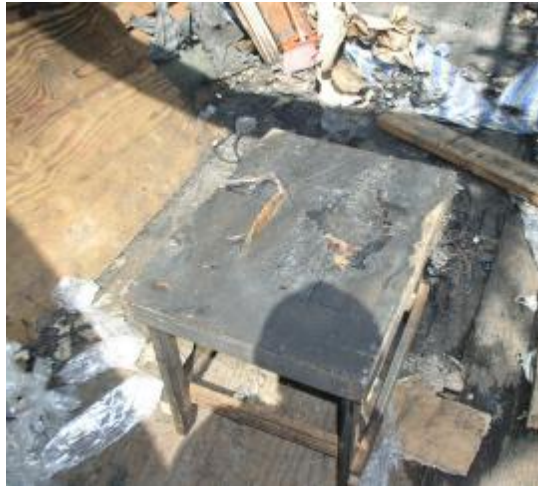
5.14 The circular saw bench (see fig. 6) was found at the starboard side of the cargo hold. A circular saw was mounted underneath the wooden bench in such a way that the circular saw cutter protruding up to the table surface through a slot. The switch of the circular saw bench was set at "ON" position and the extension power cable was rigged for obtaining electrical power from the electric mains of *the Vessel*. The bench was badly burnt and the circular saw disc was tangled with the legwires of the PSEM via the slot (see fig. 7).

Fig. 6: The burnt saw bench

5.15 The circular saw bench was normally used for cutting wooden dunnage and hatch cover boards. The crewmembers stated that the circular saw bench was in working order and it was not stowed inside the cargo hold prior to the accident.

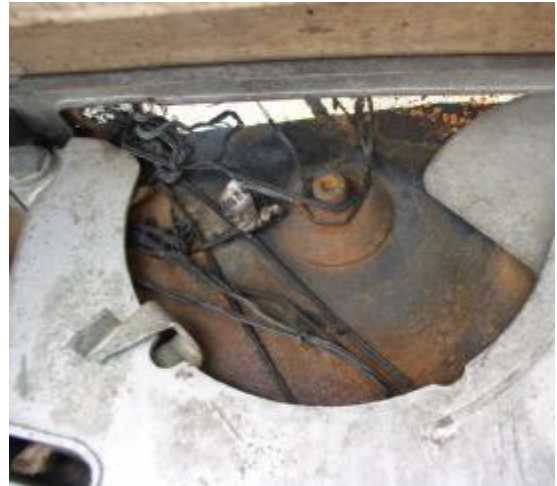
Fig. 7: Legwires were tangled at the circular saw cutter

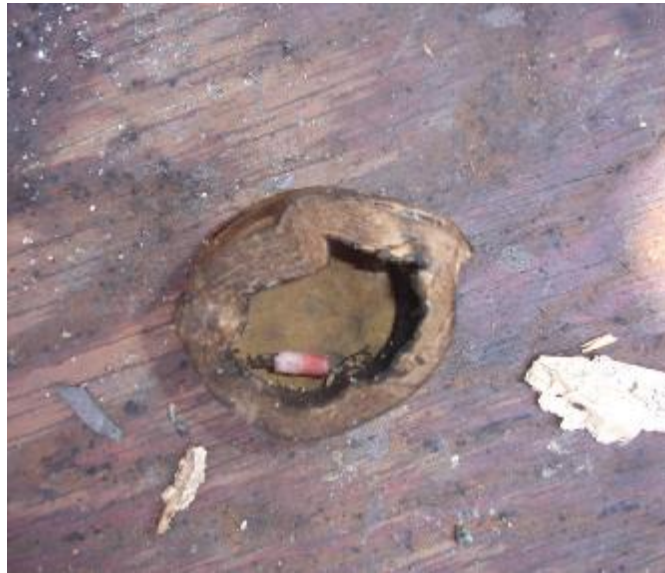
5.16 A number of cut cylindrical cardboard tubes (see fig. 8) were found scattered on the floor of the cargo hold. It appeared that, for an unknown reason, the deceased had been cutting the misfired PSEM cylindrical tubes with the circular saw bench inside the cargo hold. Such cutting process

was extremely dangerous, as a large amount of heat could be generated during the cutting of cardboard tube. Explosive powder contained in the lift charge and pyrotechnic materials might also spread in form of dust in the cutting operation. It is believed that the explosion was caused by the heated up saw blade which ignited the explosive powder. The unused PSEM were subsequently ignited by the heat and fire generated in the explosion.

Fig. 8: The cut away PSEM cardboard cylinder found inside the cargo hold.

- 7.2 Instructions and procedures for the disposal of unused and misfired PSEM should be established and made known to all crewmembers.
- 7.3 The Marine Department may consider appropriate measures to monitor more closely the movements of DG carrying vessels.
