Report of Investigation
into the Fatal Accident of a
Crewmember when Working
Outboard of “Hebei Friendship”
on 9 November 2005

The Hong Kong Special Administrative Region
Marine Department
Marine Accident Investigation Section

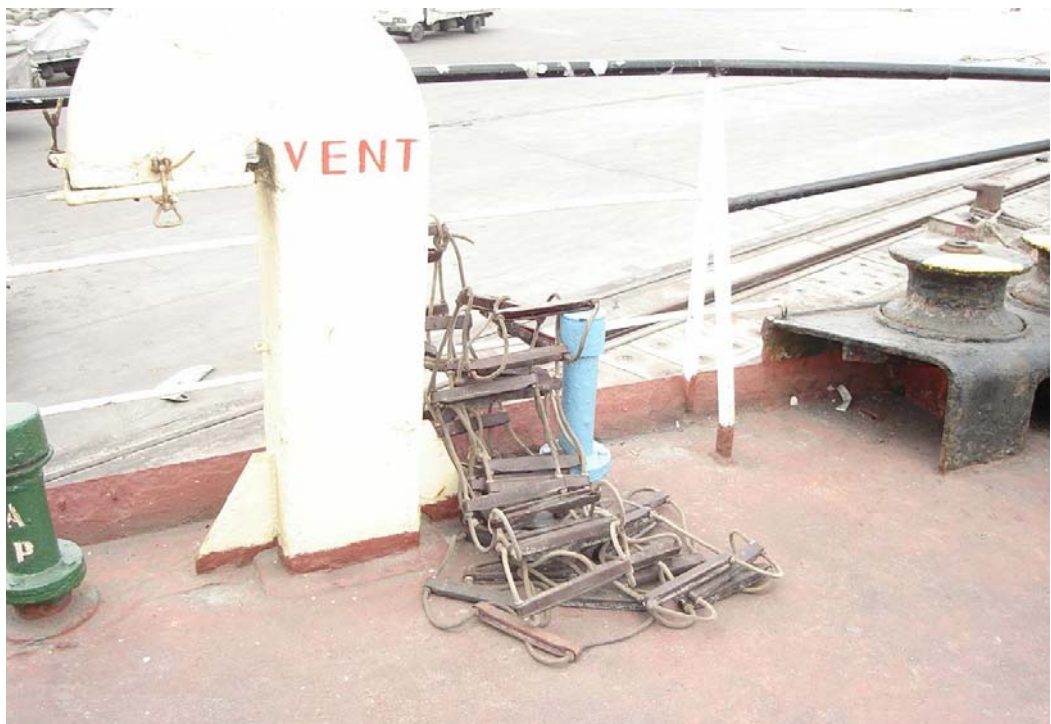
Figure 2 – Jacob Ladder secured on Handrail

- 5.3 The Jacob ladder was rigged by the AB himself and it was secured on the handrail on the poop deck (Figure 2). After the accident, it was found that the Jacob ladder was in good working condition and it was rigged and secured properly.

- 5.4.1 The ISM Manual of the company had laid down the safety precautions for carrying out works outboard. It was stipulated that when climbing down a Jacob ladder to read draught, the crewmember should wear lifejacket and safety harness attached to a lifeline. Two persons should carry out the job together and a lifebuoy attached with a buoyant line should be on standby at the scene.
- 5.4.2 In this particular case, it appeared that the above safety precautions had not been followed. The AB did not wear lifejacket and safety harness when he climbed down the ladder to read the after draught, nor was there any crewmember on standby on the poop deck. As a result, the AB fell into the water without the attention of other crewmembers on board and immediate assistance was not available.

- 7.1 A copy of the report should be sent to the ship management company of the vessel. They should be advised of the findings of the accident and the importance of instructing their crewmembers to strictly comply with the safety procedures as laid down in the ISM Manual.
