Report of Investigation
into the Collision Between a
Mainland Cargo Vessel
“中食 238” and a Local Motor
Launch “M73339Y”
with One Fatality
on 21 December 2005

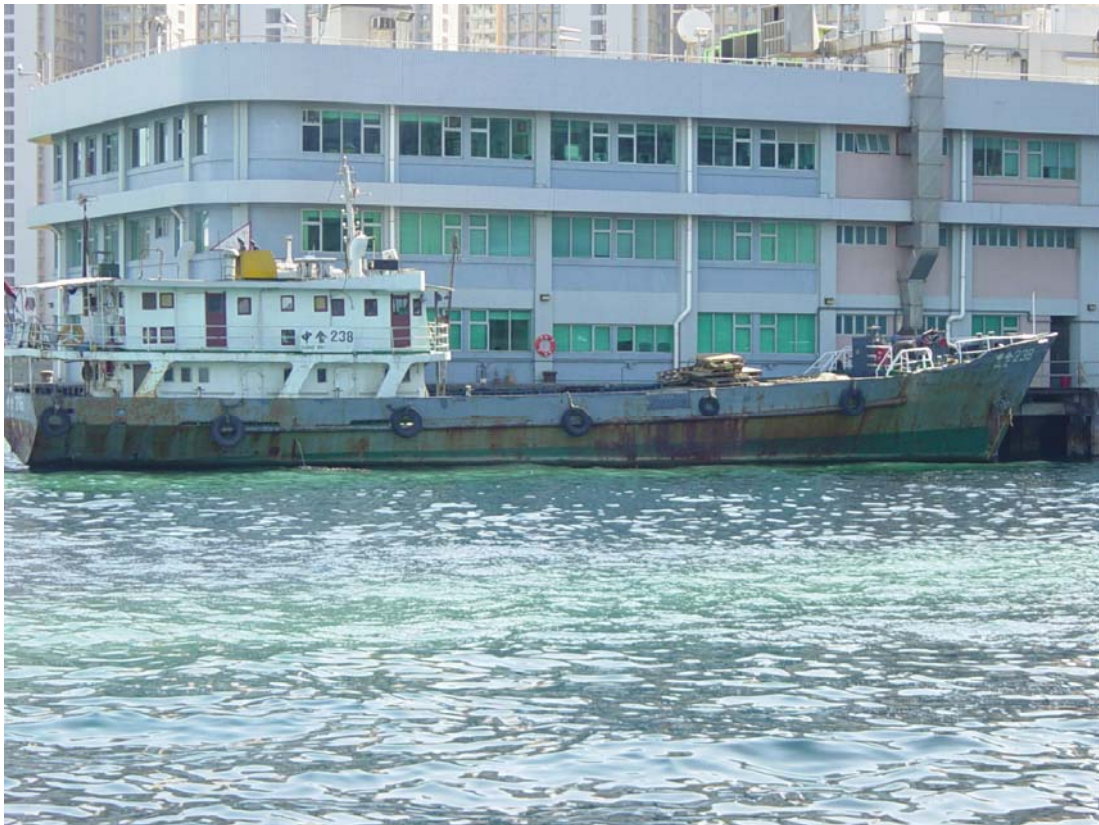
Figure 1: River trade cargo vessel “中食238”

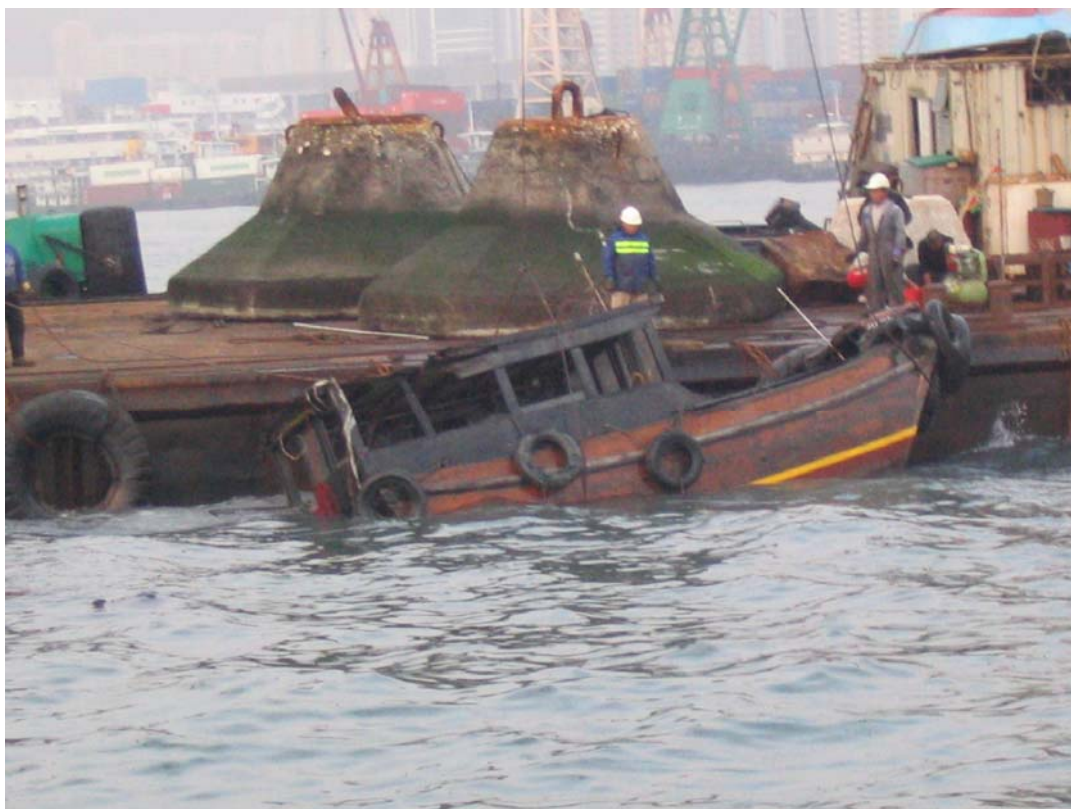
Figure 2: Wooden motor launch “M73339Y” after salvage

5.6.3 Two days after the collision, the wreckage of “M73339Y” was resurfaced and the collision damage was examined. Other than the damaged ceiling at the starboard quarter there appeared no other collision damage at the hull of the wooden launch. It is believed that the first impact between the two vessels occurred at the starboard quarter of “M73339Y”. As the speed of “中食238” was faster it’s bow pushed “M73339Y” to its side and forced the wooden launch to capsize and sink due to the forward momentum of “中食238”.

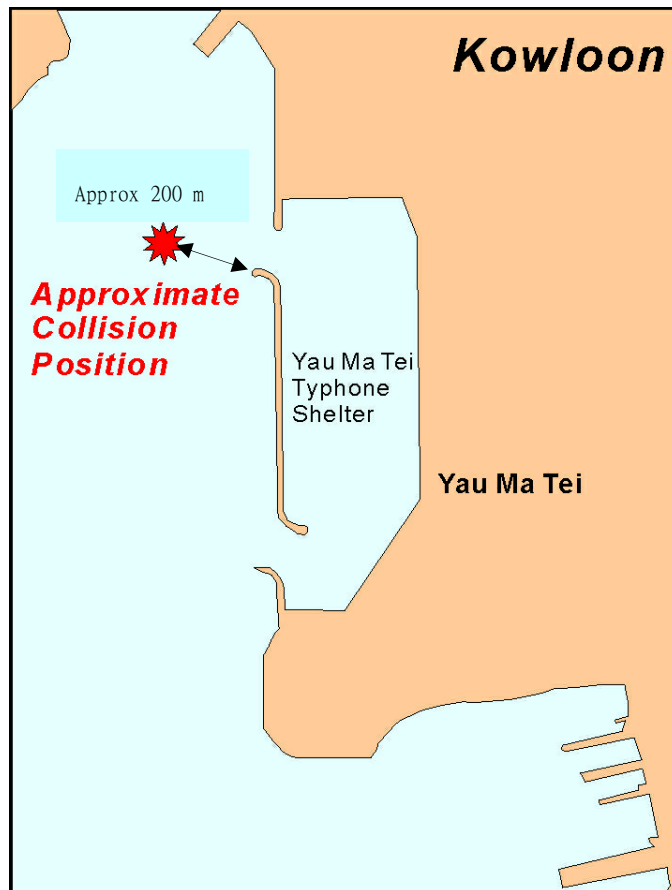
Figure 3: Position of Collision

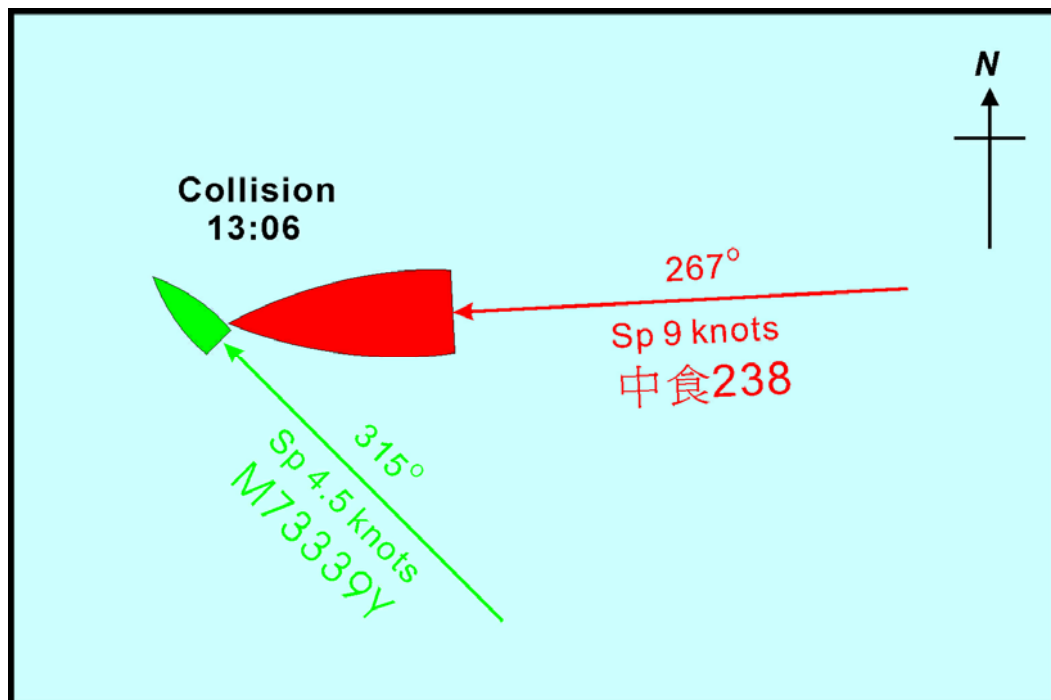
- 4.1.6 The bow of “中食238” collided with the starboard quarter of the wooden motor launch. After the impact the Quartermaster saw the wooden motor launch pushed to its starboard bow.

Fig. 4 Sketch of collision between the two vessels
