Report of Investigation
into the Fatal Accident of a
Crewmember Onboard HKR
Feng Sheng
on 6 February 2006

The Hong Kong Special Administrative Region
Marine Department
Marine Accident Investigation Section

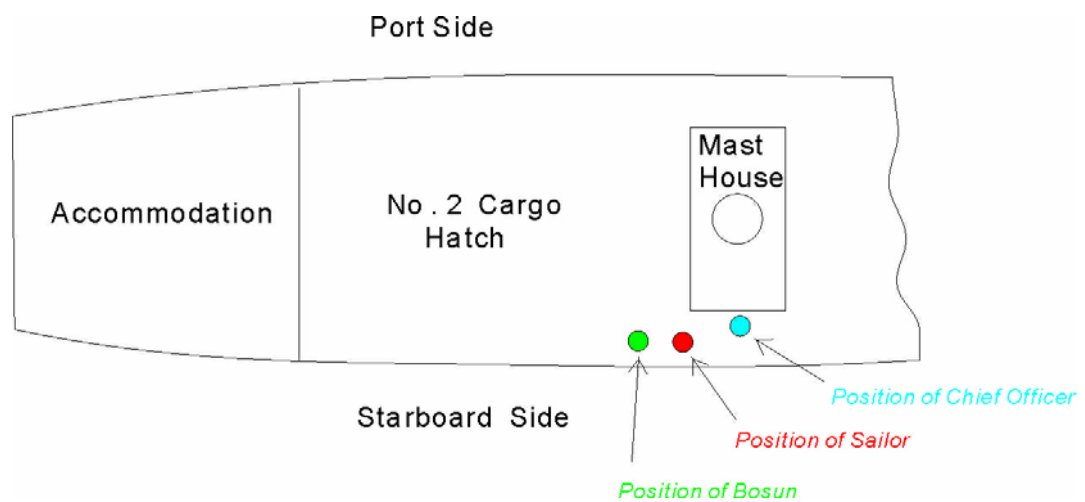
Figure 2 – Diagram showing the positions of the Chief Officer, Bosun and Sailor

- 4.1 The Vessel departed from Zhang Jia Gang of China on 18 January 2006 and arrived at Matong Port of Papua New Guinea on 1 February 2006 for loading deck log cargo.
- 4.2 At 2000 on 6 February 2006, loading of deck log cargo at No. 2 hold was completed. 3 crew members including the Chief Officer, the Bosun and a sailor were supervising the stevedores who operated the derrick to do the trimming of the deck cargo. The above crew members were standing on the deck log cargo at the starboard side of the Vessel adjacent to the masthouse (Figure 2).

- 4.3 At about 2010 when a log was lifted by the derrick, both the Bosun and the sailor who were standing nearby slipped and fell overboard into the sea when they tried to dodge the swinging log. The sailor swam to a tug which had berthed alongside the berth in front of *Feng Sheng* and was recovered by the tug's crew. He suffered minor injury.
- 4.4 The Bosun was found submerging beneath the water after swimming for a few steps. A sailor on board the tug jumped into the water and dragged the Bosun to the tug with a rope. At 2018, the Bosun was recovered on the tug and emergency medical treatment was rendered.

- 7.1 A copy of the report should be sent to the ship management company of the vessel. They should be advised of the findings of the accident and should instruct their crew members to take safety precautions by keeping themselves well clear from the cargo working area and wearing studded shoes and lifejackets when working deck log cargo. The above safety precautions should be incorporated in the ISM Manual of the Vessel.
- 7.2 A Merchant Shipping Information Note (MSIN) should be issued to draw the attentions of all concerned parties to the lessons learnt in the incident.
