Report of Investigation
into the Fatal Accident of a
Crewmember Onboard
HKR Jin Da
on 26 February 2006

The Hong Kong Special Administrative Region
Marine Department
Marine Accident Investigation Section

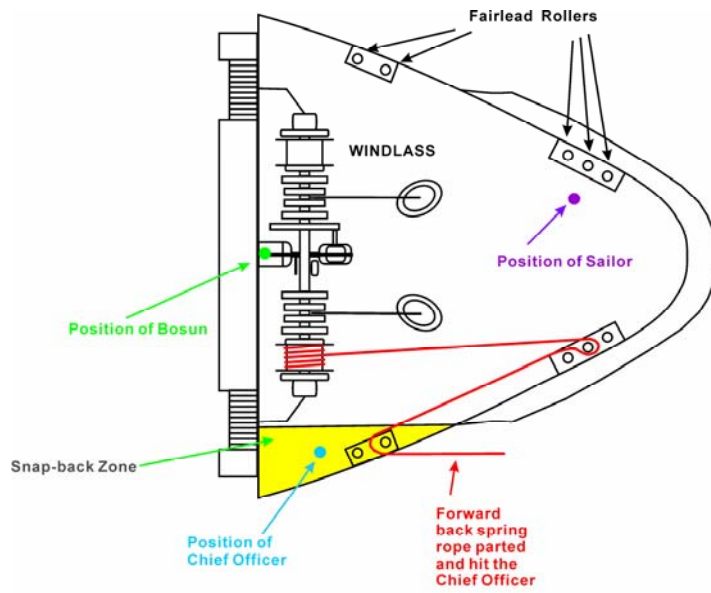
- 5.4.2 In this particular case, the above safety precautions had not been followed by the Chief Officer. After the forward back spring rope had been let go from the bollard ashore, the Chief Officer ordered the Bosun to commence heaving it with the winch. However, the forward back spring rope was unexpectedly jammed by the fender ashore in the course of heaving. The rope parted due to excessive tension caused by jamming and the vessel's astern movement. The Chief Officer who was standing within the snap-back zone was hit by the parted forward back spring rope (Figures 2 & 3).

Figure 2 – Diagram showing the positions of the Chief Officer, Bosun and Sailor

- 7.1 A copy of the report should be sent to the ship management company of the vessel. They should be advised of the findings of the accident and the importance of reminding their crewmembers not to position themselves within the snap-back zone when the moorings are under strain during mooring/unmooring operations on forecastle or poop deck.
- 7.2 A Merchant Shipping Information Note (MSIN) should be issued to draw the attentions of all concerned parties to the lessons learnt in the incident.

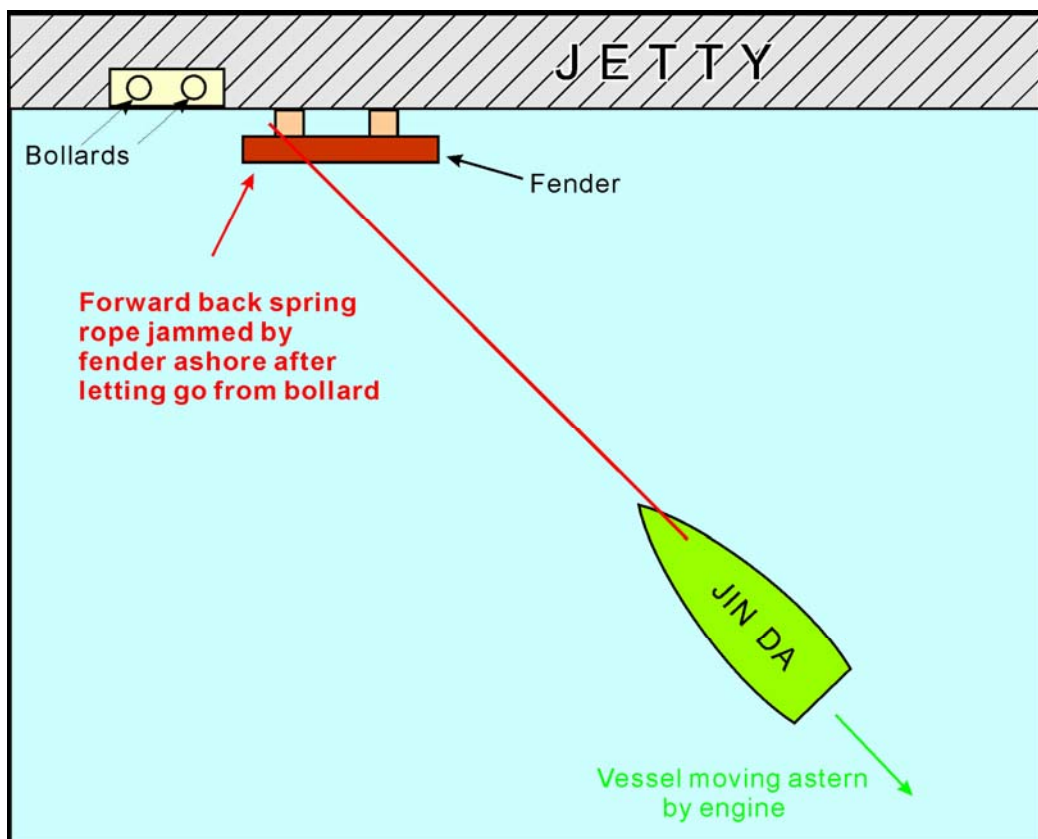
1.2 The cause of the accident was due to the failure of the Chief Officer to keep himself away from the snap-back zone when heaving the forward back spring rope with the winch. When the vessel was moving astern, the forward back spring rope was unexpectedly jammed by the fender ashore. The forward back spring rope was caused to part under excessive tension and hit the Chief Officer.

Figure 3 – Diagram showing the forward back spring rope was jammed by fender ashore when *Jin Da* was moving astern
